REGIONAL DISTRICT OF CENTRAL KOOTENAY
DEVELOPMENT PERMIT
DP2116A-05497.170-Kehler-DP000121

12523 LEWIS BAY RD
BOSWELL, BC

Riparian Assessment

Proposed Site and Mitigation Plan 12523 Lewis Bay Road, Boswell, BC Aug 10, 2021

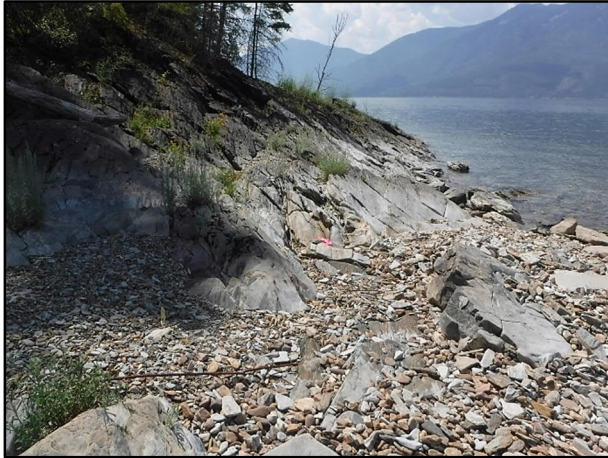
Photo 1. View of Kootenay Lake near northern property boundary, looking south.

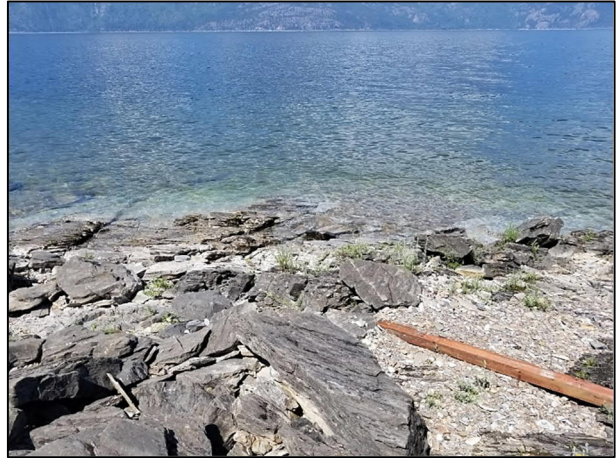
Photo 2. View of Kootenay Lake near southern property boundary, looking west.

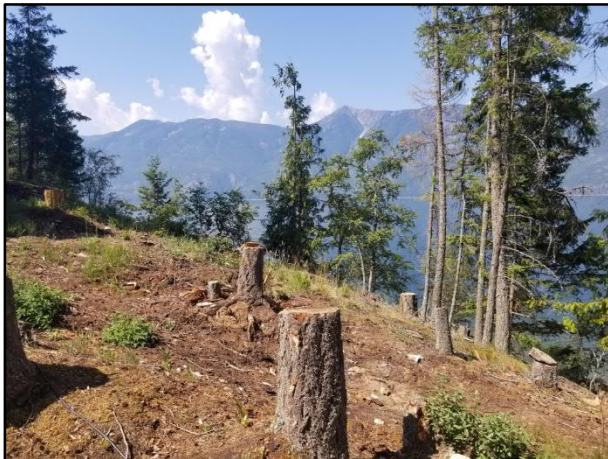
Historical development on the subject property within the ESDP area includes: vegetation removal (tree and shrub clearing), existing orchard and lawn area. Most recently the Owner has parked a trailer on the property at the top of bank (~ 20 m from the natural boundary) and has had several trees removed within and around the proposed building site at the recommendation of a certified arborist.

Photo 3. Trees removed from subject property.

To mitigate for potential vegetation loss within the SPEA and to compensate for the removal of two Douglas fir trees considered to be hazardous, it is recommended that the Owner revegetate a 50 m² area west of the proposed residence within the SPEA to enhance existing riparian habitat.

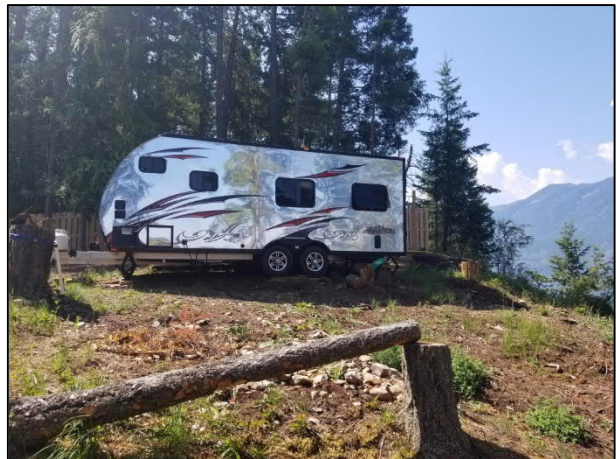
Photo 4. Trailer parked on subject property.

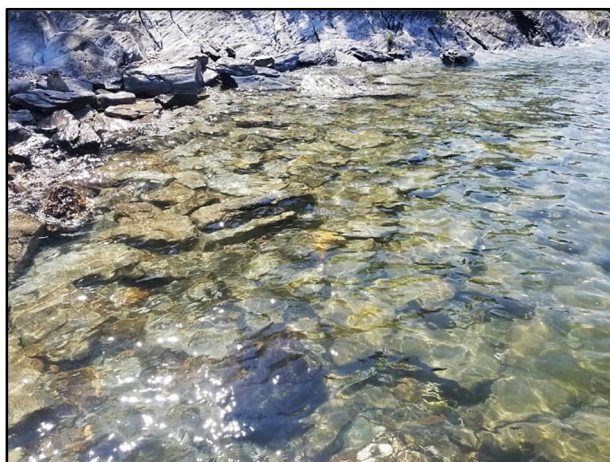
The Kootenay Lake foreshore consists of a rocky shoreline with angular boulders and pockets of gravel and cobble overlying bedrock (Photo 5). The bedrock is steeply sloping at 50 - 70 % gradient (Photo 6). A rocky beach at the north corner of the property was more moderately sloped at ~ 18 % (Photos 1-2). The angular boulders instream provide potential rearing and cover habitat for juvenile fish. LWD on the shoreline may also provide some cover at high water. No aquatic vegetation was observed in Kootenay Lake along the subject property.

Photo 5. Substrate in Kootenay Lake

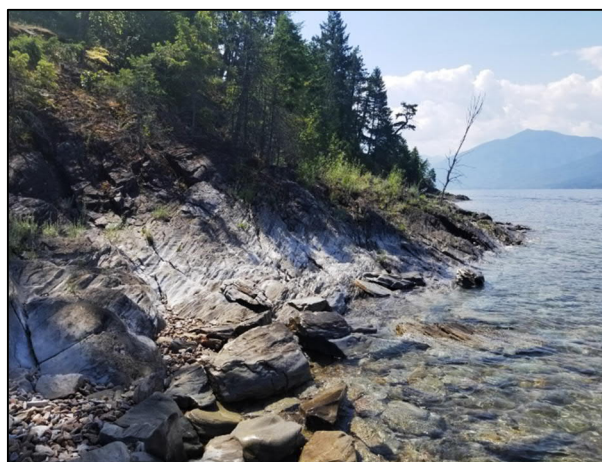
Photo 6. Steeply sloping bedrock on Kootenay Lake.

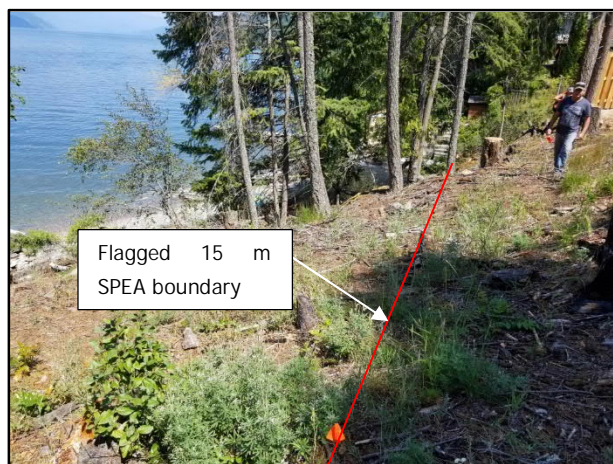
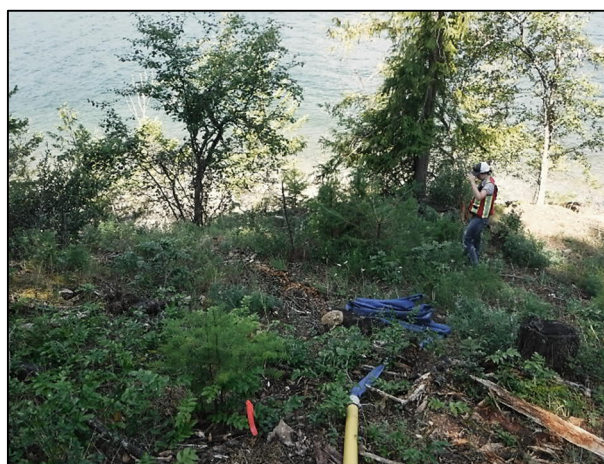
The riparian area along Kootenay Lake consists of native trees with pockets of understory shrubs and herbaceous species (Photo 7-8). This provides some bank stability and erosion protection, shade, litter fall,

Photo 7. View of riparian area looking north and Photo 8. Trees and shrubs in the riparian area. flagged SPEA boundary.
