DEVELOPMENT PERMIT

DP2113A -05007.010-Rose_Fraser-DP000118 (DP2113A)

**13745 Hwy 3A
BOSWELL, BC**

Riparian Assessment

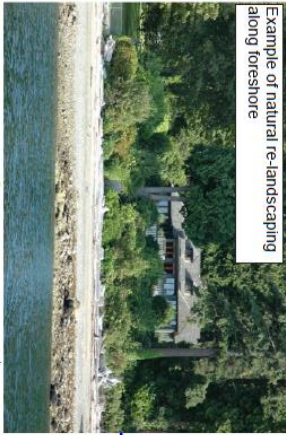
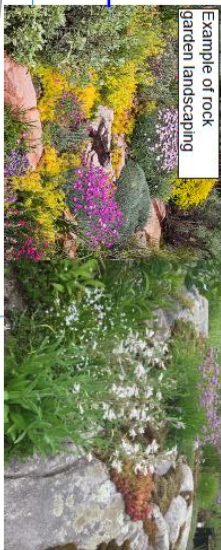
Schedule 2: Site Plan

Sketch of site information and cross sections of part of Lot A, Plan NEP77016, District Lot 4595, Kootenay District.

Example of natural re-landscaping along foreshore

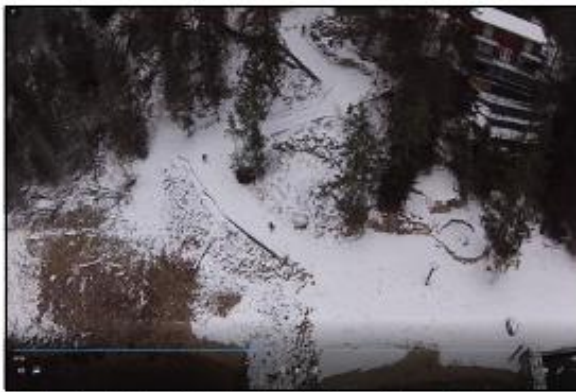
Photo 1. Historical photo of site, date unknown. area.

from Google Earth and RDCK mapping. It appears that the existing lower portion of the access road encroached into Kootenay Lake on Crown Land. According to Photo 1, the 15 m ESDP area on the subject property was sparsely forested.

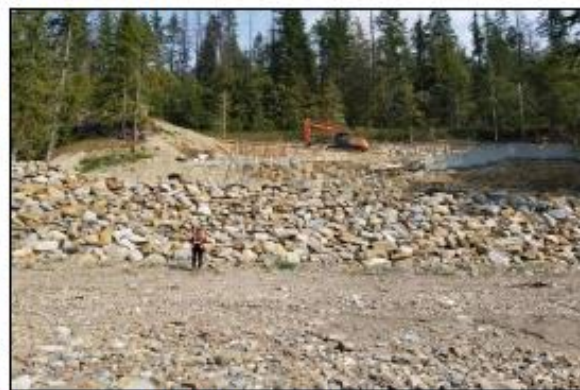
Photo 4. View of re-grading within riparian setback, Sep 8, 2021.

Existing structures and landscaping were removed during the re-grading works completed in 2020/2021 in preparation for the proposed new development. A stepped descending profile was created between Hwy 3a and the shoreline of Kootenay Lake. Refer to Appendix 3 for current site survey and site profile prepared by Griffith Surveys on September 16, 2021. Works within the ESDP area were completed without a development permit. Material from the upper half of the property was scraped and pushed down to the lower half of the property to create a large level area, elevated up to 3.5 m above the beach elevation, which encroached into Crown Land both to the north and west (Photos 2 and 3). The bank was graded to a $\sim 1:1$ slope, geotextile cloth placed, and armoured with angular rock (Photos 2-4). The building permit is currently on hold until a Development Permit is approved.

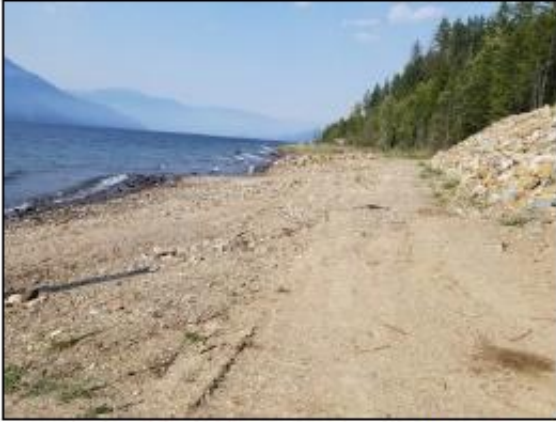
Photo 5. View of beach area fronting the property, Sept 8, 2021.

The foreshore area is gently sloped beach (up to ~10 % gradient) with substrate predominantly cobble and gravel with some small boulders (Photos 5 and 6). Fish habitat along the foreshore supports juvenile rearing habitat. Small fry are able to utilize the cobble and boulder substrate for cover. Signs of historical beach grooming were present with some areas of the beach lacking larger cobble and boulder (Photo 7). It is suspected that this rock was relocated to create a rock groin (15 m x 5m) present at the north end of the property (Photo 8). No known spawning has been reported in this area. Emergent vegetation along the foreshore north of the property consists of sandbar willow (*Salix exigua*), red osier dogwood (*Cornus stolonifera*), common horsetail (*Equisetum arvense*), pasture sage (*Artemisia frigida*) and lance leaved aster (*Symphotrichum lanceolatum*) (Photo 9). Kootenay Lake supports a variety of fish species, including several species of regional interest, such as Rainbow Trout (*Oncorhynchus mykiss*), Bull Trout (*Salvelinus confluentus*), Kokanee (*O. nerka*), White Sturgeon (*Acipenser transmontanus*), Westslope Cutthroat Trout (*O. darki lewisi*), and Burbot (*Lota lota*). A mussel survey conducted in March 2021 by Masse Environmental within the breakwater structure directly to the south of the property found no mussels present (Photo 10).

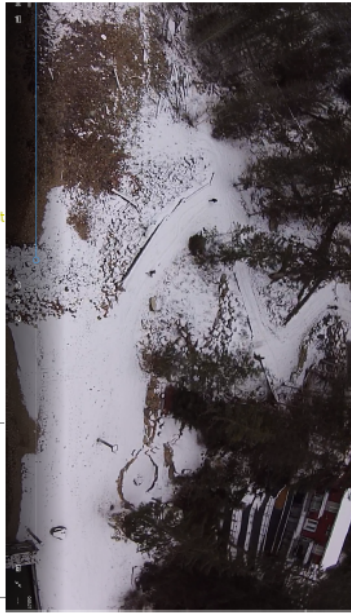
APPENDIX 2
PRE-EXISTING DEVELOPMENT SITE PLAN

Sketch of site information and cross sections of part of Lot A, Plan NEP77016, District Lot 4595, Kootenay District.

- Notes:**
1. Areas of pre-existing development are estimated from historical photos and aerial imagery and were not surveyed and have been overlaid on the survey

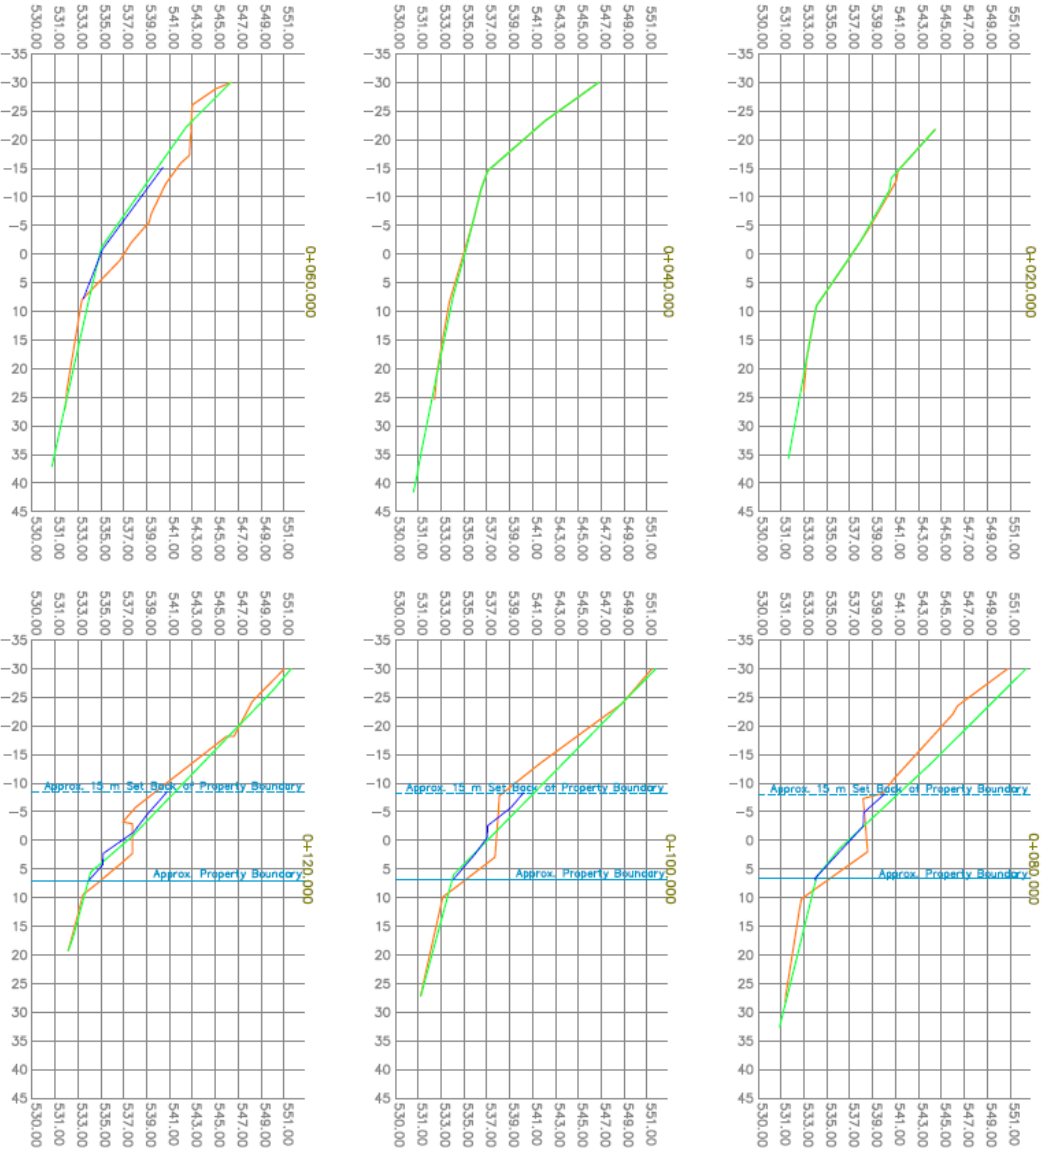
Cross Sections showing surface comparison of current ground and presumed former ground at Lot A, Plan NEPT7016, District Lot 4595, Kootenay District.

Blue = Proposed ground
 Orange = Current ground
 Green = Presumed former ground

The presumed former ground was created from undisturbed ground, primarily on neighbouring lots. All distances are in metres unless otherwise noted. Elevations are geodetic and in metres.

Due to the recent earthworks completed on the subject property, the natural topography has changed substantially (Refer to Appendix 3). The riparian area has been disturbed by the removal of conifer trees and placement of fill material on top of the native soils. The total amount of trees removed is unknown; however, a few conifer trees were retained in the southwestern corner of the property within the ESDP area. A mature Douglas fir (*Pseudotsuga menziesii*) tree located along the foreshore was backfilled around, which may slowly suffocate the root system (Photo 11). The fill material and rock armour placed within the riparian area does not provide any growing medium potential for natural plant recruitment.
