**REGIONAL DISTRICT OF CENTRAL KOOTENAY**  
**DEVELOPMENT PERMIT**  
**D2103A-05130.000-Waters-DP000108**

**Schedule 3: Riparian Assessment (Masse Environmental Consultants)**

15361 HWY 3A  
GRAY CREEK, BC

## Riparian Assessment

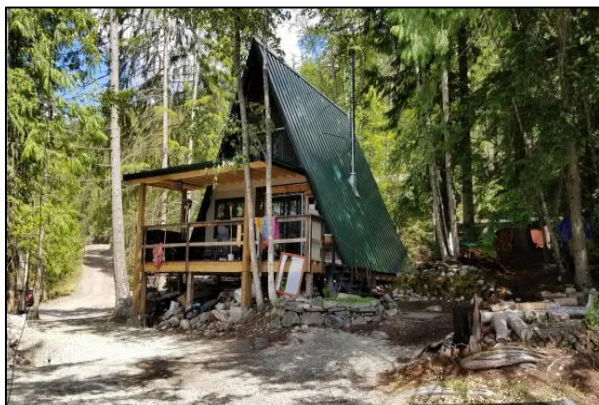
Photo 3. Existing A-frame cabin on property, looking east.

The subject property appears to have been mostly forested (Photos 1-2) prior to recent development with existing development concentrated on the northern half of the property. According to the Owners and based on historical imagery, development prior to unauthorized activities within the ESDP area included small parking areas, fire pit area on beach, access paths/steps to the beach and small retaining walls. Exact locations and areas of previous development could not be quantified because of recent disturbance and therefore previous development footprints within the ESDP area is largely unknown. Existing development outside of the ESDP area includes a small cabin, outbuildings, septic field and driveway (Photo 3).

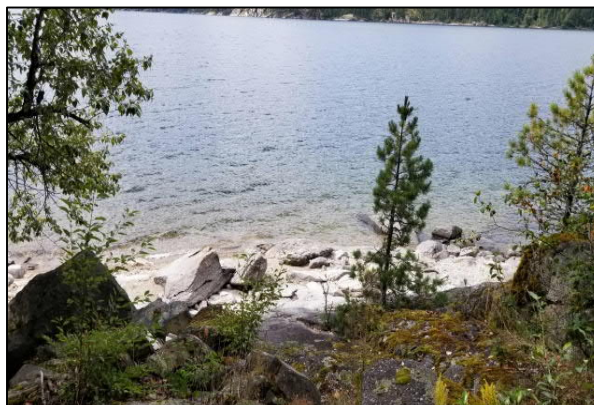
Photo 4. Existing undisturbed riparian area along south portion of property, looking west.

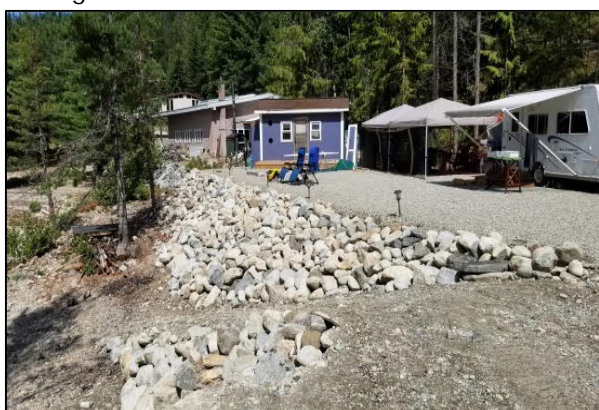
Photo 5. Recent development, imported fill, at north end of property, looking north.

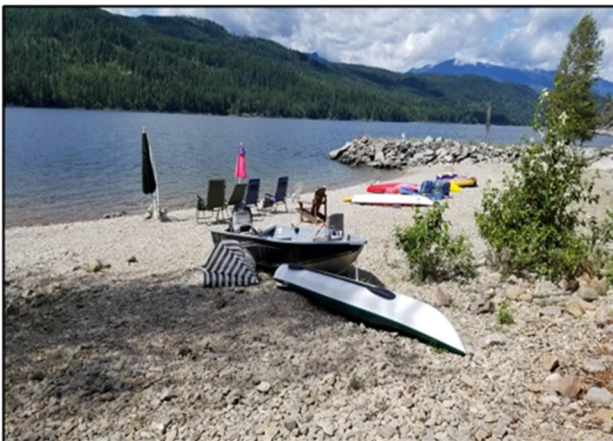
Photo 7. View of foreshore looking southeast.

The foreshore along the northern half of the property consists of a gently sloped beach (up to ~10 % gradient) with substrate consisting of gravel and pebbles, with some cobble and small boulders (Photos 7 and 8). Fish habitat along this section of foreshore supports juvenile rearing habitat with coarser substrates providing cover. No known kokanee spawning has been reported in this area; however, habitat is potentially conducive for salmonid shore spawning (EEC 2016).

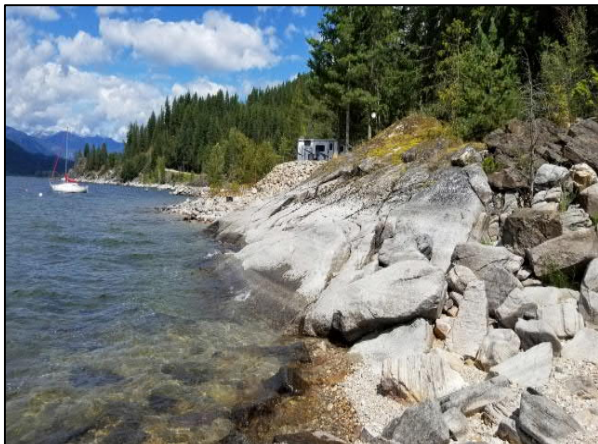
Photo 9. Deep water habitat along foreshore at south end of property, looking north.

The foreshore along the southern half of the property consists mostly of steep exposed bedrock outcroppings ( ~ 65% gradient) with some overlying boulders (Photo 9). As you head south in front of Wilmot Creek mouth, the foreshore changes into a cobble and boulder beach with a gradient of ~15% (Photo 10). Fish habitat along these sections of foreshore includes deeper water habitat for adult fish, juvenile rearing habitat and feeding habitat at the mouth of Wilmot Creek.

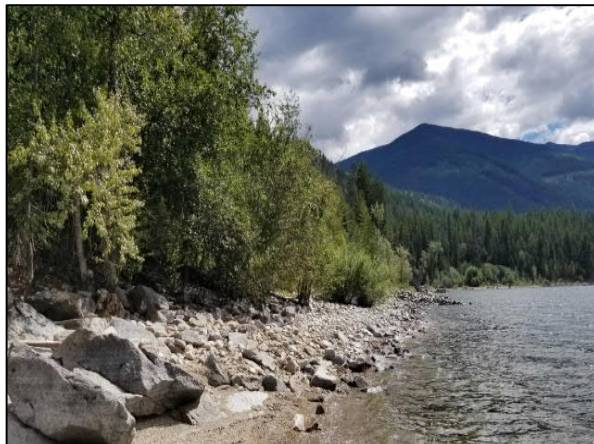
Photo 10. Shallow water and feeding habitat at Wilmot Creek Mouth, looking south.

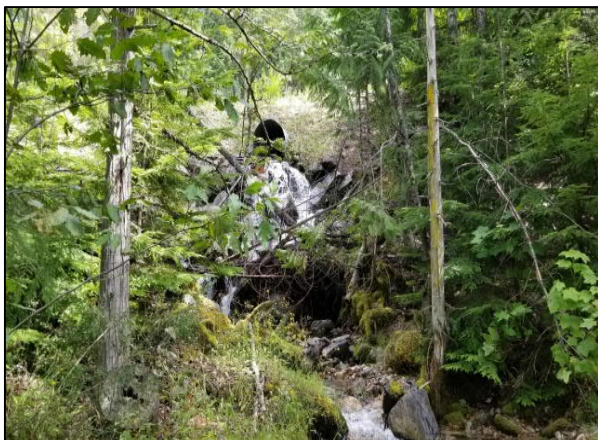
Photo 11. Upstream view of Wilmot Creek towards highway culvert crossing.

Wilmot Creek is a small stream, ~4.4 km long which flows in an east to west direction from the Purcell Mountain Range into Kootenay Lake (MOE 2020). The creek is located on crown land; ~ 7 m south of the property boundary. The lower reach of the stream has an average bankfull width of 5.4 m, gradient of ~16% with step pool morphology (Photo 11). Dominant substrate consists of boulders and cobbles with subdominant fines and gravels (Photo 12). Upstream of the creek mouth the channel is braided with 3 distinct channels for approximately 25 m. Within this section, a flood plain area was observed, characterized by signs of soil erosion and dominant flood tolerant vegetation. No fish have been recorded in Wilmot Creek (MOE 2020); however, this does not indicate that fish are not present. The highway culvert crossing located above the SE property corner, ~40 upstream of the stream mouth appears to be a barrier to fish and restricts upstream movement. Fish habitat with this section includes overhanging vegetation, large woody debris and coarse substrate which provide shade and cover for fish.

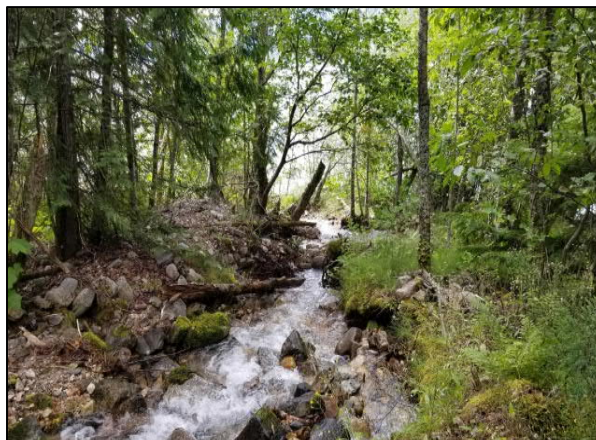
Photo 12. Downstream view of Wilmot Creek towards Kootenay Lake.

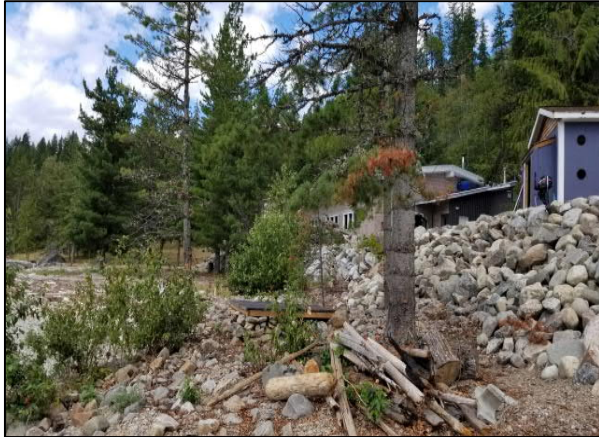
Photo 13. Retained riparian vegetation along foreshore at north portion of property.

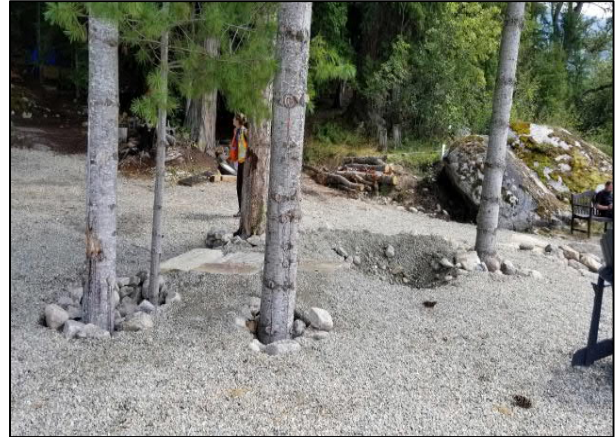
Photo 14. Backfill placed around conifer trees in front of existing cabin at north portion of property.

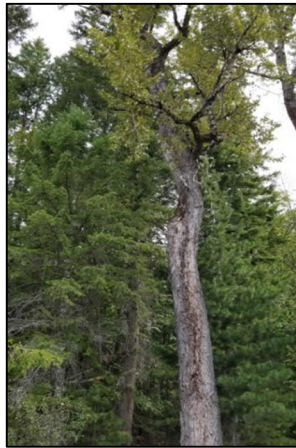
Photo 15. Mature black cottonwood along foreshore.

The southern portion of the property along Kootenay Lake remains undeveloped and supports an ecologically diverse and functioning riparian system including a mixture of varying stand age conifers, mature black cottonwood (*Populus balsamifera*) (Photo 15), paper birch (*Betula papyrifera*), with several species of under-storey vegetation. The Kootenay Lake foreshore has large, exposed rock outcroppings with sparse tree cover, sporadic drought tolerant shrubs and abundant moss (Photo 16). Upland riparian habitat changes into a more densely colonized forest, with deeper topsoil layers and plant root systems.

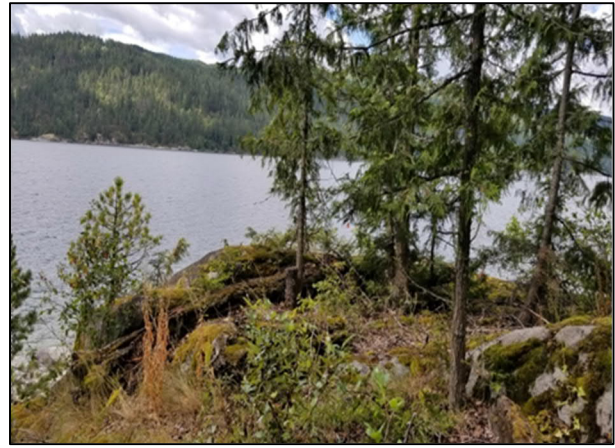
Photo 16. View of typical riparian vegetation along foreshore.

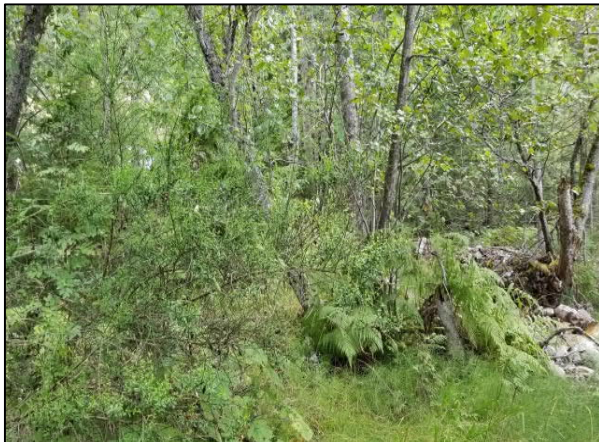
Photo 17. View of riparian vegetation within floodplain area of Wilmot Creek.

Riparian vegetation along the southern portion of the property north of Wilmot Creek is undeveloped and consists of variety of mixed conifer and deciduous tree species with abundant understorey vegetation. A flood plain area along the lower section of Wilmot Creek supports more flood tolerant species (ie. common horsetail (*Equisetum arvense*), red osier dogwood (*Cornus stolonifera*), thimbleberry (*Rubus parviflorus*) and mountain alder (*alnus incana*) graduating to more upland riparian species (ie. interior Douglas fir, Douglas maple (*Acer glabrum*), pin cherry (*Prunus pensylvanica*) and saskatoon (*Amelanchier alnifolia*).

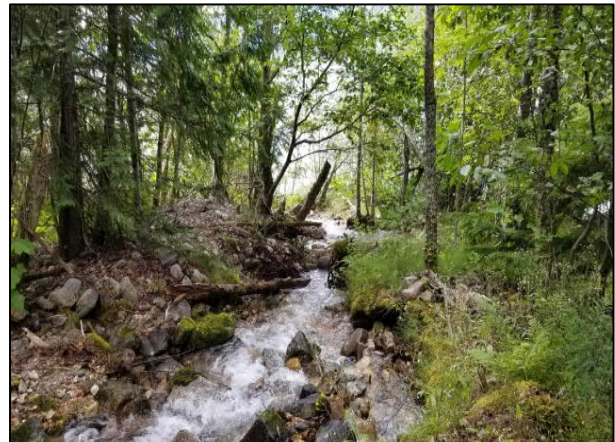
Photo 18. View of riparian vegetation along Wilmot Creek, looking downstream.

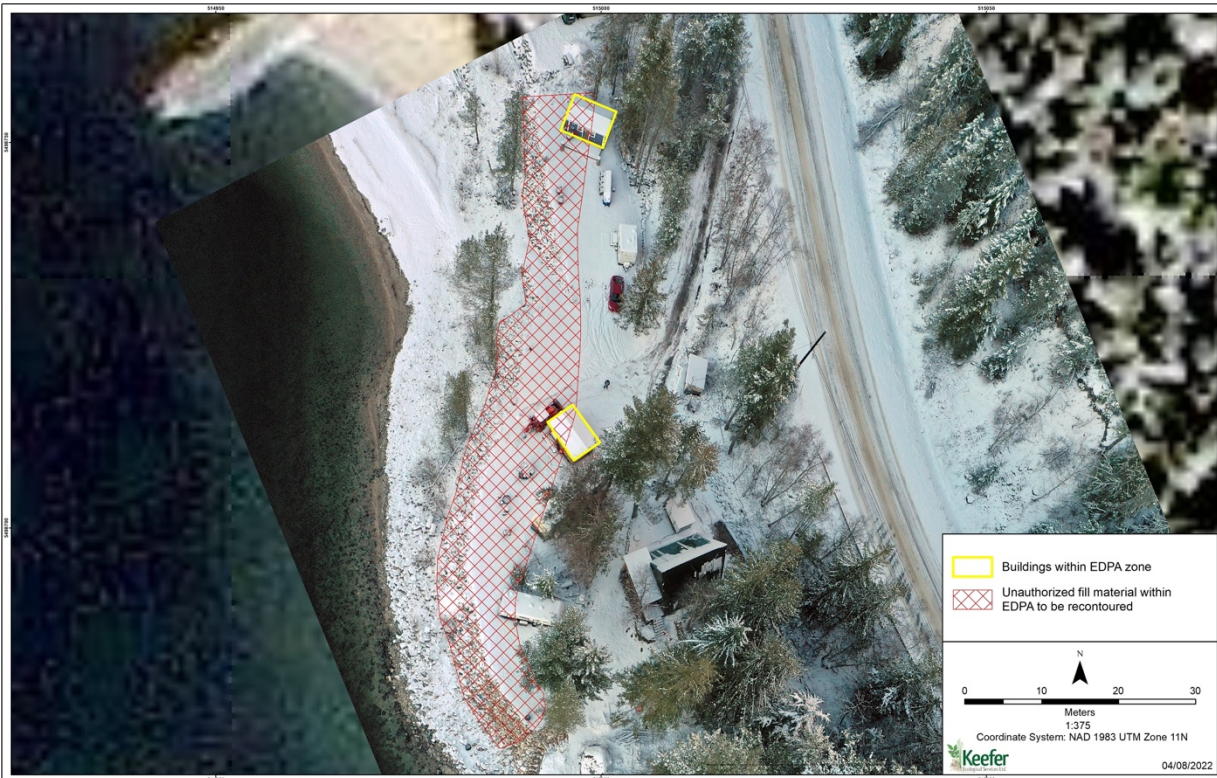
Figure 2. Overhead view of the assessed property with area to be re-contoured and buildings to be moved identified

The shoreline access ramp should be narrowed to a width of approximately 1.3 m and retain its gravel surface to ensure that foot traffic and wheelchair access to the shoreline is maintained and continues to be directed away from vegetation. An overview of the proposed revegetation zones on the assessed property is provided in Figure 3.
