# Development Permit

## DP2205E (BALFOUR RESORT OWNERS ASSOCIATION)

7298 HWY 3A  
BALFOUR, BC

## Riparian Assessment

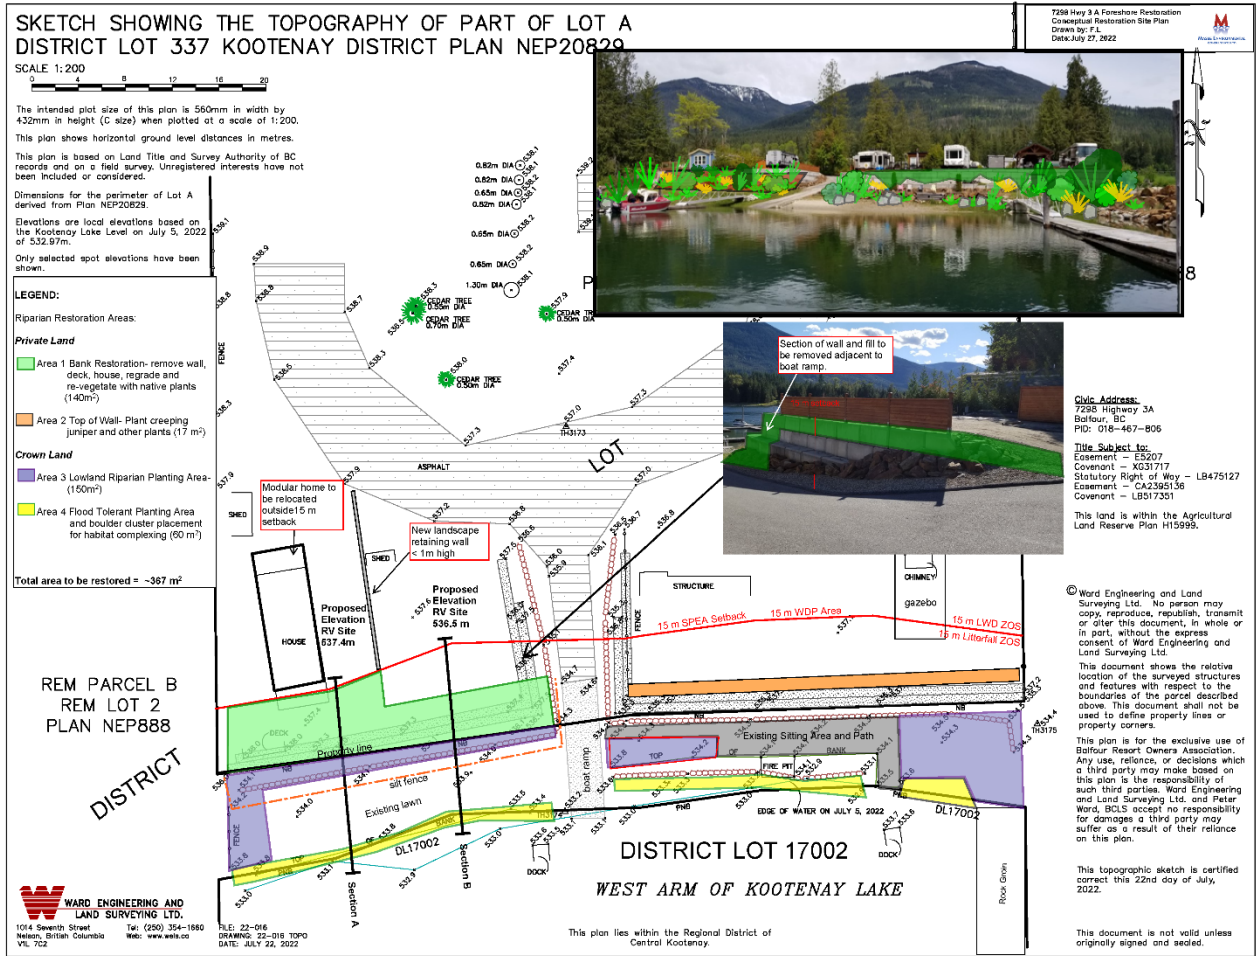
**Schedule 2: "7298 Hwy 3A Foreshore Restoration: Conceptual Restoration Site Plan" drawn by Fiona Lau, dated July 27, 2022**

- 6.1.1 The development authorized by this permit shall be substantially in accordance with "7298 Hwy 3A Foreshore Restoration: Conceptual Restoration Site Plan" drawn by Fiona Lau, dated July 27, 2022 which is attached to this permit as Schedule 2.

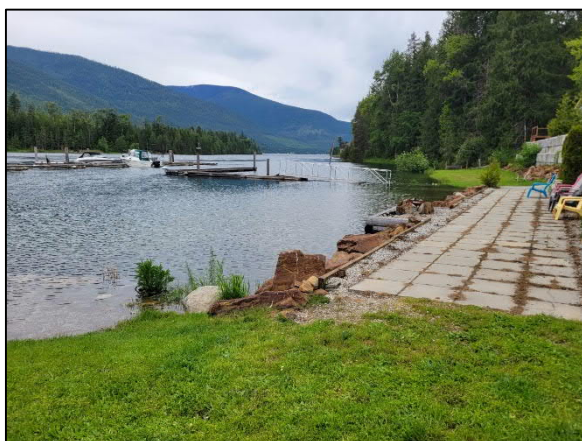
Photo 1. View of Kootenay Lake foreshore looking west during peak lake levels (~533.0 m onsite), June 12, 2022. Photo credit BROA.

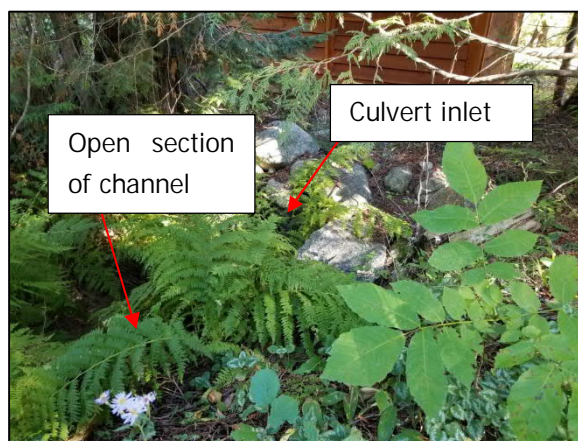
A small unnamed ephemeral creek was observed at the northeast corner of the subject property and flows from upland, across the highway through culvert, onto the property for ~30 m (partially culverted) and then onto the neighboring property to the east (Photo 2). The channel has an average width of 1 m (based

Photo 2. Section of unnamed ephemeral stream at northeast corner of property, Sep 8, 2021.

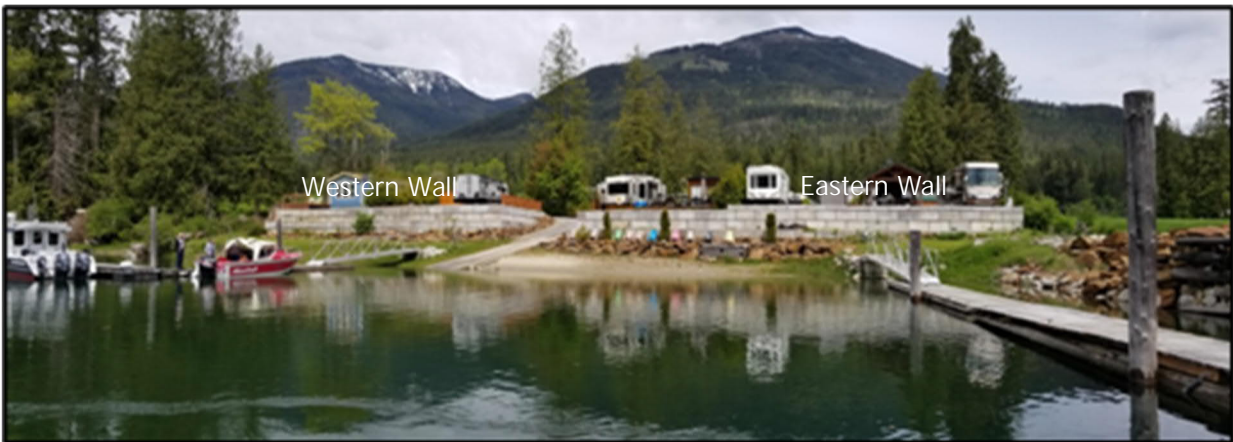
Photo 3. View of developed foreshore area looking north on the subject property, May 31, 2022

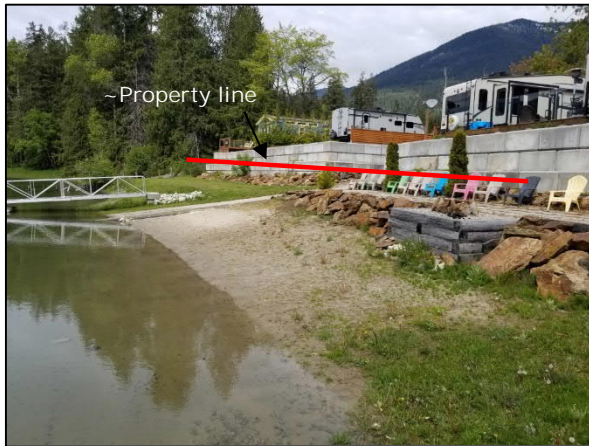
Photo 4. Approximate property line along foreshore looking west May 31, 2022.

In 2011-2013, the resort underwent redevelopment which included development of 46 designated Recreational Vehicle (RV) lots and one site approved for a permanent residence. This work involved re-grading of the south end of the property, utility upgrades (water, sewer and storm), marina upgrades (Photo 3 and Photo 6) and construction of a new wrap around road. Specific upgrades that were completed within the riparian area (15 m from the natural boundary) included the removal of riparian vegetation, placement of fill, construction of a boat ramp, patio/pathway area with fire pit, and construction of two-3.3 m high lock block retaining walls along the south property line (Photo 3 and Photo 4). The placement of fill and construction of the lock block retaining walls by the Developer were unpermitted and would have required at the time a Site-Specific Floodplain Exemption and Building Permits from the Regional District Central Kootenay (RDCK). The western lock block retaining wall is 27 m long along the foreshore, while the eastern retaining wall is 35 m long.

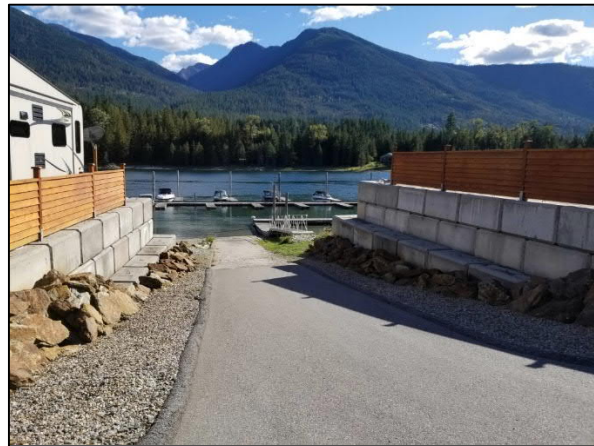
Photo 5. View of boat ramp and tie back lock block retaining walls looking south, Sept 16, 2021.

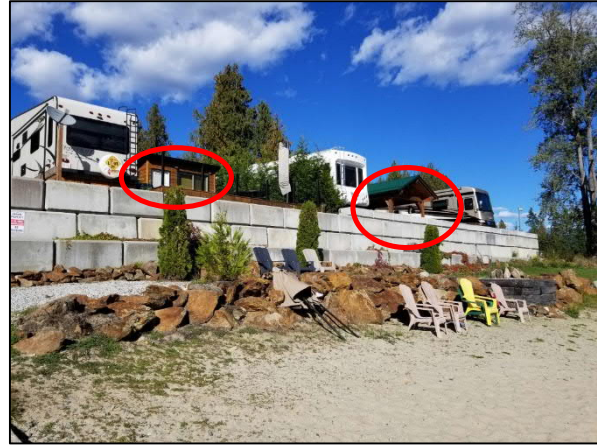
at the southeast corner of the property and partially encroaching into the WDP area was permitted by the RDCK on April 10, 2018 (BP024358, Photo 7).

Photo 7. View of shed, gazebo and firepit/ patio constructed in southeast corner of property, Sept 16, 2021.

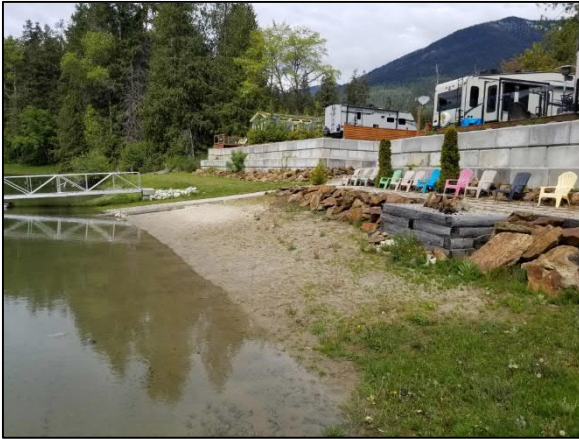
The foreshore area along Kootenay Lake, which consists of the area between the high and low water marks, is a gently sloped sandy beach (up to ~10% gradient) with substrate consisting predominantly of sand and silt (Photo 8 and Photo 9). A rock retaining wall ~1m in height is present in front of the eastern lock block wall along the natural property boundary (Photo 8), while the western side consists of a vegetated slope

Photo 8. View of beach area fronting the property, Sept 8, 2021.

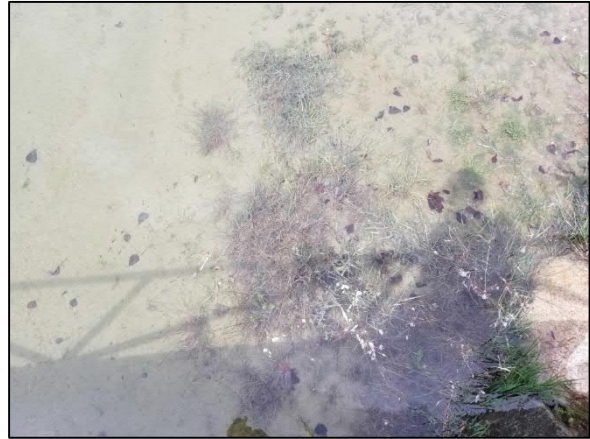
Photo 9. View of typical instream substrate, Sept 8, 2021.

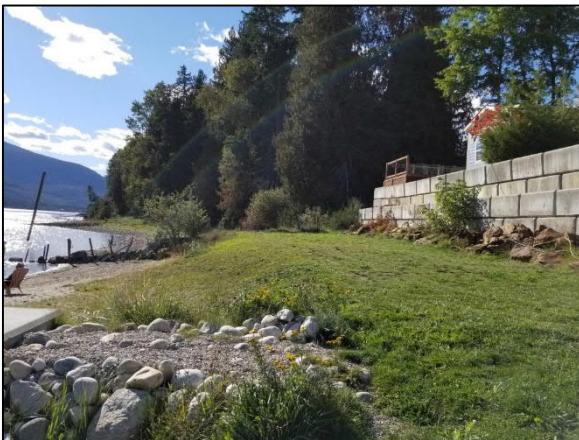
with grass(30%-50%) and some evidence of soil erosion at the west end (Photo 10 and Photo 11). The shoreline is devoid of native riparian shrubs and trees, which are important contributors to fish habitat and nutrient inputs. Fish habitat along the foreshore may support juvenile rearing, fish migration and staging habitat. No shore spawning has been reported in this area (Redfish 2011). The West Arm of Kootenay Lake supports a variety of fish species, including several species of regional interest, such as Rainbow Trout (*Oncorhynchus mykiss*), Bull Trout (*Salvelinus confluentus*), Kokanee (*O. nerka*), White Sturgeon (*Acipenser transmontanus*), Westslope Cutthroat Trout (*O. clarki lewisii*), and Burbot (*Lota lota*).

Photo 10. View of foreshore area fronting western retaining wall, looking west, May 31, 2022.

The natural topography along the shoreline of the subject property has changed substantially due to the works that were completed and most of the native riparian vegetation was removed (Photo 8, 10 and 11). Species observed on the site included black hawthorn (*Crataegus douglasii*), blue elderberry (*Sambucus cerulea*), rose sp. (*rosa sp.*), ornamental cedar (*Thuja sp.*), common horsetail (*Equisetum arvense*), wild

- Remove rock armouring along front of west retaining wall and re-grade back to natural slope.
- Remove paving stones along the front side of sitting area (west of the firepit). De-compact soil to 30 cm depth and add necessary growing medium into planting holes.
- Plant at least 5 native trees or tall shrubs (2 or 5 gallon pot size) and 100 native plants spaced at ~1.0 m between each plant and/or directed by the QEP.
- Spread mulch around each plant to a thickness of 8 cm (3").
- Spread recommended seed mix on exposed soils.

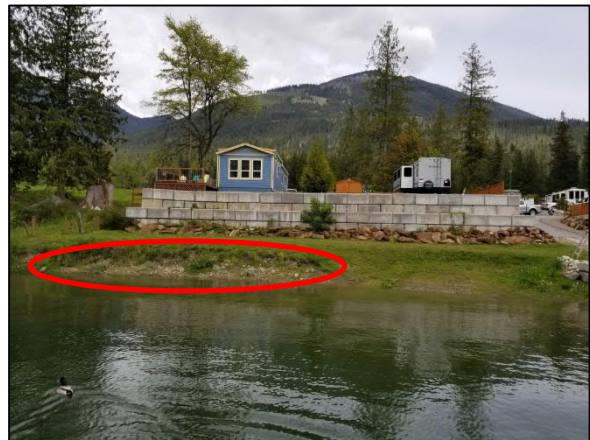
Photo 11. View of foreshore and visible erosion fronting western retaining wall, looking north, May 31, 2022.

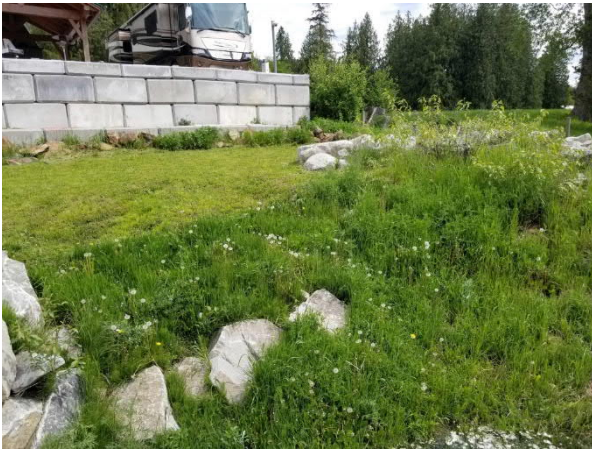
Photo 12. View of grassy area at SE corner of property within Crown Land.

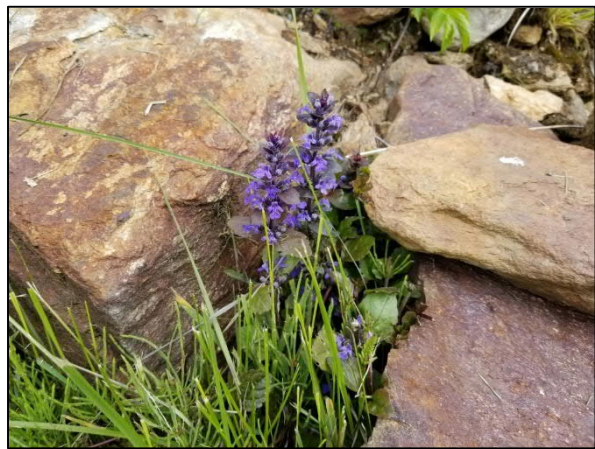
strawberry (*Fragaria virginiana*), and pasture sage (*Artemisia frigida*). Non-native species observed included agronomic grasses, bugle-weed (*Ajuga reptans*; Photo 13Photo 14Photo 1), clover (*Trifolium sp.*), dandelion (*Taraxacum officinale*), spotted knapweed (*Centaurea maculosa*), vetch (*Vicia sativa*). Noxious weeds included common tansy (*Tanacetum vulgare*) and scotch broom (*Cytisus scoparius*, Photo 14).

Photo 13. Bugle-weed located within rock along the front of the retaining walls.

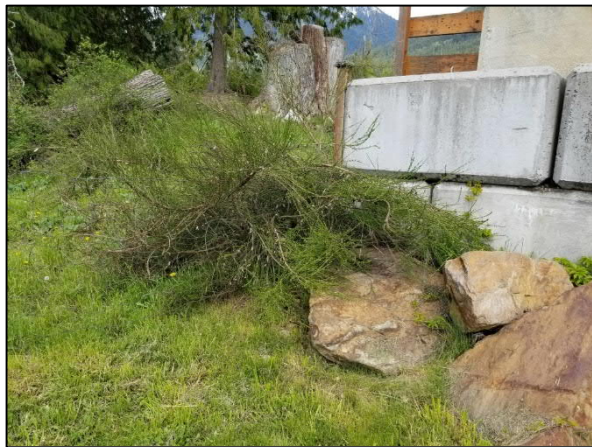
Photo 14. Scotch broom plant located at SW corner of property.

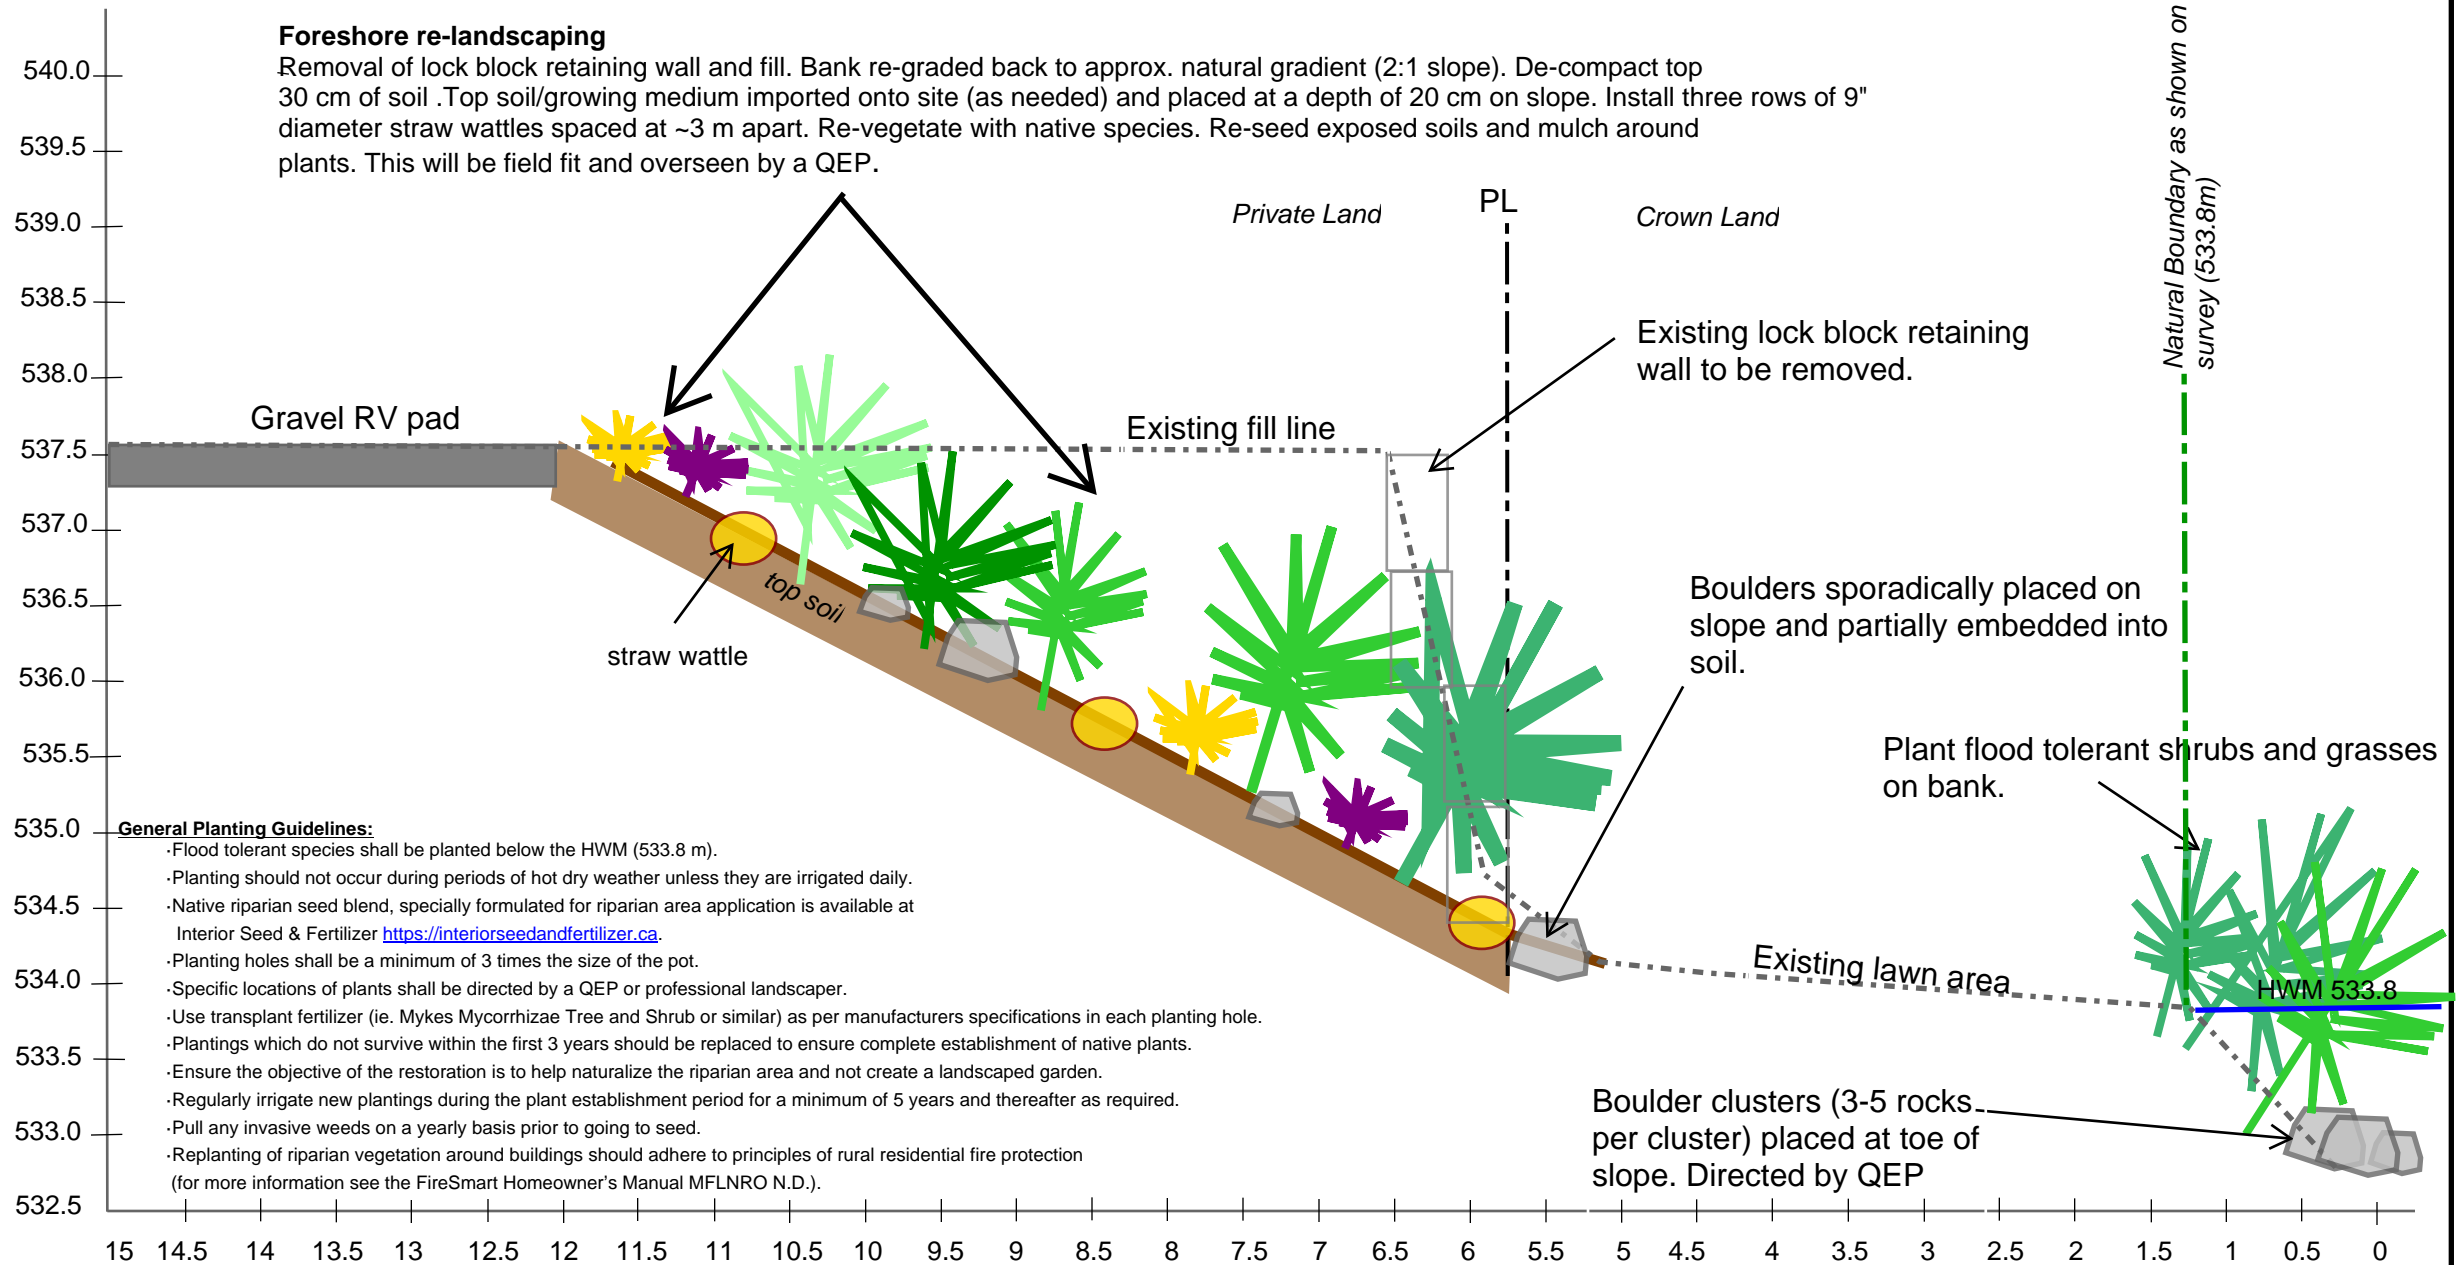
## Section A- Foreshore Restoration

7298 Hwy 3 A Foreshore Restoration  
 Section A -Conceptual Design Profile  
 Drawn to Scale (as shown)  
 Drawn by: F.L  
 Date: July 27, 2022

- Place boulder clusters (3-5 boulders) along toe of slope.
- Plant at least 40 flood tolerant shrubs (1 gallon pot size), sedges and grasses (plugs, 4" or 1 gallon). Recommended species can be found in Table 4. Plant spacing to be >0.5m apart and/or directed by QEP in the field.
- Additional growing medium to be used in planting holes as required.

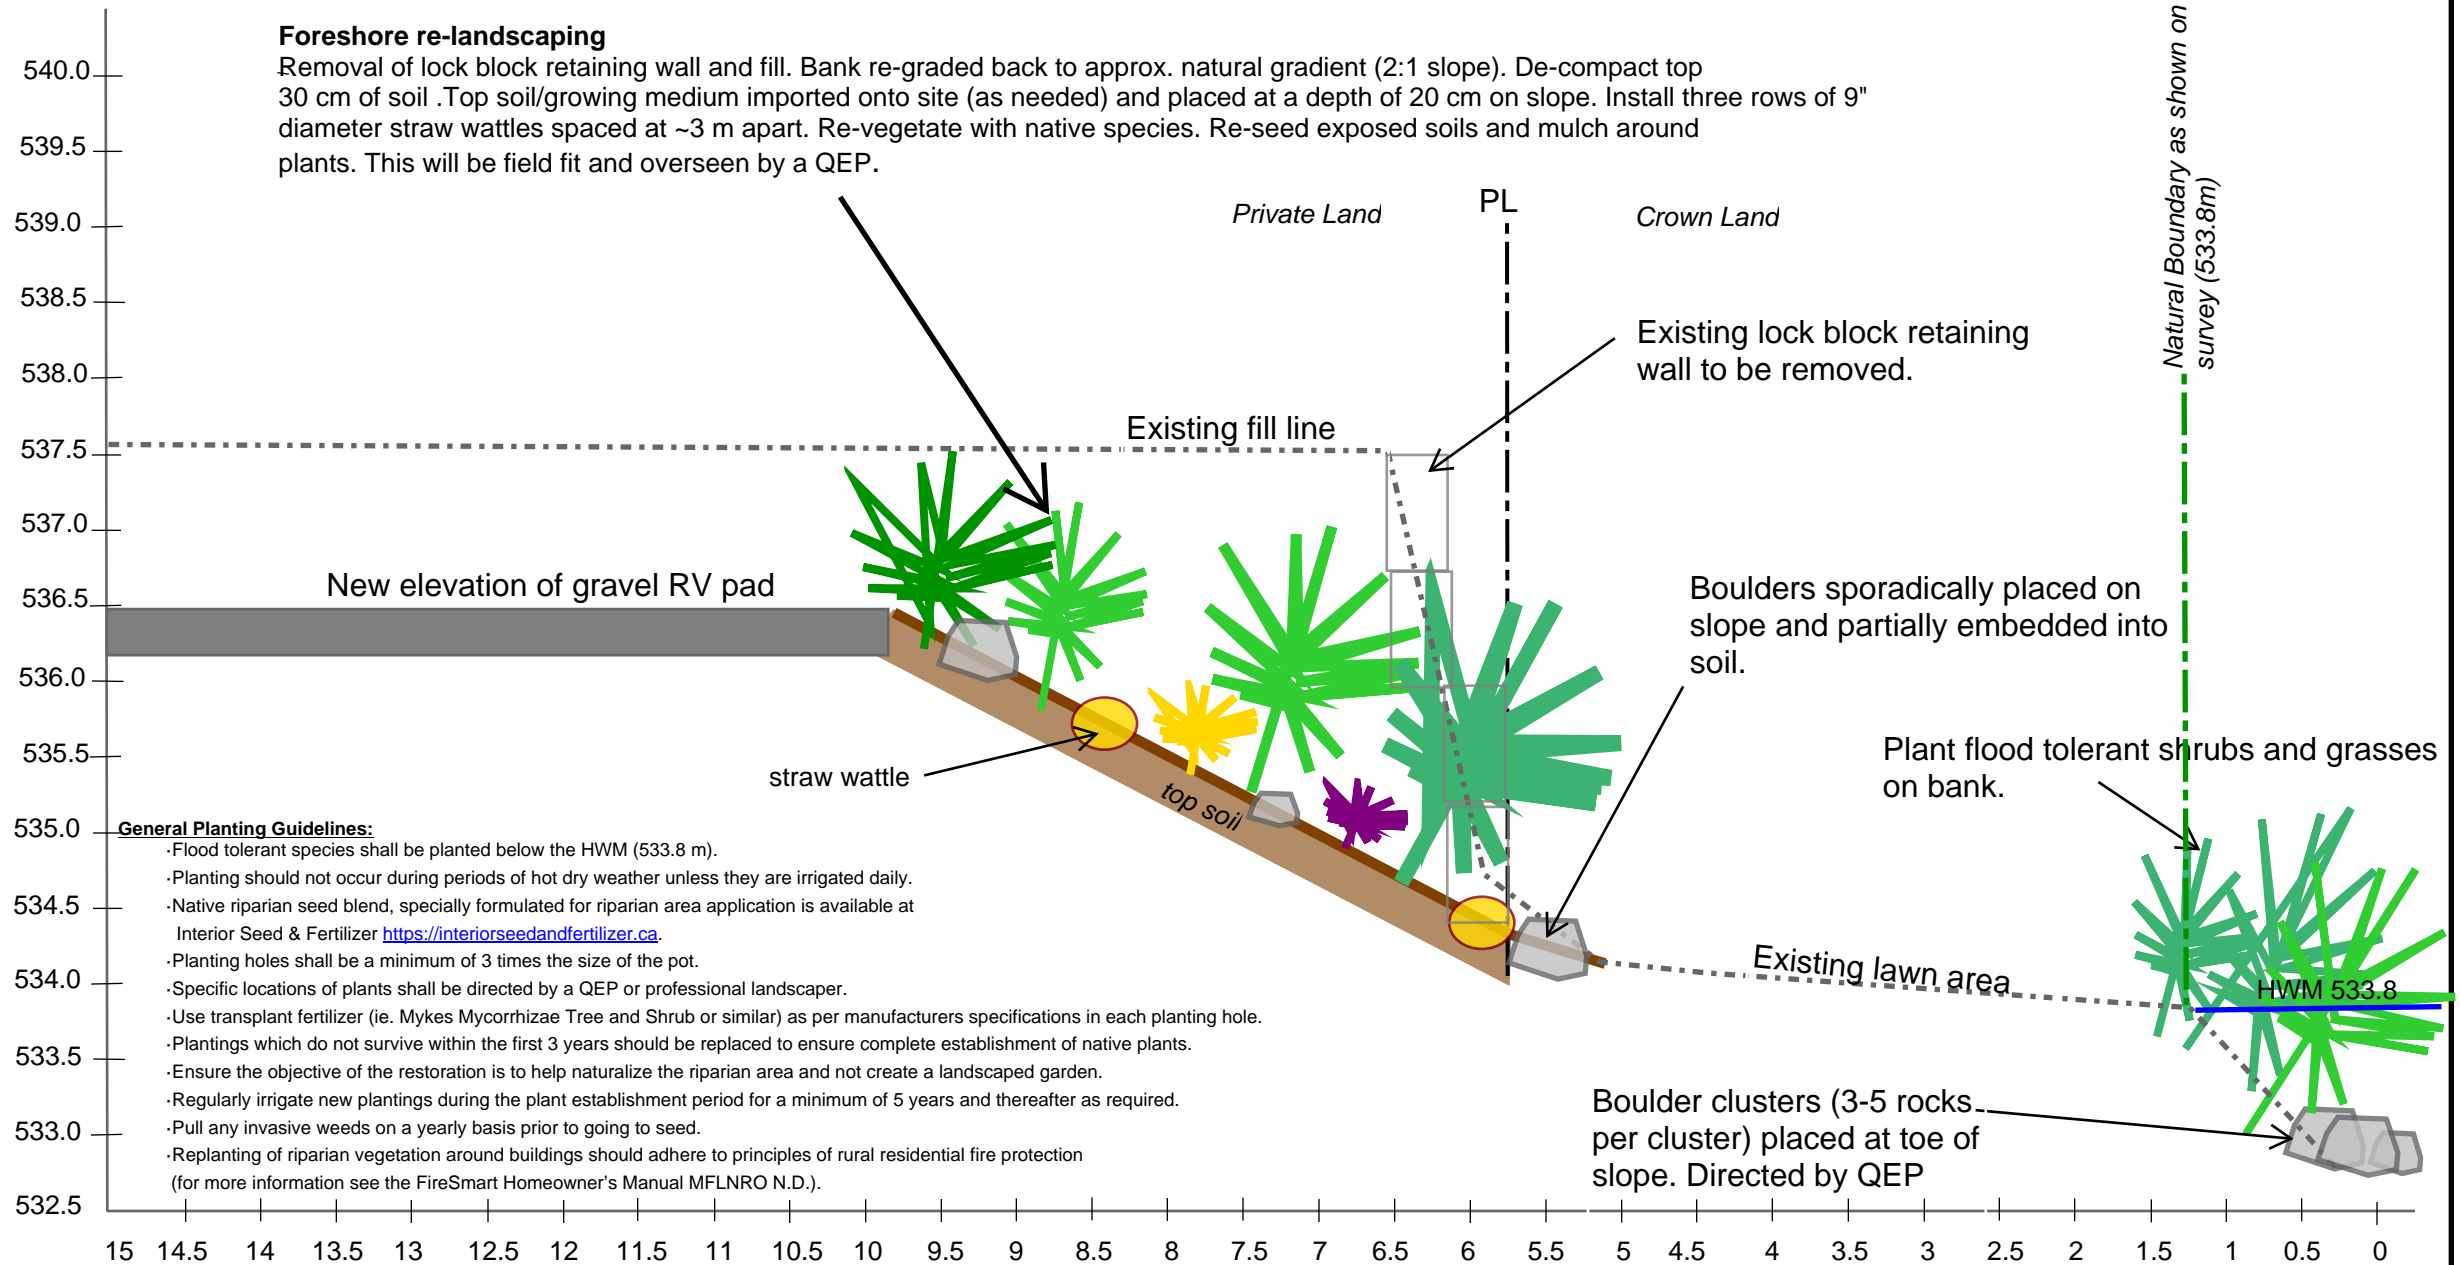
## Section B- Foreshore Restoration

7298 Hwy 3 A Foreshore Restoration  
 Section B -Conceptual Design Profile  
 Drawn to Scale (as shown)  
 Drawn by: F.L  
 Date: July 27, 2022

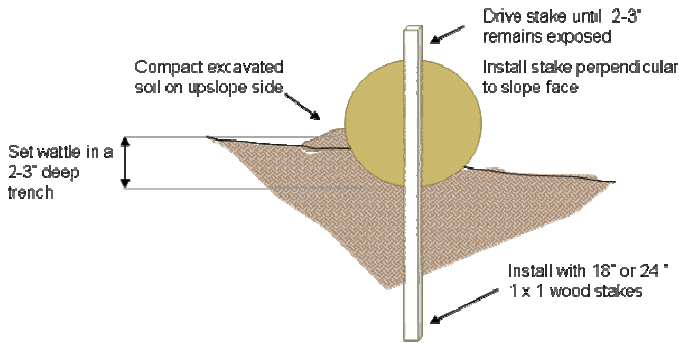
**Entrenchment Detail**

1. BEGIN AT THE LOCATION WHERE THE WATTLE IS TO BE INSTALLED BY EXCAVATING A 2-3" (5-7.5 CM) DEEP X 9" (22.9 CM) WIDE TRENCH ALONG THE CONTOUR OF THE SLOPE. EXCAVATED SOIL SHOULD BE PLACED UP-SLOPE FROM THE ANCHOR TRENCH.
2. PLACE THE WATTLE IN THE TRENCH SO THAT IT CONTOURS TO THE SOIL SURFACE. COMPACT SOIL FROM THE EXCAVATED TRENCH AGAINST THE WATTLE ON THE UPHILL SIDE. ADJACENT WATTLES SHOULD TIGHTLY ABUT.
3. SECURE THE WATTLE WITH 18-24" (45.7-61 CM) STAKES EVERY 3-4' (0.9 - 1.2 M) AND WITH A STAKE ON EACH END. STAKES SHOULD BE DRIVEN THROUGH THE MIDDLE OF THE WATTLE LEAVING AT LEAST 2-3" (5-7.5 CM) OF STAKE EXTENDING ABOVE THE WATTLE. STAKES SHOULD BE DRIVEN PERPENDICULAR TO SLOPE FACE.

- De-compact top 30 cm of native soil with excavator bucket and leave in rough and loose condition.
- Place topsoil on slope to a depth of 20 cm.
- Install two to three rows of 9" diameter straw wattles, spaced at ~3 m apart (Product Nilex straw wattle or similar product). Bottom row should be installed at toe of slope and top row near the crest of the slope. It is estimated that twelve, 25' rolls are required for the restoration area. Refer to Appendix 4 for installation guide.
- Plant a minimum of 120 shrubs and perennials at an average of ~1 meter spacing on slope. Refer to Table 4 for recommended plant species. Plant placement will be dependent on species and plant size.
