**REGIONAL DISTRICT OF CENTRAL KOOTENAY**  
**DEVELOPMENT PERMIT**  
**DP2311E (POLLOCK)**

**Schedule 3:** Riparian Assessment, dated July 24, 2023 by Masse Environmental Consultants Ltd. for 6826 Marian Lane

## **John Pollock – 6826 Marian Lane Water Intake Riparian Assessment**

Project Number 2023-1047

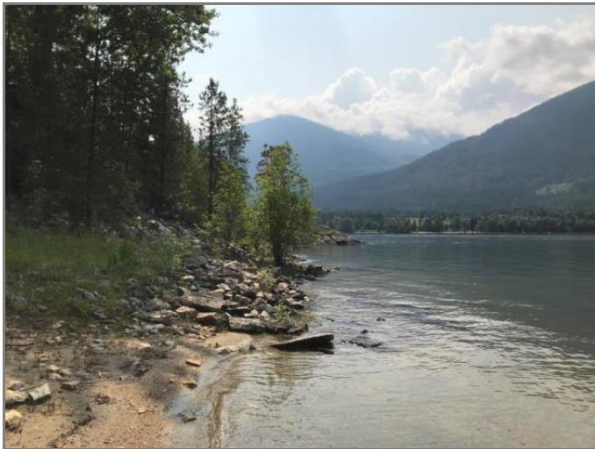
Photo 1. Foreshore habitat, looking southeast (June 15, 2023).

The foreshore of the property consists of a rocky shoreline with a southwest aspect (Photo 1 and Photo 2). The littoral zone has a mixed substrate consisting mostly of boulders and exposed bedrock, with angular cobble, gravel and sand intermixed (Photo 3 and Photo 4). Fish habitat along this section of foreshore supports juvenile rearing habitat (Schleppe and Cormano 2013), with boulders and cobbles providing cover for fish when water levels are higher. This area has also been reported to support Rainbow Trout (*Oncorhynchus mykiss*) spawning habitat (pers. comm. Taylor Josephy 2023).

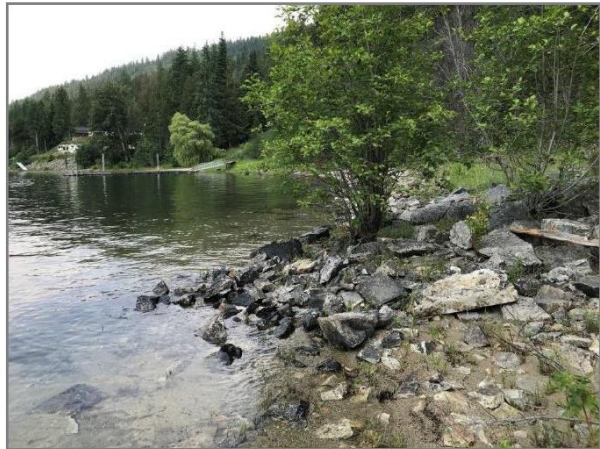
Photo 2. Foreshore habitat, looking northwest (June 15, 2023).

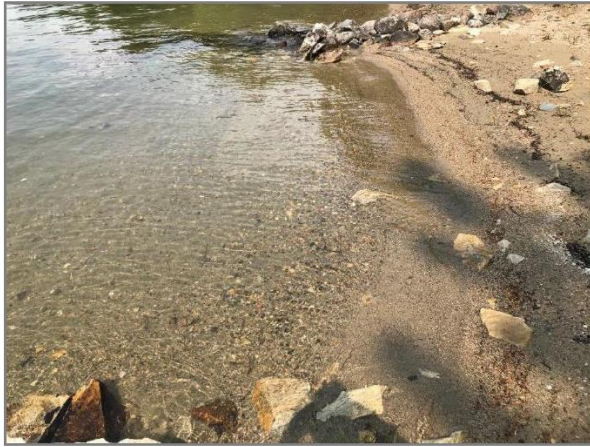
Photo 3. View of in-water substrate along the shoreline (June 15, 2023).

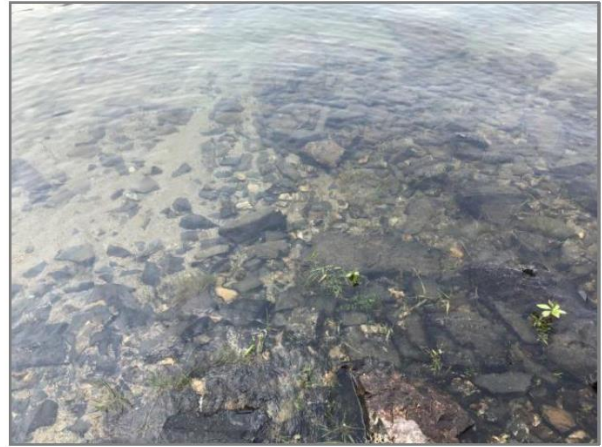
Photo 4. View of rocky in-water substrate along the shoreline (June 15, 2023).

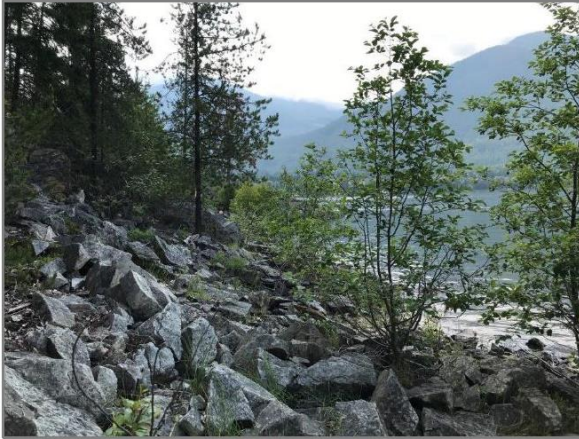
Photo 5. Mountain alder, black cottonwood and lodgepole pine along the foreshore area, looking southeast.

The riparian area along Kootenay Lake foreshore is rocky and supports a mix of native trees and understory shrubs and herbaceous species (Photo 5 – 8). Overstory vegetation along the shoreline consists of Lodgepole pine (*Pinus contorta*), western redcedar (*Thuja plicata*), grand fir (*Abies grandis*) and Douglas-fir (*Pseudotsuga menziesii*). The shrub community consists of mountain alder (*Alnus incana*), red-osier dogwood (*Cornus sericea*), Douglas maple (*Acer glabrum*), saskatoon (*Amelanchier alnifolia*), oceanspray (*Holodiscus discolor*), mountain ash (*Sorbus sp.*), pacific yew (*Taxus brevifolia*), and regenerating black cottonwood (*Populus trichocarpa*). The herbaceous plant community was dominated by common wormwood (*Artemisia absinthium*), grass spp. (*Poa spp.*), horsetail (*Equisetum sp.*), scouring rush (*Equisetum hyemale*), with drought tolerant species on drier rocky sites including kinnickinnick (*Arctostaphylos uva-ursi*), lance-leaved stonecrop (*Sedum lanceolatum*), common juniper (*Juniperus communis*), Oregon grape (*Mahonia aquifolium*) and soopolallie (*Shepherdia canadensis*). Non-native species mostly present on the upper limits of the 15 m WDP area include spotted knapweed (*Centaurea stoebe*; invasive), oxeye daisy (*Leucanthemum vulgare*; invasive) and yellow devil hawkweed (*Pilosella glomerata*). The foreshore vegetation provides shade, litterfall and insect drop that benefit aquatic organisms in Kootenay Lake.

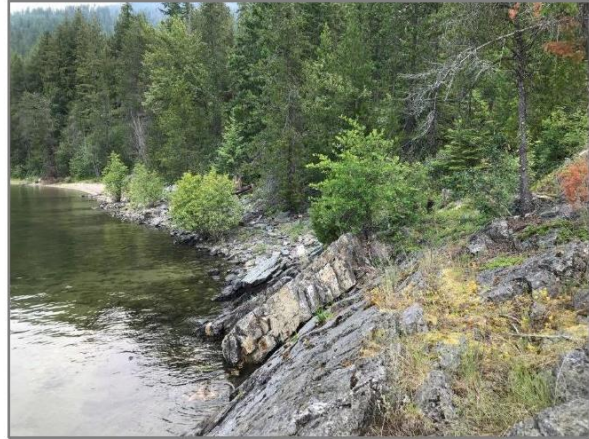
Photo 6. Riparian vegetation on the foreshore and exposed bedrock, looking northwest.

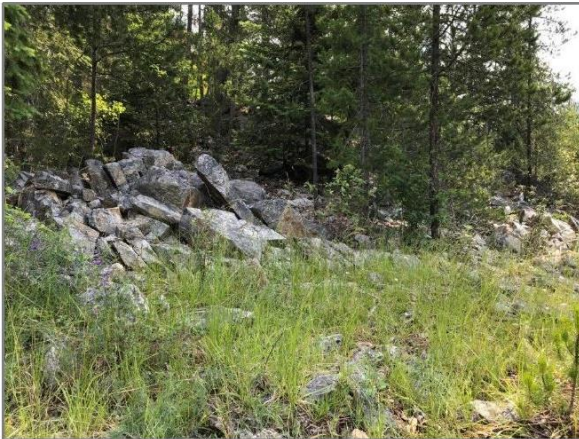
Photo 7. Boulders and riparian vegetation, looking northeast.

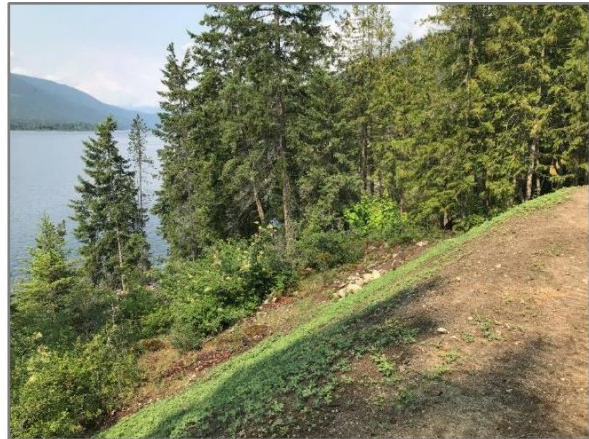
Photo 8. View of upper limits of riparian area and embankment descending from housing development.

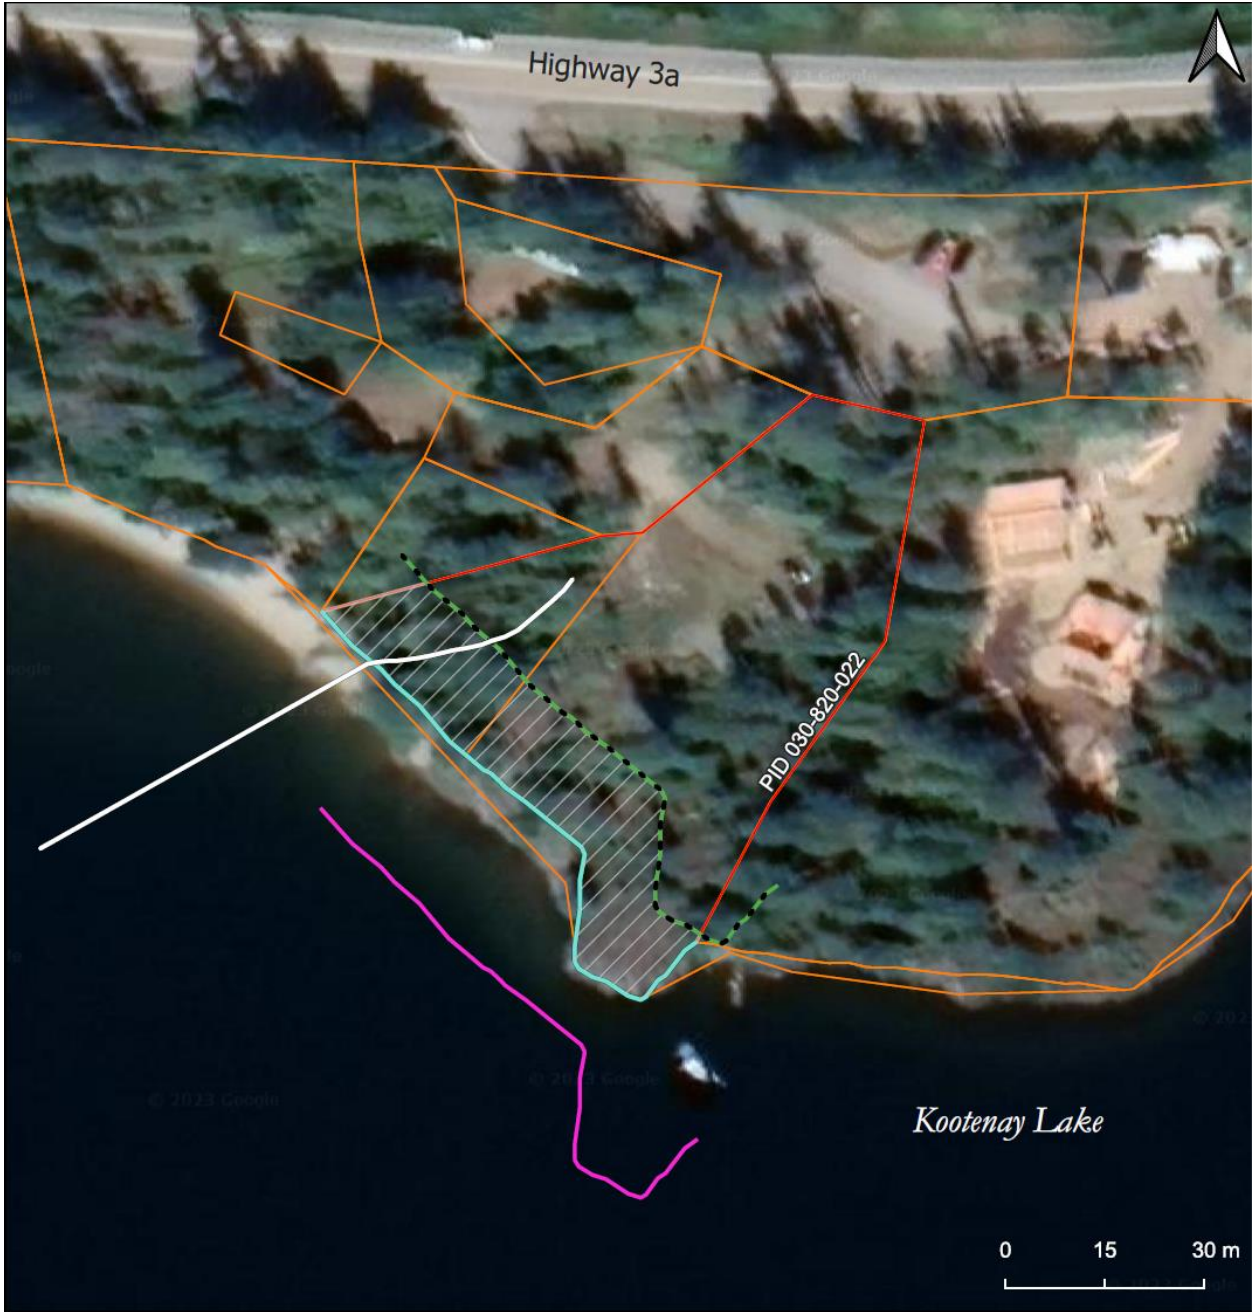
**APPENDIX 2. SPEA SETBACKS**

The proposed development within the 15 m WDP area includes a new waterline that is expected to be ~40 m long above the HWM and ~57 m long below the HWM, with a total approximate length of 97 m. The waterline is expected to be installed in a 60 cm wide and 60 cm deep trench on the west side of the property and will extend into the lake at 240 degrees (Appendix 2). The waterline installation will be completed during low water to allow for the pipe to be buried as far into the lake as possible before running along the lakebed. The water intake stand depth is estimated to be 7.6– 10.7 m depending on the lake level throughout the year.

Refer to Appendix 2 for proposed waterline alignment.
