## RDCK FLOODPLAIN AND STEEP CREEK STUDY

# Cooper Creek

**Final**  
**March 31, 2020**

BGC Document No.:  
**RDCK2-SC-007F**

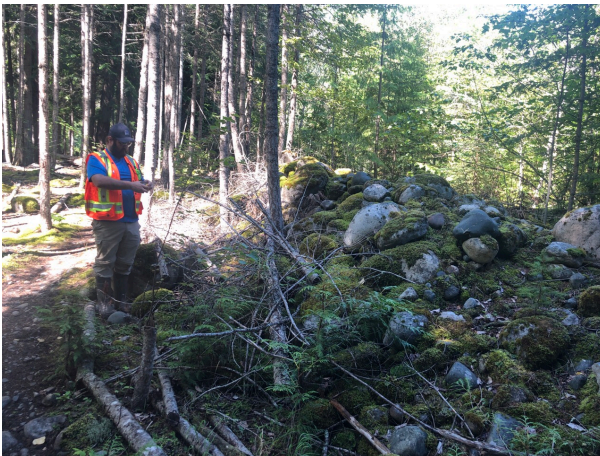
B) Old berm, 300 m upstream of Highway 31 bridge crossing and 10 m from the right bank of the creek (CPR-FP-02).

Figure 3-4. Select flood protection structures along Cooper Creek. BGC photos taken July 25, 2019. Refer to Table 3-3 for attributes and Drawing 02A, 02B for locations.

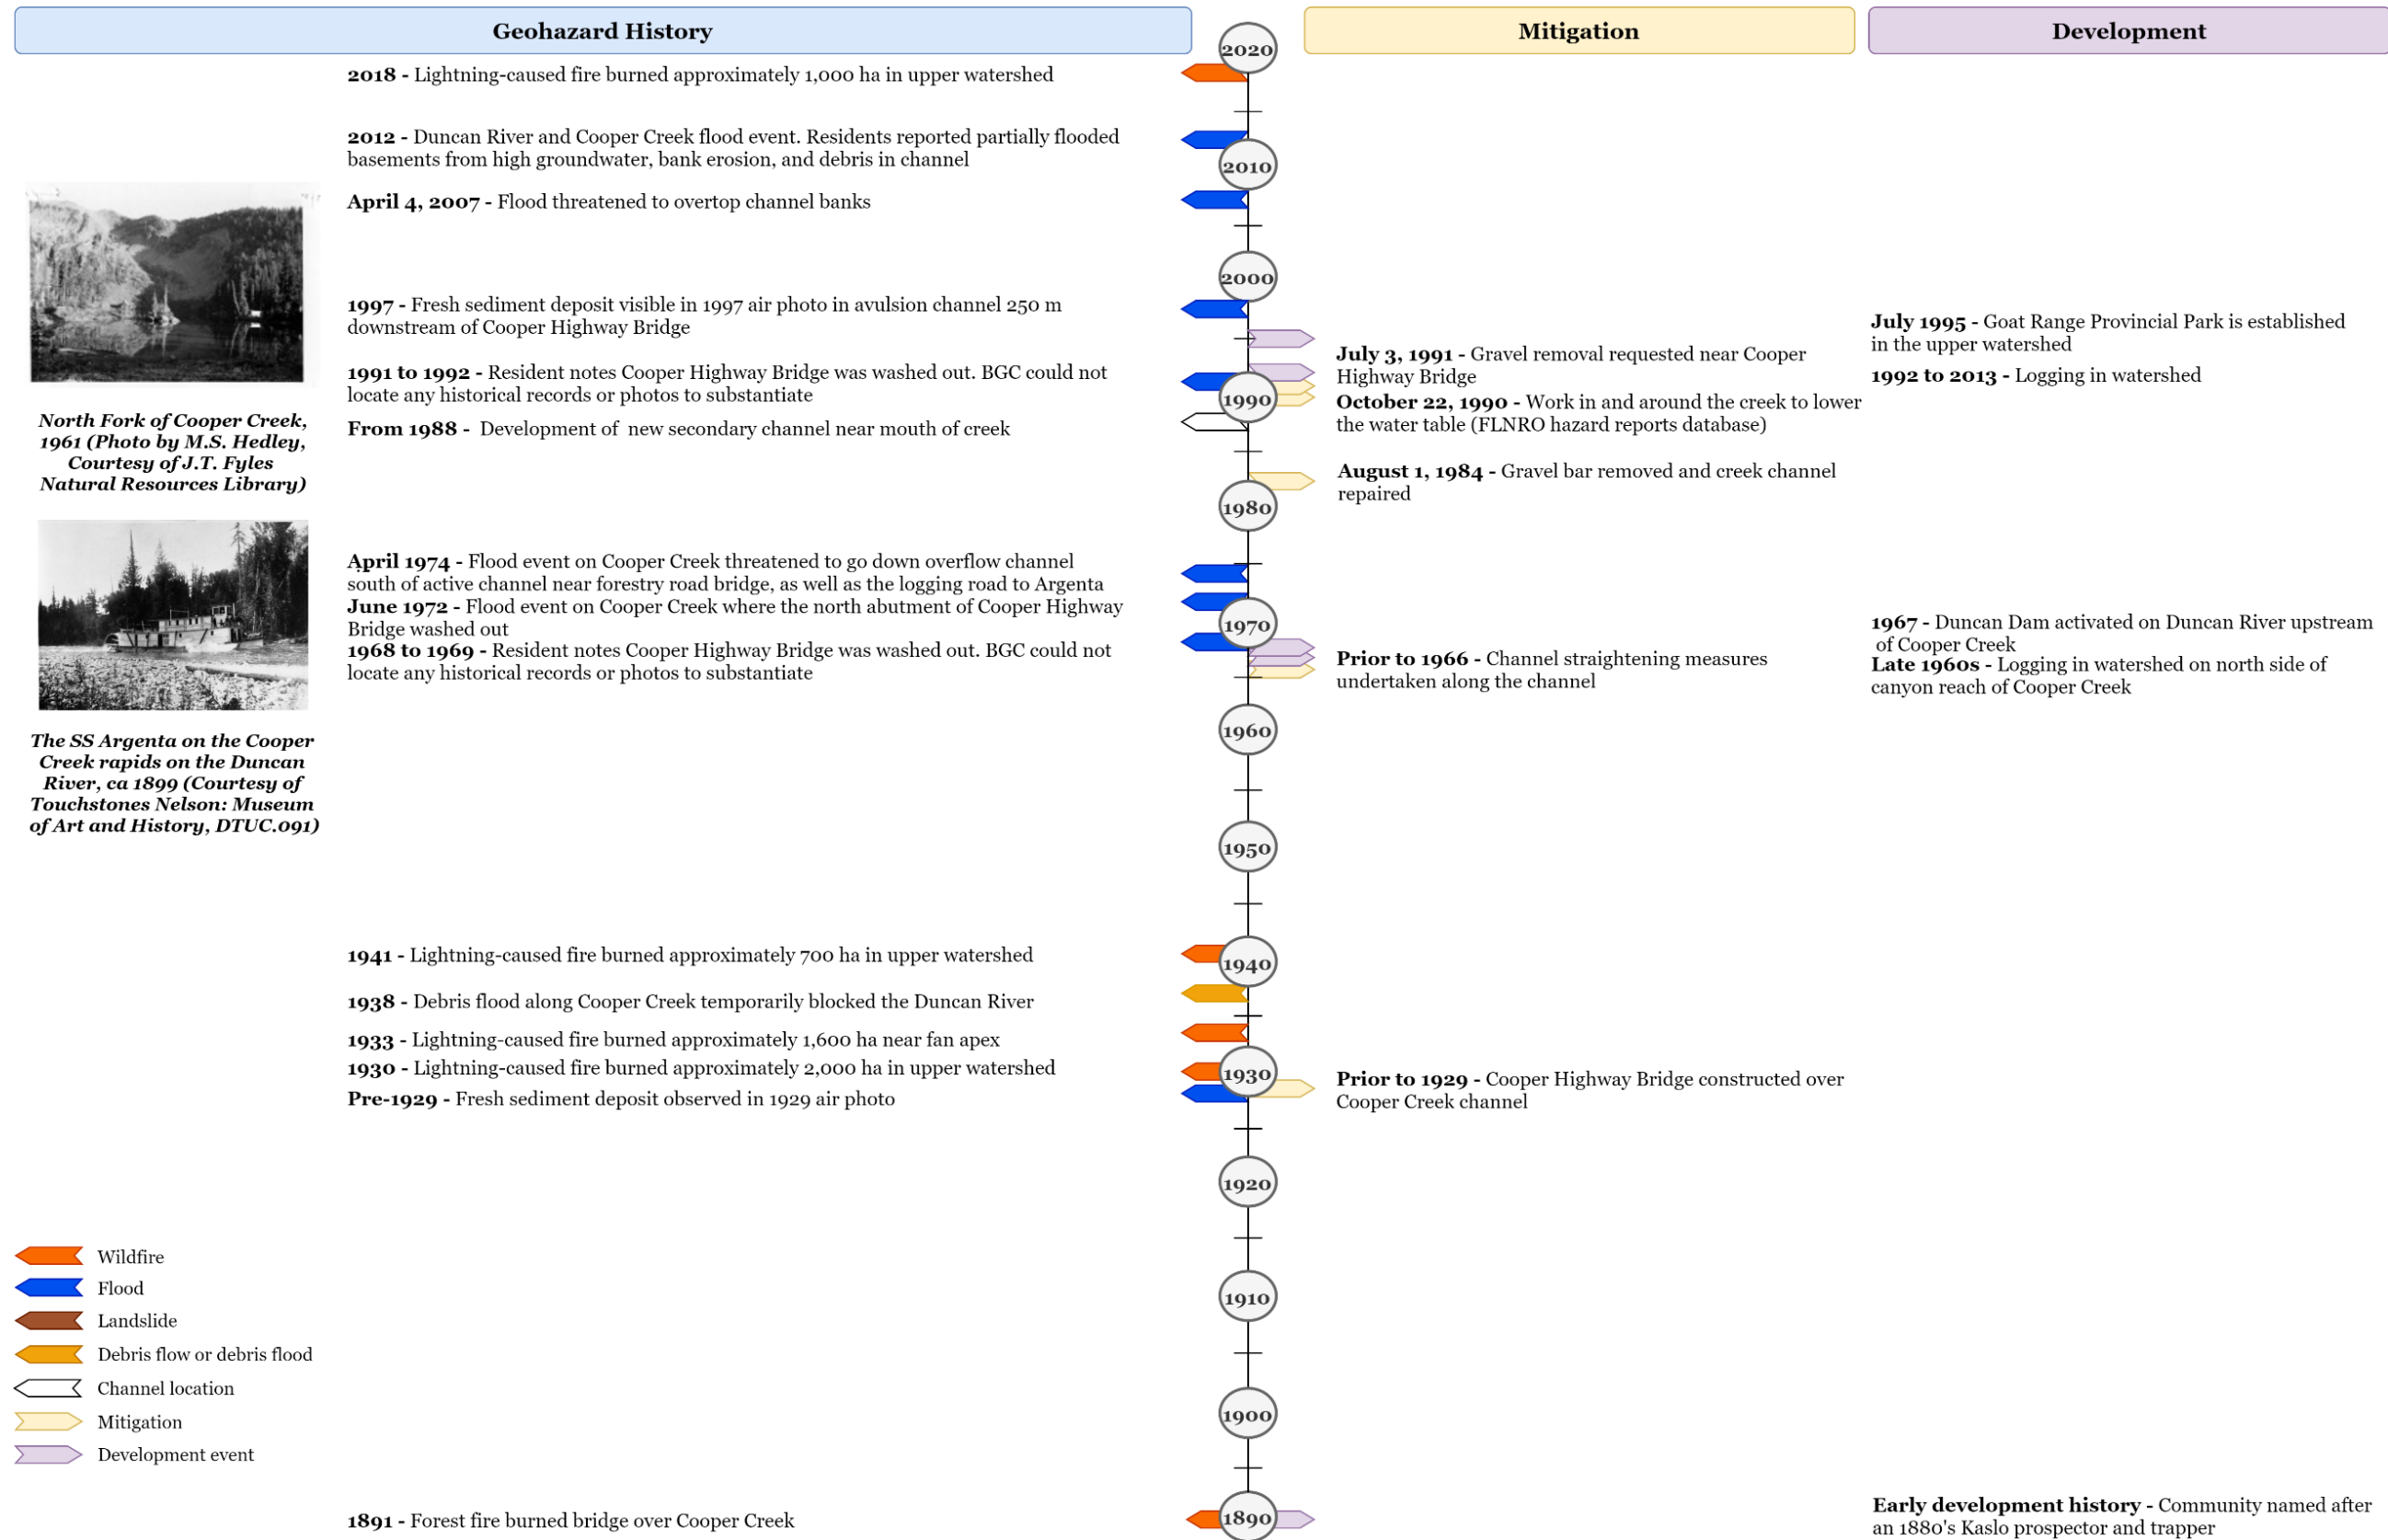
Figure 4-1. Summary of recorded geohazard, mitigation, and development history at Cooper Creek.

Figure 4-1 provides a timeline summary of floods and mitigation history for Cooper Creek. For location references, refer to Drawings 01 and 02. The historical event inventory is assumed to be incomplete, but the information contained within it can be used to identify the location of past geohazard events and associated consequences of these events. From this information, the following can be concluded:

- The channel has been dredged (i.e., in channel material has been removed by equipment) several times since the channel straightening. Perdue Geotechnical Services (September 21, 2013) noted that these measures have been generally successful to reduce maintenance and channel hazards. However, the channel continues to accumulate sediment, causing the channel to widen and reduce the channel capacity.

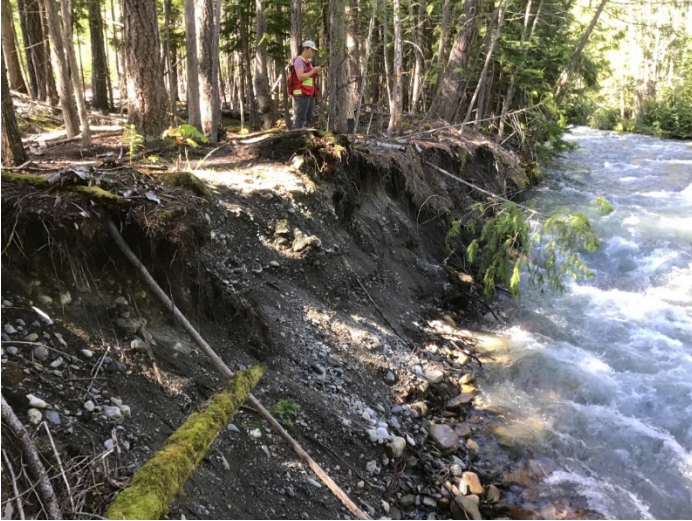
**Photo 8.**

**On the right (south) bank, looking upstream (west) at bank erosion along Cooper Creek approximately 250 m downstream of the fan apex. Photo: BGC, July 25, 2019.**

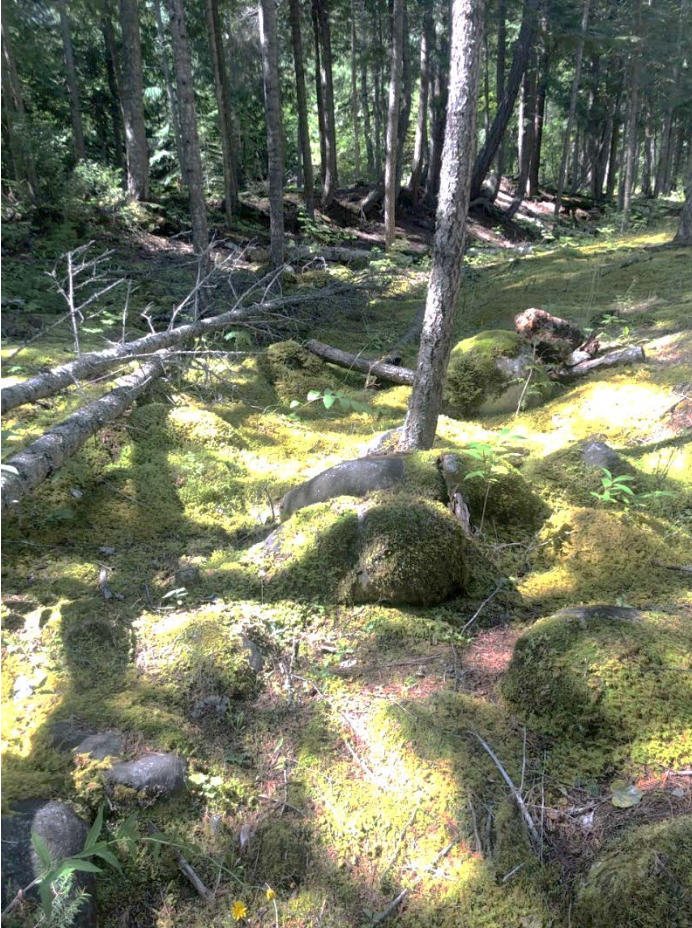
**Photo 10.**

**South of Cooper Creek, looking at old creek avulsion channel, moss covered boulders and undercut trees on old bank, approximately 60 m south of creek, 150 m west of Highway 31.  
Photo: BGC, July 25, 2019.**

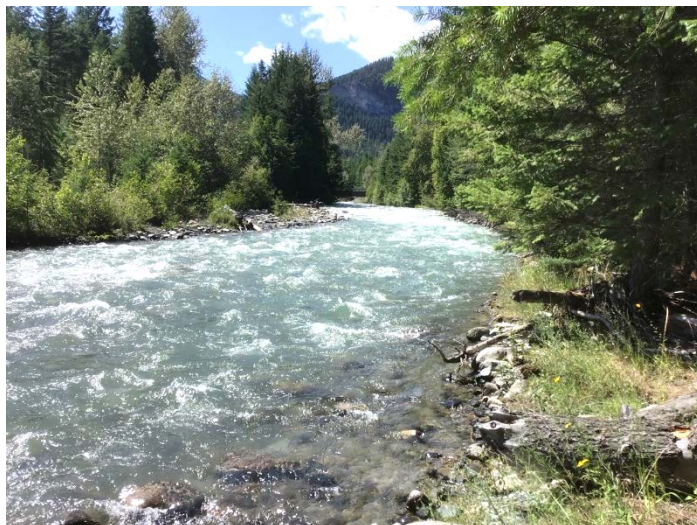
**Photo 17.**  
Standing on the left (north) bank of Cooper Creek looking upstream, approximately 250 m downstream of the Cooper Creek Highway bridge. Bridge is visible in the distance. Photo: BGC, July 25, 2019.

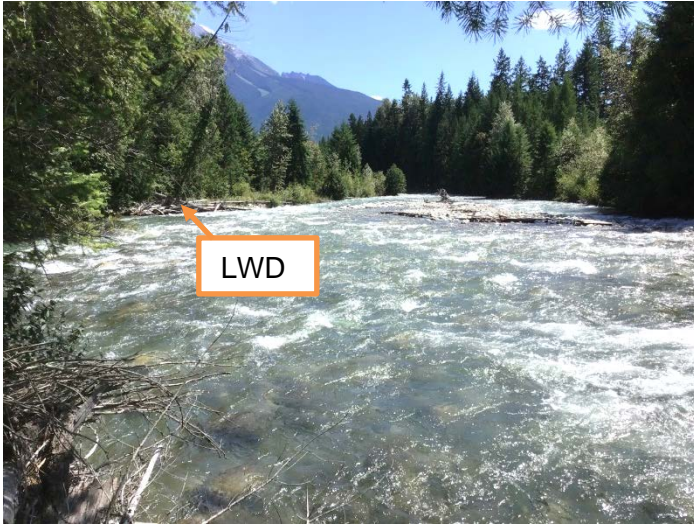
**Photo 18.**

**Standing on the left (north) bank of Cooper Creek looking downstream, approximately 250 m downstream of the Cooper Creek Highway bridge. Large woody debris (LWD) pile on left (north) bank blocks deep creek path rendering it currently inactive. Photo: BGC, July 25, 2019.**

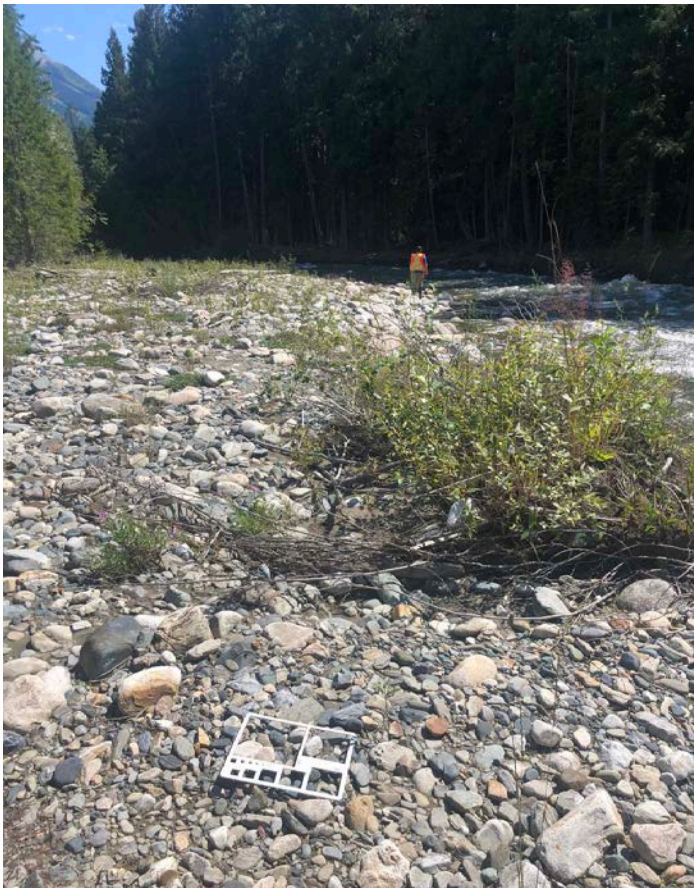
**Photo 19.**

**Standing on the left (north) bank looking downstream at bank, approximately 300 m upstream of the mouth. Photo: BGC, July 25, 2019.**

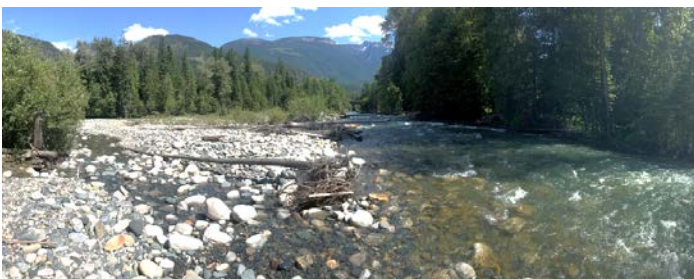
**Photo 22.**  
Standing on the left (north) bank of Cooper Creek looking downstream, approximately 150 m upstream of the mouth. Minor distributary channel has split around a mid channel bar. Duncan Lake Road bridge is visible in the distance. Photo: BGC, July 25, 2019.

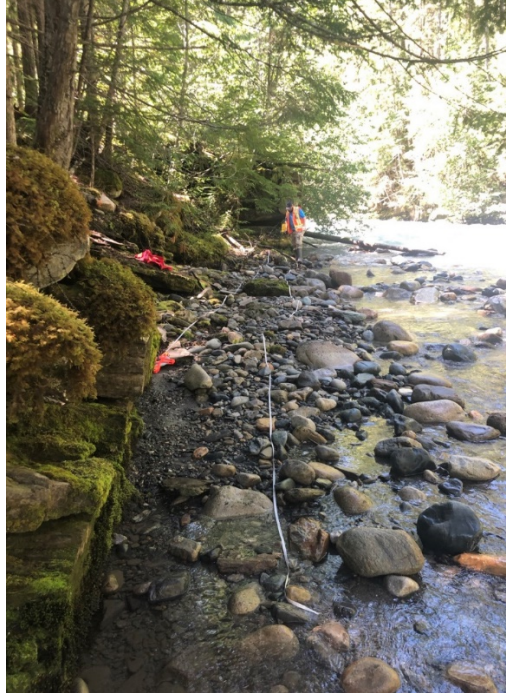
**Figure C-2. Photograph taken of Wolman sampling location Cooper 1. BGC photograph of July 25, 2019.**

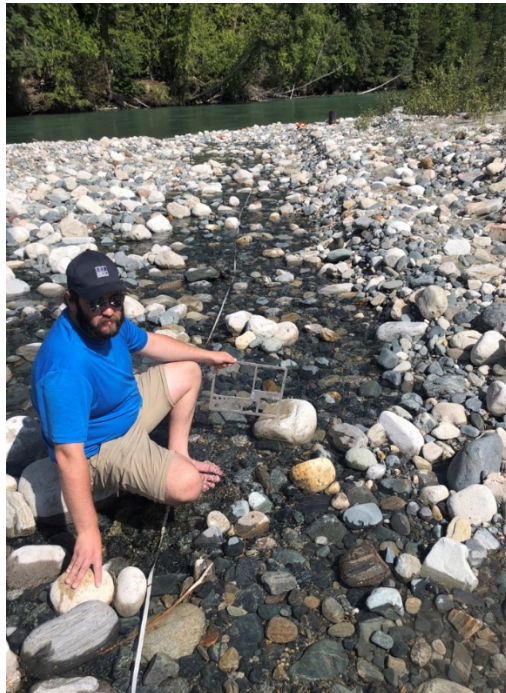
**Figure C-3. Photograph taken of Wolman sampling location Cooper 2. BGC photograph of July 25, 2019.**
