RDCK FLOODPLAIN AND STEEP CREEK STUDY

Duhamel Creek

Final
March 31, 2020

BGC Document No.:
RDCK2-SC-008F

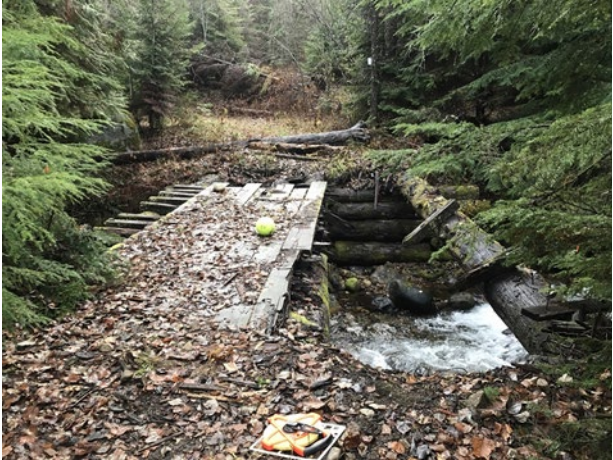
A) Old Log Bridge.

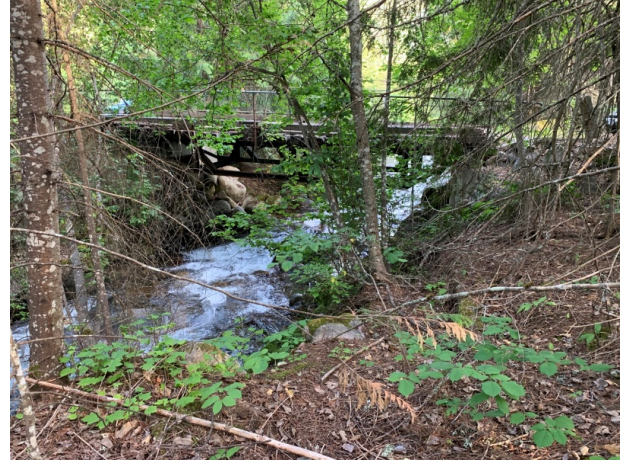
B) Looking downstream at Driveway Bridge 1.

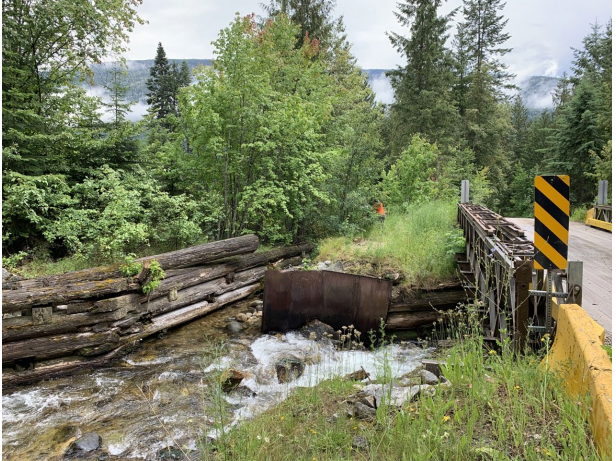
A) On the upstream right bank looking downstream at the bifurcation structure in the centre and Bifurcation Bridge on the right.

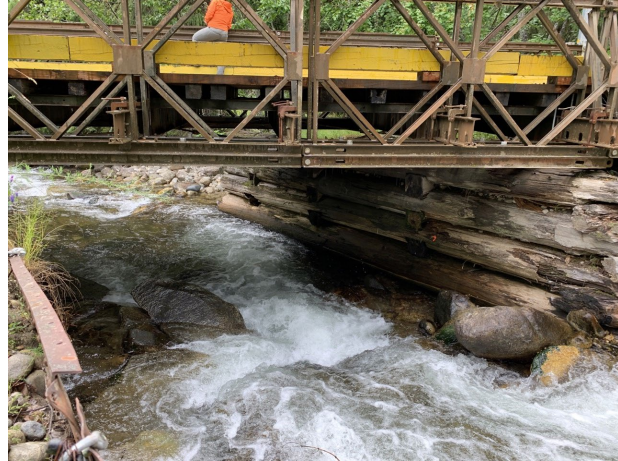
B) Looking downstream (towards western channel) underneath Bifurcation Bridge at the bifurcation structure (see also Photos 4 and 5 in Appendix B for aerial view of bridge).

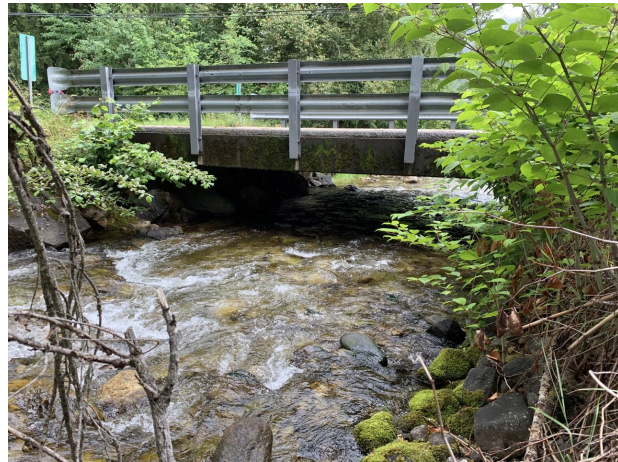
D) Looking downstream at Lower 6 Mile Road West Bridge over western channel.

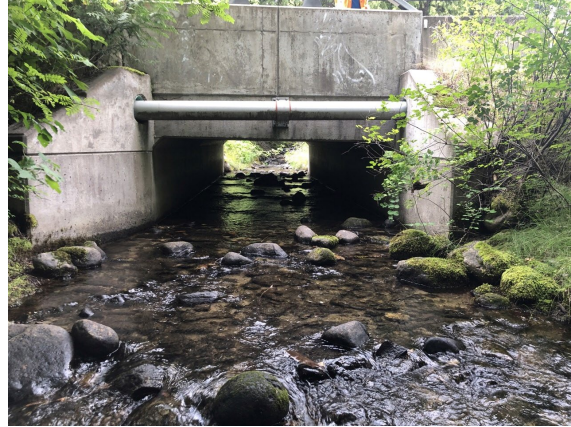
The two Highway 3A bridges are located approximately at mid-fan. The channel gradient decreases from approximately 6.5% upstream of the bridges to approximately 4% on the downstream side of the channels. During the site visit in July 2019, BGC noted the limited capacity (see Figure 3-5A and B) of the Duhamel Highway 3A East Bridge and identified the potential for overland flooding that may affect properties in the event of a blockage. This potential was investigated with numerical models (Section 6.5).

B) Looking upstream through opening of Duhamel Highway 3A East Bridge opening on the eastern channel.

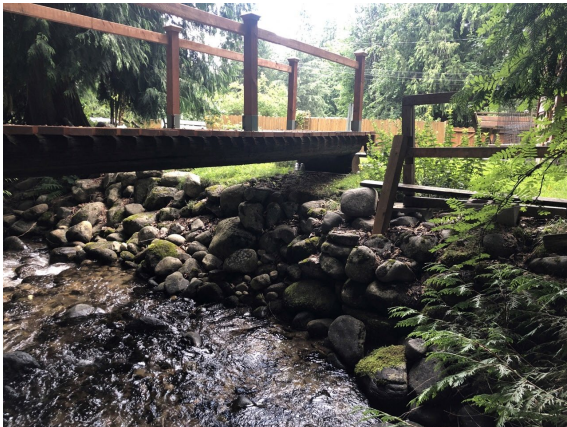
C) Looking downstream at Pedestrian Bridge 1 approximately 50 m downstream of Duhamel Highway 3A East Bridge on the eastern channel.

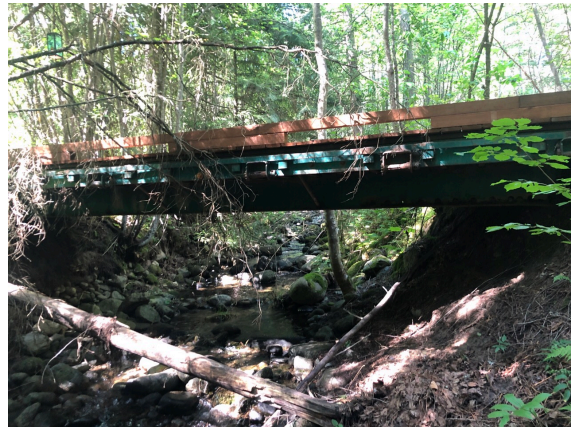
D) Looking upstream at Driveway Bridge 2 approximately 100 m downstream of Duhamel Highway 3A East Bridge on the eastern channel.

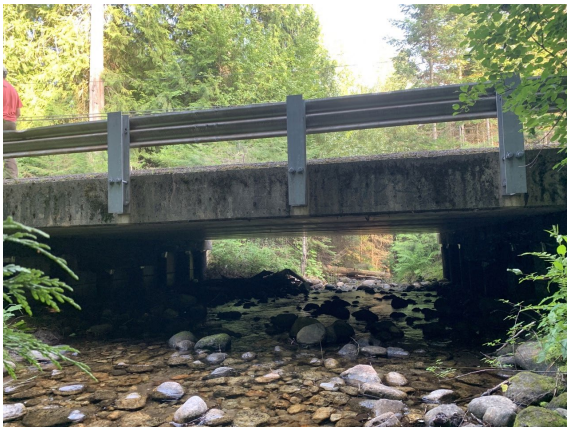
E) Looking downstream at the clearance of the Lower 6 Mile Road East Bridge across the eastern channel.

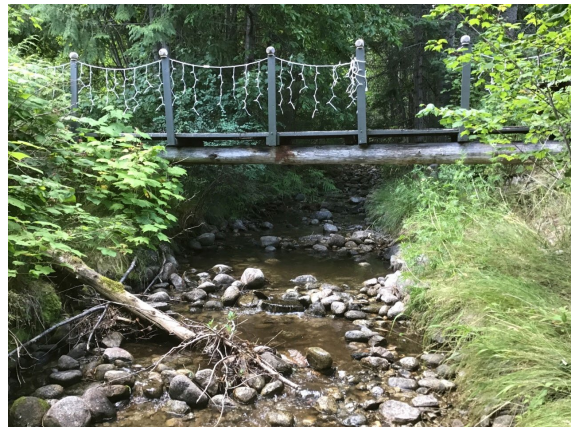
F) Pedestrian Bridge 2, approximately 70 m downstream of Lower 6 Mile Road East Bridge.

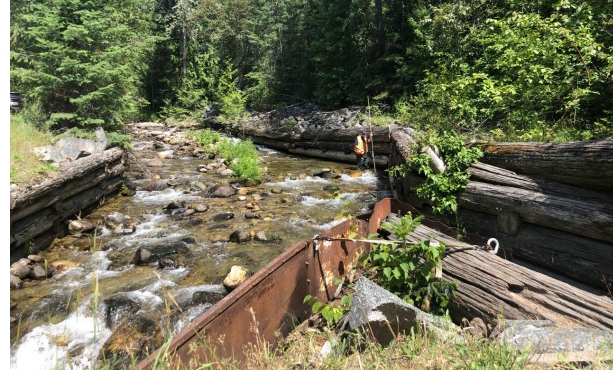
B) Looking upstream (north) at bifurcation with DHL-FP-01 (right), DHL-FP-02 (left), and DHL-FP-03 (center, "V") with Duhamel Creek Rd seen on upper left.

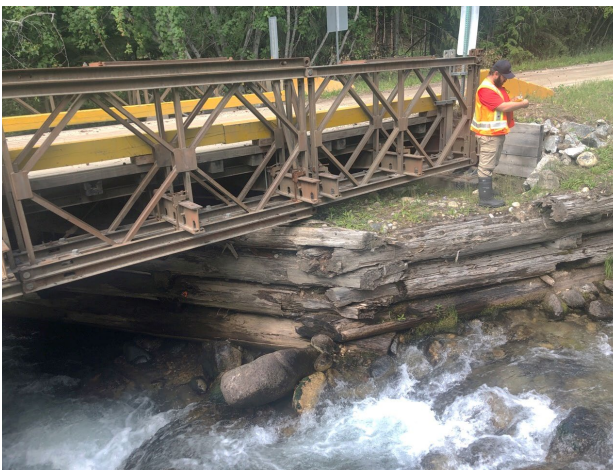
C) Looking at the right bank (west) at the DHL-FP-02 and Duhamel Creek Rd Bridge on the left.

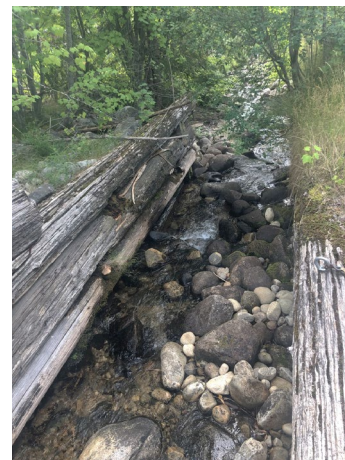
The flow split at the bifurcation structure will likely vary with water elevation and deposition at the entrance to the eastern channel. At the time of fieldwork in July 2019, the flow split was estimated to be 75% in the western (main) channel and 25% in the eastern channel. At the entrance to the eastern channel, the slope of the bed was gradual while the western channel dropped approximately 1 m to 2 m under the Duhamel Creek Road Bridge (Figure 3-6A). This difference in bed slope will affect flow split during moderate flows. If future deposition occurs at the entrance to the eastern channel, the portion of flow entering this channel will be reduced. The logs forming

D) Looking downstream (south) at beginning of the eastern channel with DHL-FP-01 (left), DHL-FP-03 (right).

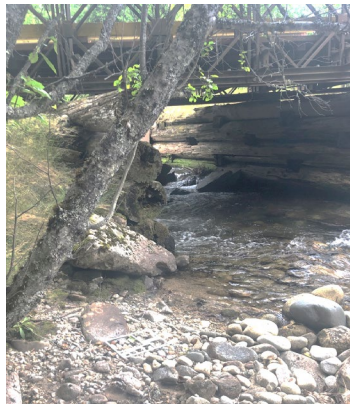
E) Looking upstream (east) at the end of DHL-FP-02 (on the left) and DHL-FP-03 (on the right) with Duhamel Creek Rd Bridge along the top.

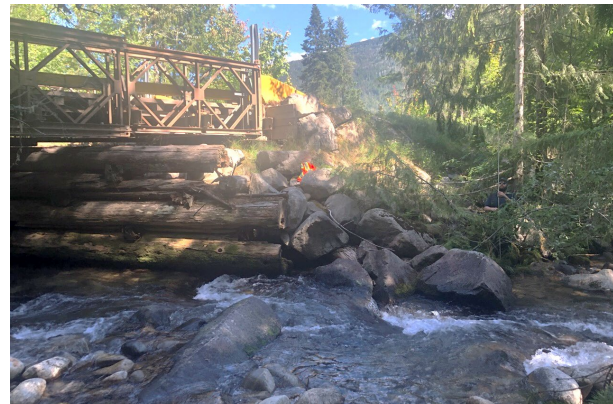
BGC's scope of work did not include the evaluation of specific mitigation works. The following descriptions are therefore meant to alert the readers of this report but are not meant as a comprehensive evaluation of the said structures. This would require specialist input. Irrespective, all three structures (DHL-FP-01, 02 and 03) show signs of damage and some logs have slipped out of their original alignment in places. Bushes and small trees are growing along the edge of DHL-FP-01 and in places, in the log cribbing. Erosion behind the structures as well as deposition of gravel against the structures was observed at DHP-FP-03. The metal sheeting at DHP-FP-03 is attached with two canvas ratchet tie-down straps. Riprap has been placed at the end of DHP-FP-03 on the western (main) channel and angular material, approximately 1 m in diameter, was observed in the creek channel, downstream of the bank protection structure (Figure 3-6F).

F) Looking at the left bank (south) at end of DHL-FP-03 with Duhamel Creek Rd seen on upper left.

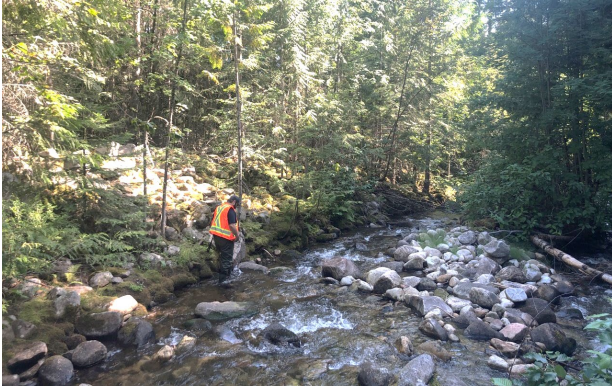
Along the western (main) channel, between the bifurcation structure and Highway 3A, both banks have flood protection structures (DHL-FP-04 and 05) (Figure 3-7). The left bank berm (DHL-FP-04) extends for the full length (360 m) between the bifurcation and Highway 3A. This structure appears to be mainly placed bed material with some short sections of log cribbing and concrete block wall and varies in height along its length (Figure 3-7A and B). In some sections, vegetation and trees are growing in and along the berm material, while others appear to be maintained. Several water intakes were observed along the edge of the berm. The right bank berm (DHL-FP-05) is located upstream of Highway 3A for approximately 80 m. This structure appeared to be mainly placed bed material with large trees growing along the berm and was approximately 1 m to 2 m lower than DHL-FP-04.

A) DHL-FP-04: Rounded creek bed material on left bank with trees growing through berm, approximately 50 m downstream of bifurcation structure.

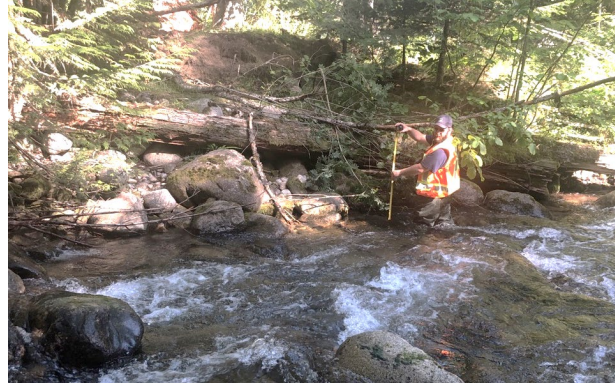
B) DHL-FP-04: Log berm 1 m high on left bank, approximately 140 m downstream of bifurcation structure.

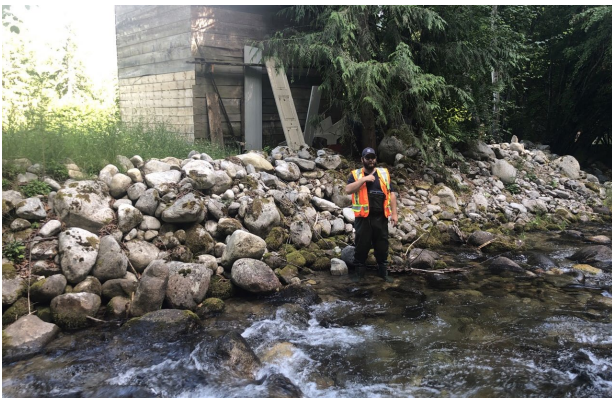
C) DHL-FP-04: Placed creek bed material on left bank approximately 180 m upstream of Highway 3A.

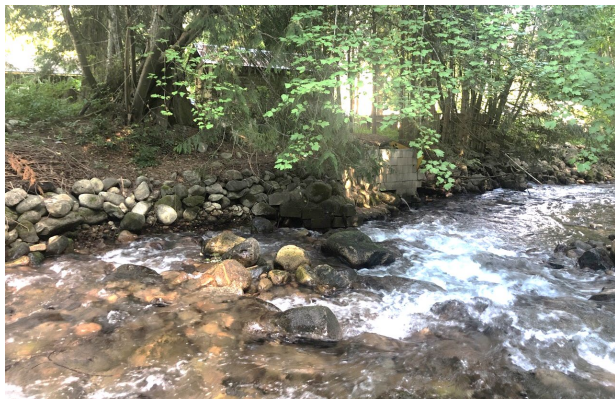
D) DHL-FP-04: Placed creek bed material on left bank approximately 130 m upstream of Highway 3A. Concrete brick wall and water intake visible in the distance

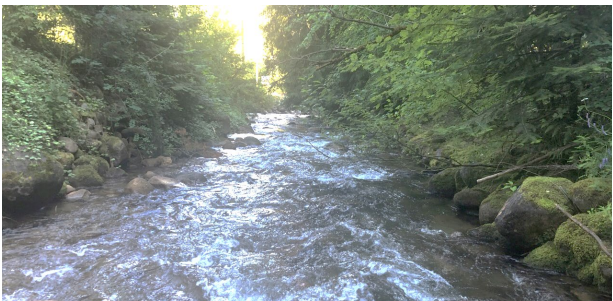
E) Looking downstream at placed creek bed material in DHL-FP-04 (left bank) and DHL-FP-05 (right bank) approximately 70 m upstream of Highway 3A.

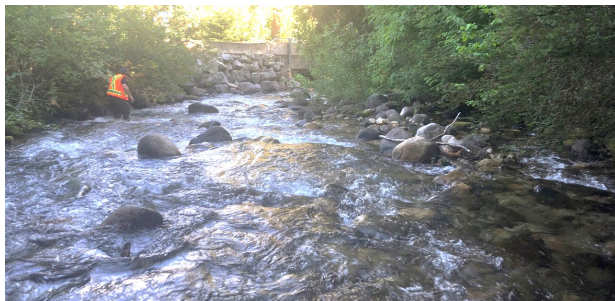
F) Looking downstream at DHL-FP-04 (left bank) and DHL-FP-05 (right bank) approximately 20 m upstream of Highway 3A. Bridge visible in the distance.

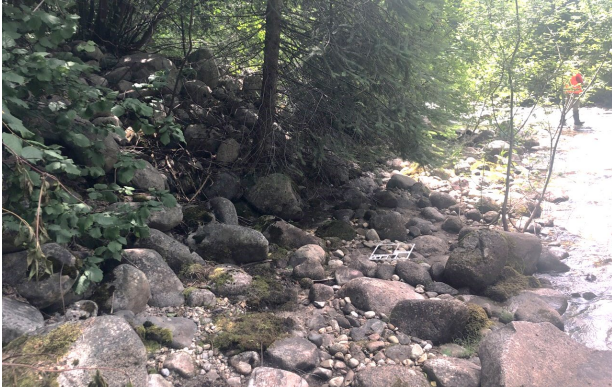
A) DHL-FP-06: Berm constructed of sub-rounded cobbles and boulders approximately 1.5 m to 2 m high on left bank, approximately 50 m downstream of Highway 3A.

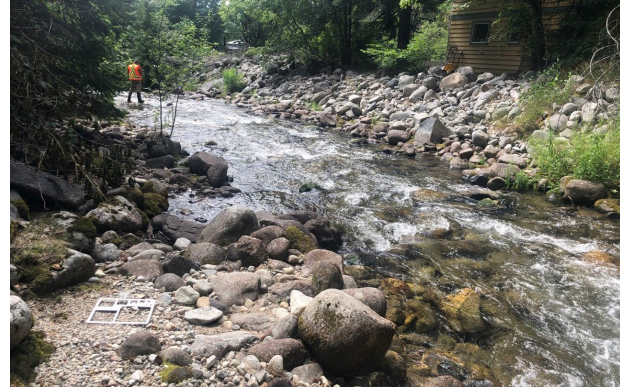
B) DHL-FP-07: Berm constructed of sub-rounded cobbles on the right bank approximately 50 m downstream of Highway 3A.

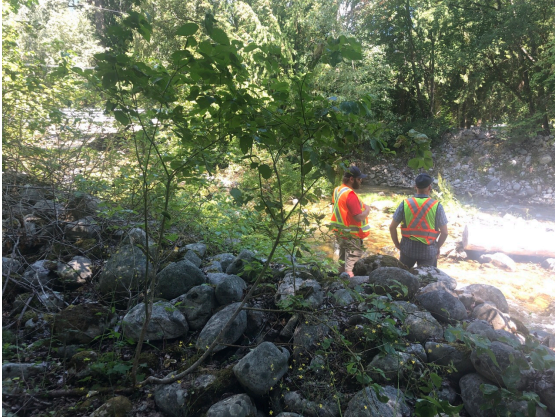
A) DHL-FP-09: Standing on right (west) bank, approximately 30 m downstream of Lower 6 Mile Road looking across at dike on left bank (DHL-FP-08).

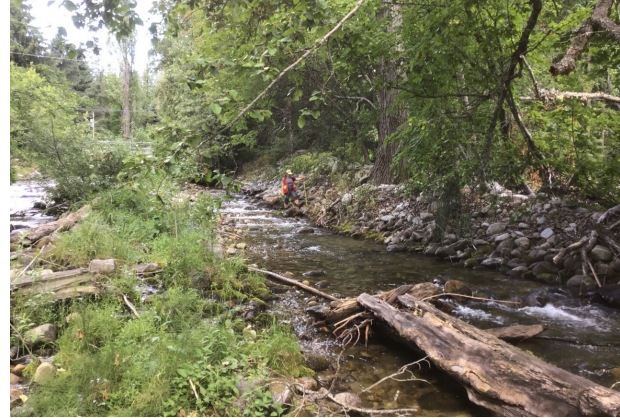
Downstream of Lower 6 Mile Road along the western (main) channel, both the left and right banks are diked (DHL-FP-08 and 09) for 220 m and 160 m (Figure 3-9). Along DHL-FP-08, approximately 60 m downstream of Lower 6 Mile Road, a low spot in the dike was noted (Figure 3-9C) where the owners of the property indicated that they plan to place material to raise the height of the dike (personal communication, July 29, 2019). A channel was visible to the east of the DHL-FP-08 on private property and the owners said it was fed from seepage through the dike year-round (personal communication, July 29, 2019). Along the opposite bank (DHL-FP-09) approximately 30 m downstream of Lower 6 Mile Road, swampy ground was noted on the west side of the dike where water likely flows through the 2-3 m tall dike (Figure 3-9 A). This indicates water leaves the channel through the both banks and bed and resurfaces in adjoining properties.

B) DHL-FP-08: On mid channel bar approximately 60 m downstream of Lower 6 Mile Road, looking at left bank (east).

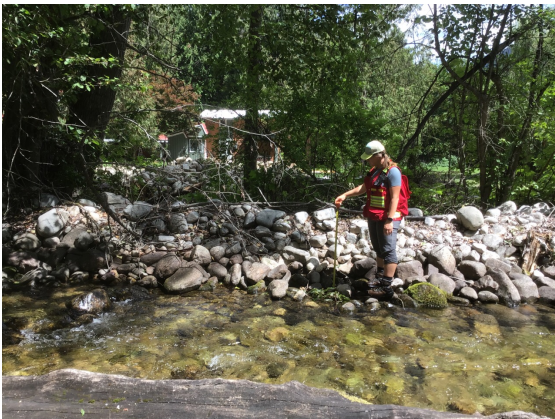
C) DHL-FP-08: Looking at left bank (east), approximately 70 m downstream of Lower 6 Mile Road. Additional berm material visible in the background.

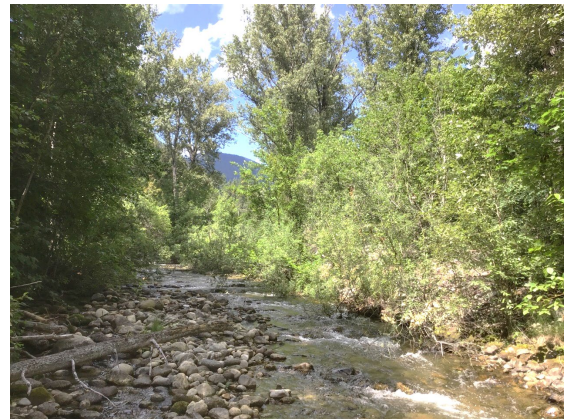
D) DHL-FP-08: Standing in the channel looking upstream (north), approximately 100 m downstream of Lower 6 Mile Road.

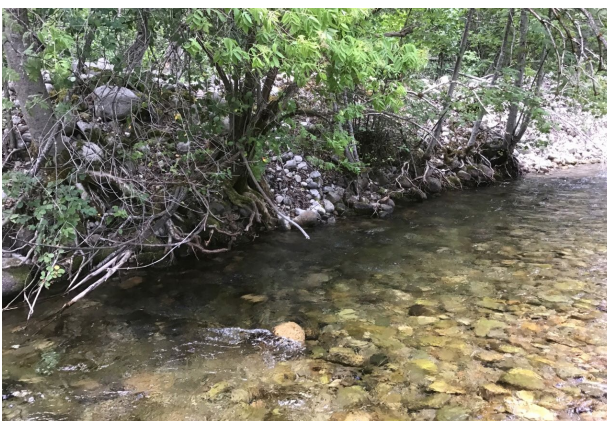
E) DHL-FP-09: Standing in the channel, approximately 100 m downstream of Lower 6 Mile Road, looking west at right bank.

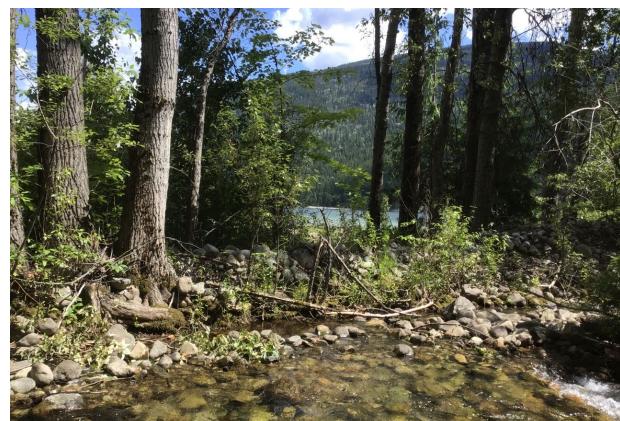
F) DHL-FP-08: Looking east at the left bank dike, approximately 150 m downstream of Lower 6 Mile Road.

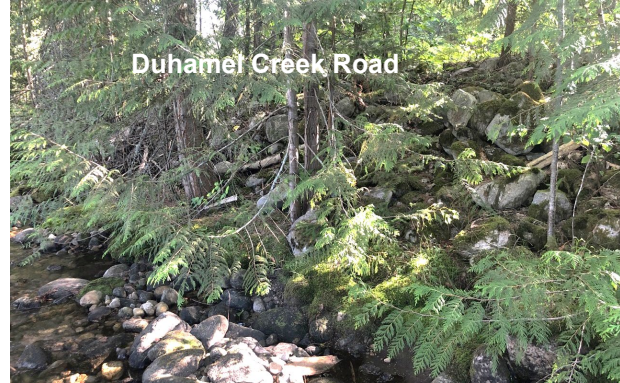
B) DHL-FP-11: Looking at rounded boulders and cobbles along right bank, approximately 70 m downstream of bifurcation structure, looking downstream.

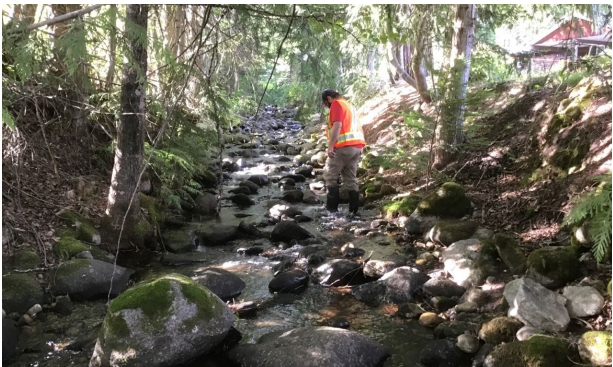
C) DHL-FP-10 & 11: Approximately 110 m downstream of bifurcation looking upstream. Minimal protection on either bank

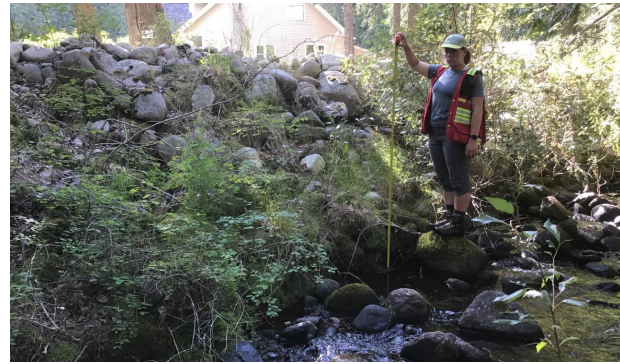
F) DHL-FP-11: Approximately 40 m upstream of Highway 3A looking at left bank with rounded cobbles and small boulders.

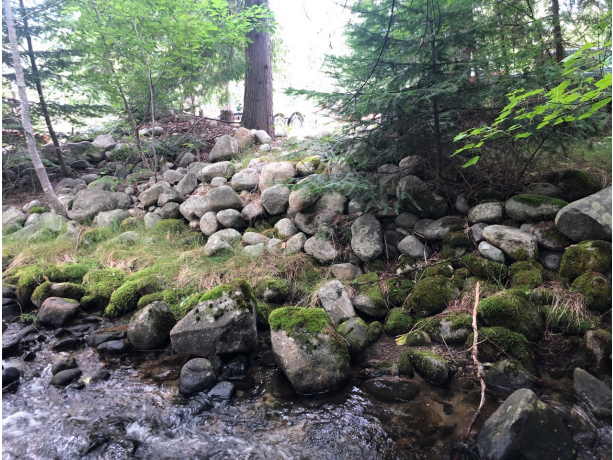
A) DHL-FP-12: In the channel looking at left bank immediately downstream of Highway 3A.

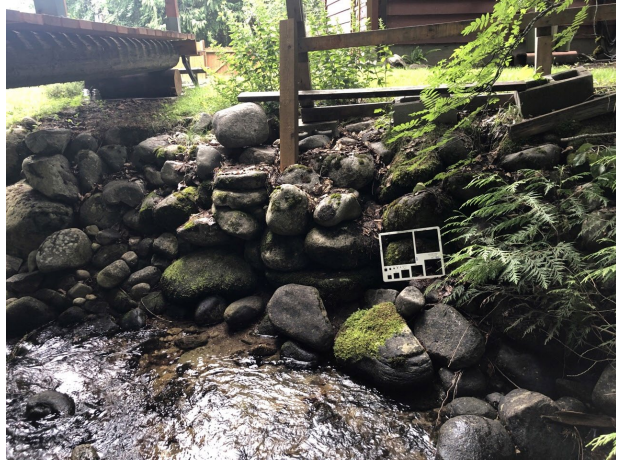
B) DHL-FP-13: In the channel looking at right bank immediately upstream of Pedestrian Bridge 1 (left side of photo).

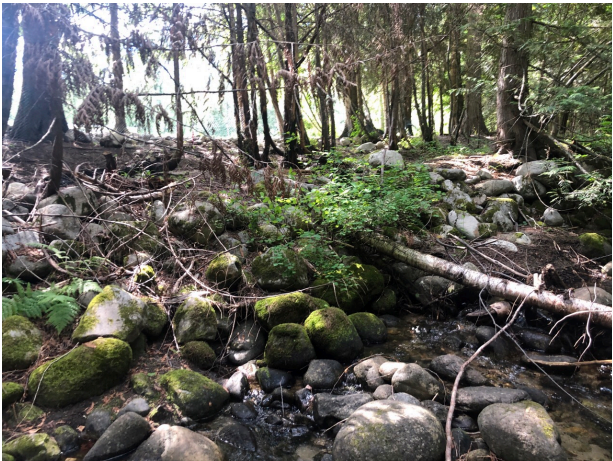
Both banks immediately downstream of Highway 3A have bank protection (DHL-FP-12 and 13) extending down to Pedestrian Bridge 1 (Figure 3-11A and B). Approximately 200 m downstream of Highway 3A, a shorter 20 m flood protection (DHL-FP-14) is located on the right bank (Figure 3-11C). The remainder of the channel has vegetated sloping banks without obvious flood protection (Figure 3-11D).

C) DHL-FP-14: Looking at right bank approximately 130 m upstream of Lower 6 Mile Road Bridge.

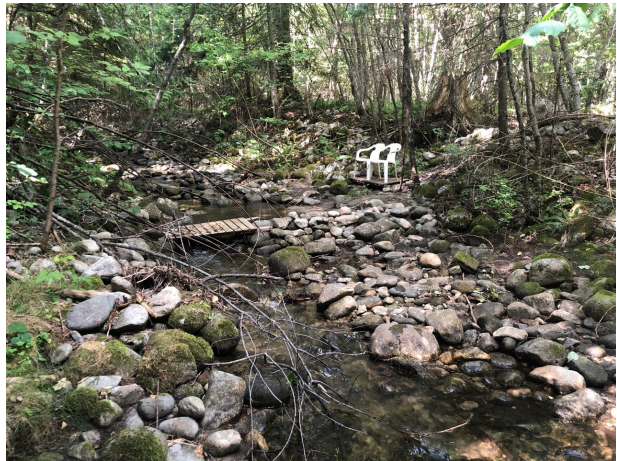
D) In the channel looking upstream, approximately 80 m upstream of Lower 6 Mile Road

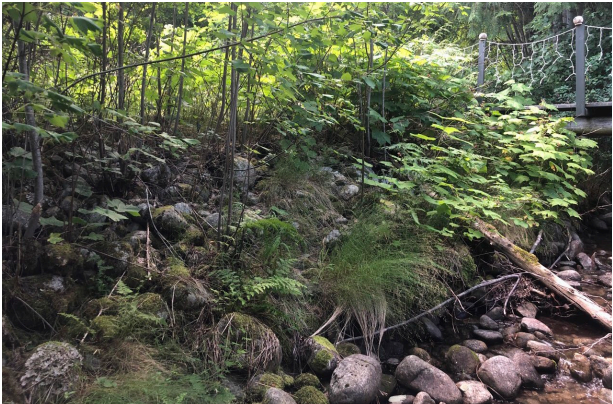
B) DHL-FP-15: Looking at left bank, just upstream of Pedestrian Bridge 2 (right side of photo).

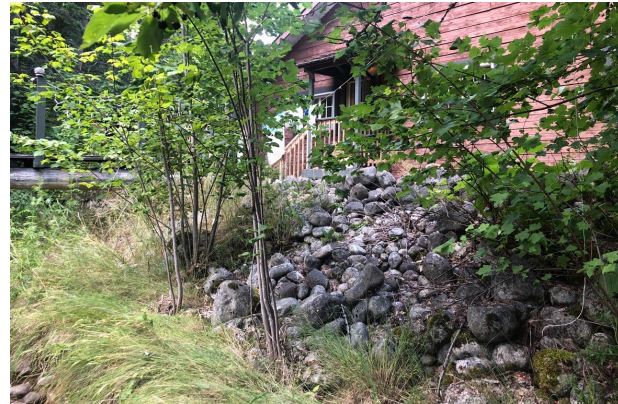
C) DHL-FP-16: Looking at right bank, just upstream of Pedestrian Bridge 2 (left side of photo).

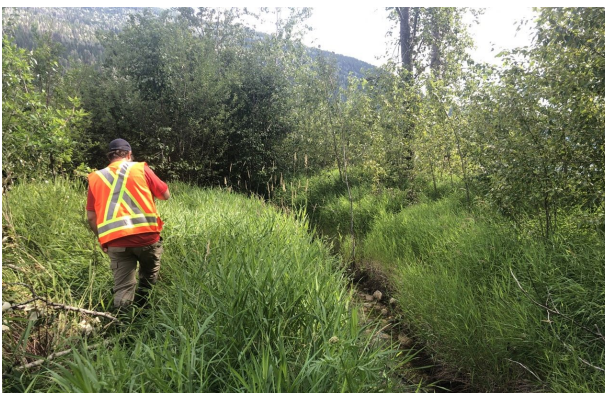
Between Lower 6 Mile Road and Pedestrian Bridge 2, both banks are lined with placed creek bed material, approximately 2 m to 2.5 m tall, extending approximately 60 m (Figure 3-12A to C). On both banks downstream of Pedestrian Bridge 2, there are indications from the lidar imagery that the banks have been raised; however, this was not able to be confirmed during BGC's July 2019 field visit due to heavy vegetation cover (Figure 3-12D).

D) Approximately 110 m downstream of Pedestrian Bridge 2, looking south at heavy vegetation cover.

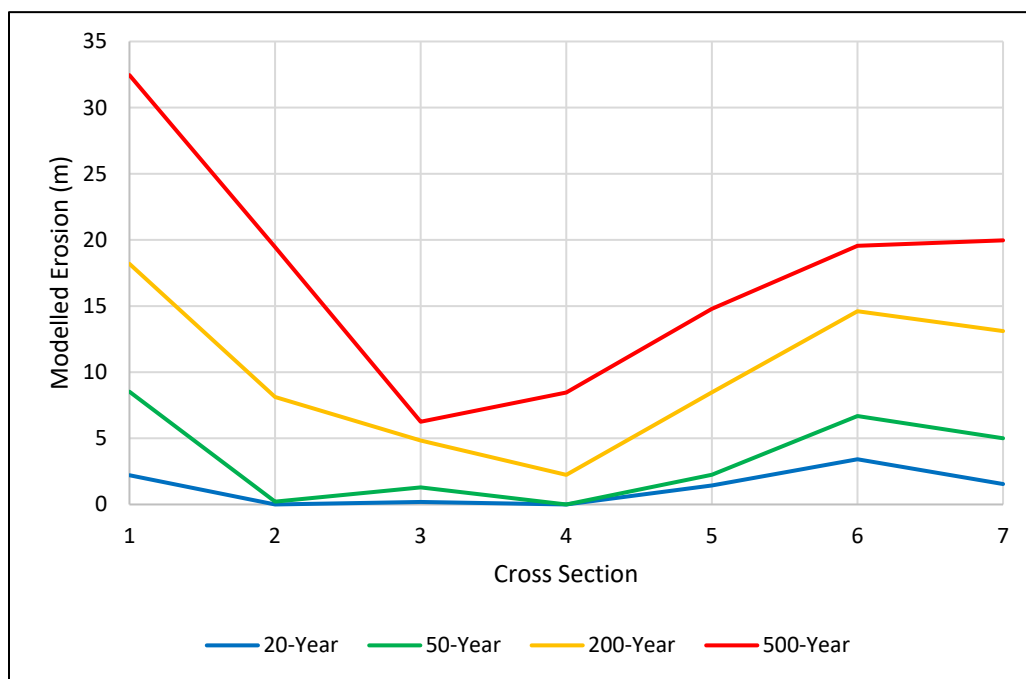
Figure 6-2. Duhamel Creek 50th percentile bank erosion model results at main channel cross-sections (1 to 7).

Figure 6-2 and Figure 6-3 shows the 50% percentile modelled bank erosion at each cross-section. The predicted erosion differs between cross-sections based on the cross-section characteristics (e.g., channel geometry, channel slope, D_{84} grain size). Erosion peaks at cross-section 6 for the 20-year return period and at cross-section 1 for all other higher return periods (see Drawings 02A, 02B). Abutments of the Highway 3A and Lower 6 Mile bridges may be impacted by erosion during a rare (high return period) event or by progressive erosion over time. Several existing buildings may be impacted as they fall within the improbable erosion corridor for the 500-year return period.

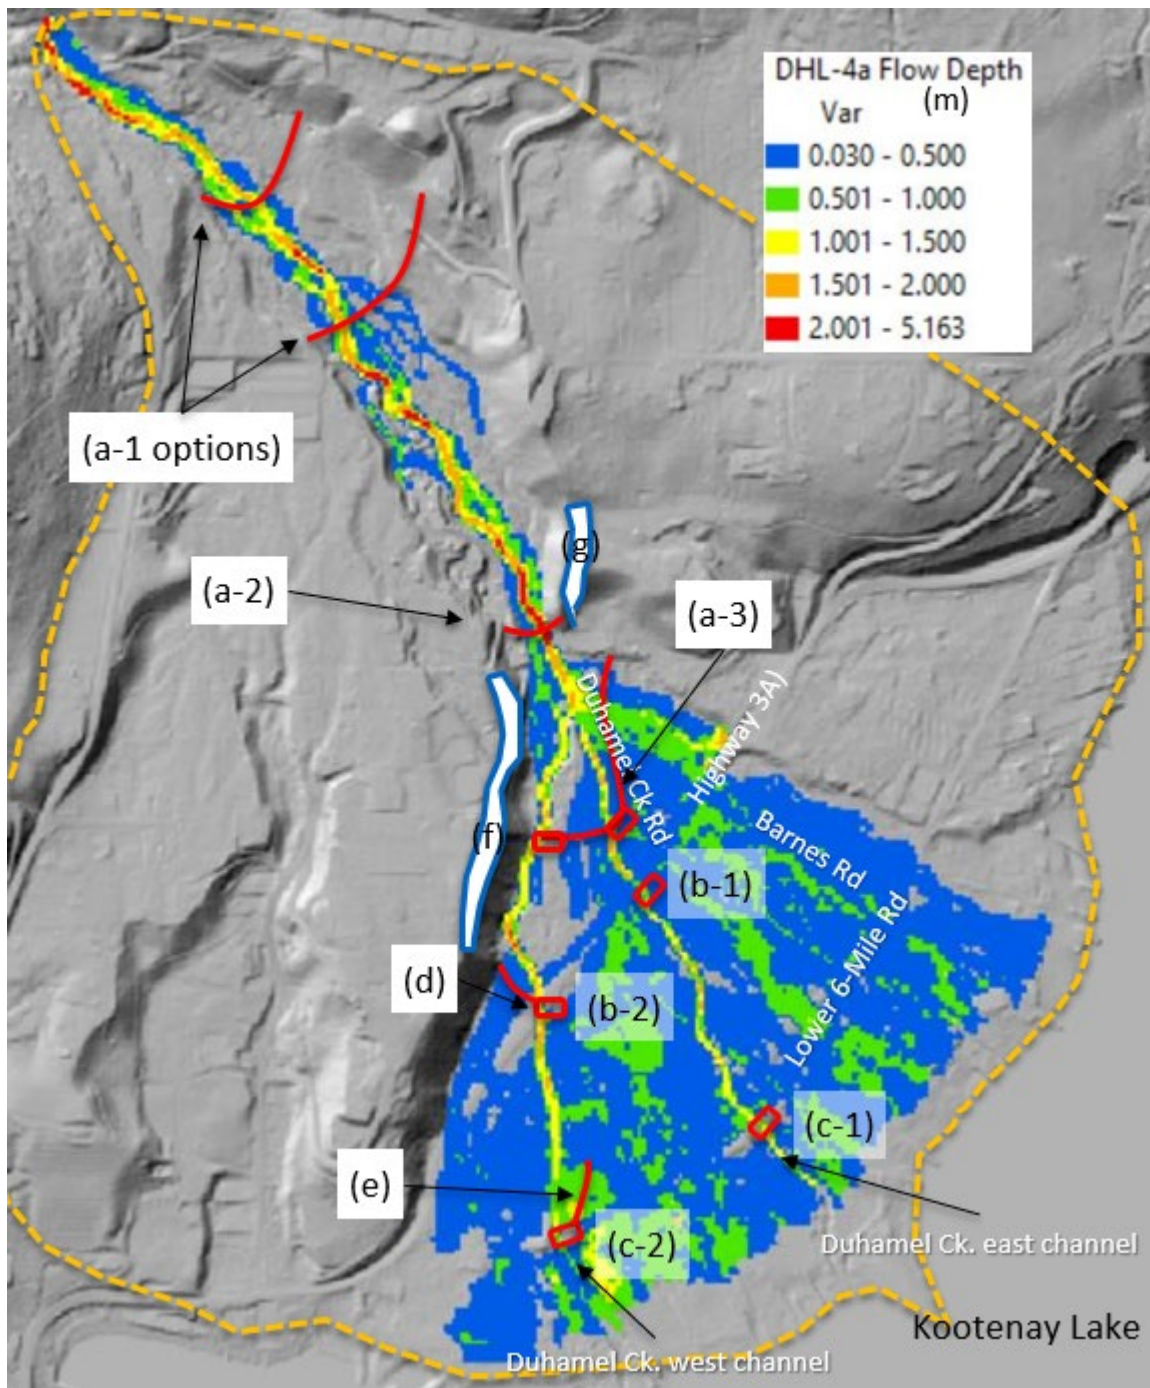
Figure 7-1. Debris-flood inundation map showing flow depths for a 500-year return period debris flood on Duhamel Creek from FLO-2D modeling with no specific bridge blockages. The figure shows conceptual-level mitigation options for Duhamel Creek fan-delta. Note that these options have not been tested by numerical modelling and only serve as an impetus for further discussion. Other options will likely be developed at the conceptual design level.

Duhamel Creek fan-delta hosts the highest value of assets of the steep creek fan-deltas studied in detail (Table 1-1). Hence, while likely expensive, Option 1 may be viable at Duhamel Creek. With reference to Figure 7-1, the following specific mitigation measures could be considered to reduce hazards and risks on Duhamel Creek:

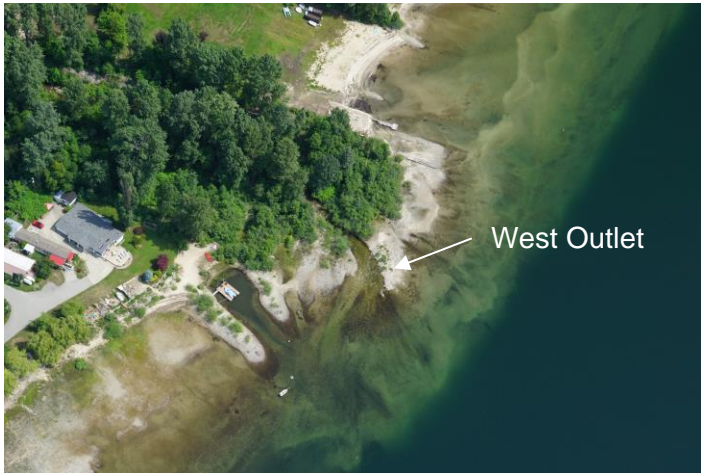
approximately 2 m and aims to keep this level relatively steady with the use of upstream dam management as well. The distal portions of the fan, visible in air photos (Section 6.2), were flooded by the lake level raise. Duhamel Creek flows into Kootenay Lake in an approximately 55 m wide reach on the western channel (Photo 6 in Appendix B) and an approximately 30 m wide reach on the eastern channel.

Photo 6.
Overview photo taken during helicopter overflight looking down at the western Duhamel Creek outlet to Kootenay Lake. Photo: BGC, July 6, 2019.

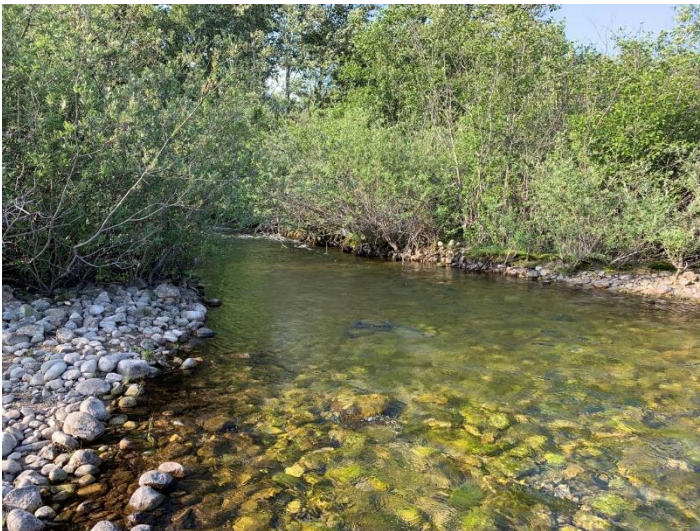
Photo 14.
Standing on the right bank of Duhamel Creek at the west outlet to Kootenay Lake looking upstream (north). Photo: BGC, July 8, 2019.
