## RDCK FLOODPLAIN AND STEEP CREEK STUDY

# Redfish Creek

**Final**  
**March 31, 2020**

BGC Document No.:  
**RDCK2-SC-003F**

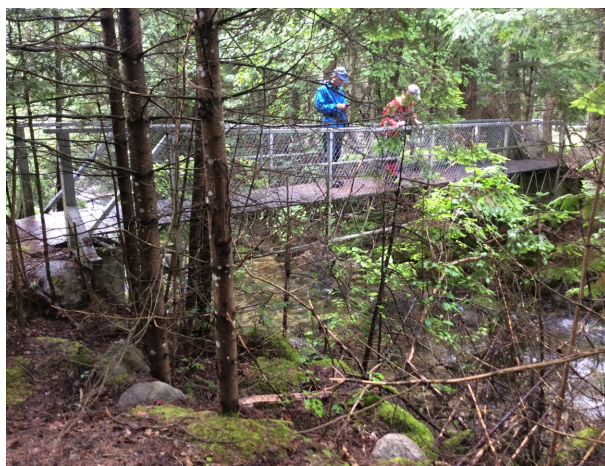
**Standing on left bank looking south at the Footbridge. Creek flows from right to left in photo.**

**Figure 3-3. Bridge structures encountered on Redfish Creek fan-delta during BGC's field work in July and November 2019. Refer to Drawings 02A, 02B for locations.**

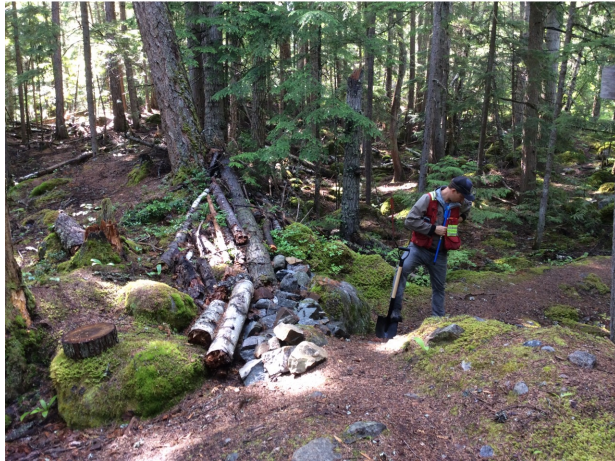
In addition to the man-made flood protection structures, there are natural levees formed from past debris flow lobes along Redfish Creek. Along these levees, there are low points where overtopping of the banks and avulsions are possible. Drawings 02A, 02B show the locations of these low points (RFS-LP-01 to -03) and Figure 3-5 shows the field photographs taken by BGC in July 2019. The NHC/Thurber (1990) report notes the locations of three low points – the west side of the fan-delta apex, the west side of Wightwick Road, and the west side of Marshall Road Bridge (now removed), which also is at Wightwick Road. RFS-LP-01 may correspond to one of the latter two low points noted by NHC/Thurber (1990).

**RFS-LP-01.** On the right bank looking southeast at low point (i.e., walking trail) in natural berm.

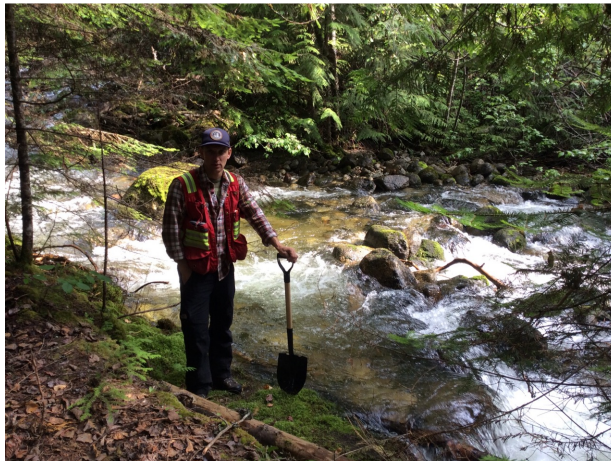
**RFS-LP-03.** Standing on right bank looking northeast at Redfish Creek. BGC personnel standing at the low point.

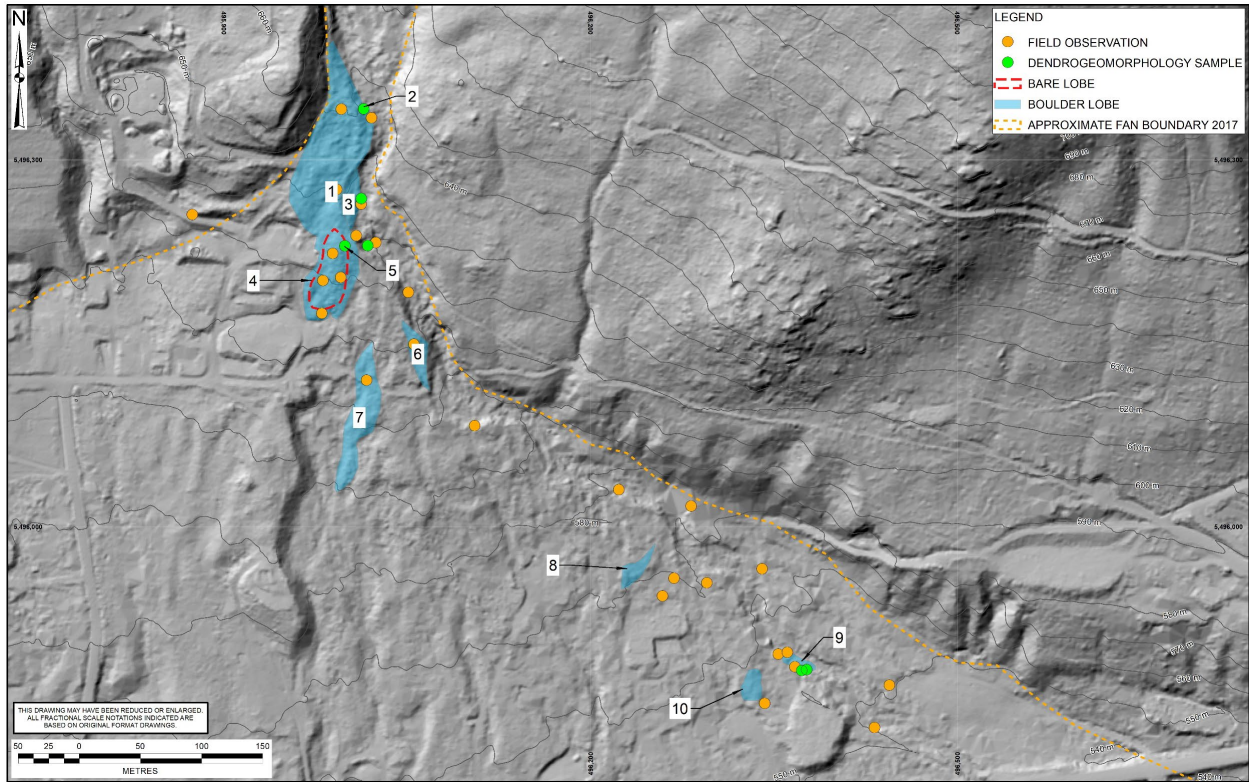
While the preponderance of evidence suggest that debris floods are the dominant hydrogeomorphic hazard on the fan-delta, multiple boulder lobes and levees were identified on the west side of Redfish Creek during BGC's field visit in July 2019. The boulders observed in lobes and levees were primarily granitic and rounded. Figure 6-1 shows the locations of the boulder lobe observations and Table 6-1 shows the images and what was observed at each location. Of note is that Table 6-1 refers to dendrogeomorphology results that are described in more detail in Section 6.2.2.

**Figure 6-1. Boulder lobe locations observed during BGC’s field visit in July 2019.**

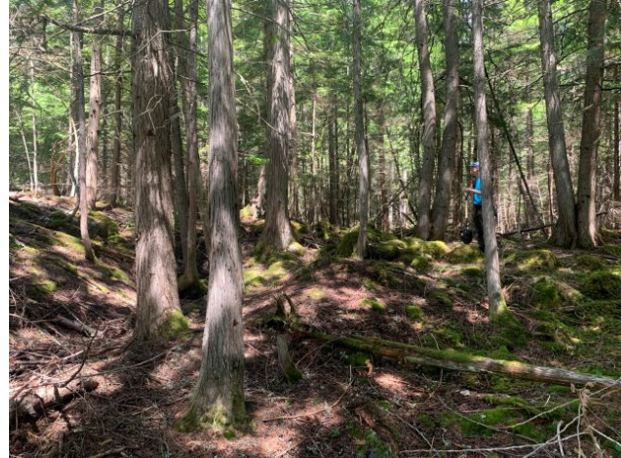
Location	Comment	Image	Location	Comment	Image
10	Boulder lobe with 0.5 to 1.0 m diameter boulders.	<p data-bbox="873 237 1463 298">Looking downslope (southeast) at moss-overgrown boulder lobe where field personnel is standing.</p>

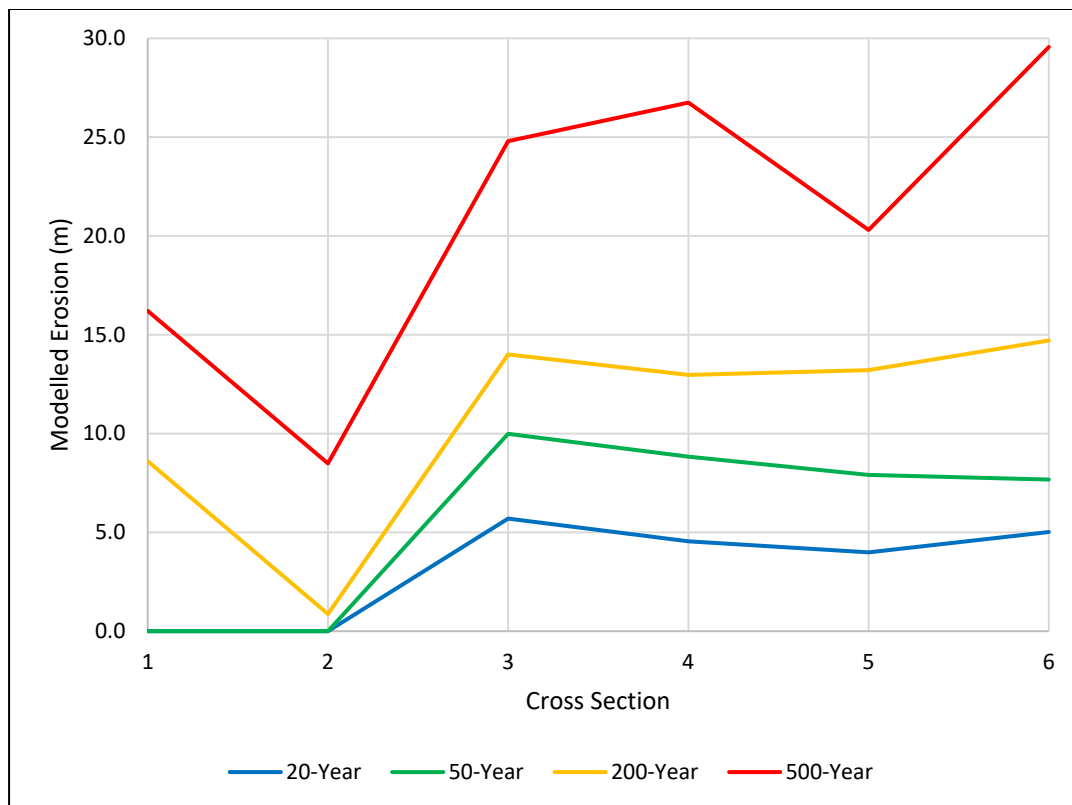
Figure 6-3 shows the 50% percentile modelled bank erosion at each cross-section. The predicted erosion differs between cross-sections based on the cross-section characteristics (e.g., channel geometry, channel slope,  $D_{84}$  grain size). Erosion-peaks at cross-section 6 for all return periods except the 200-year, which peaked at cross section 3.

**Figure 6-3. Redfish Creek 50<sup>th</sup> percentile bank erosion model results at each cross-section.**

All return periods have the potential to impact the bridge abutments at the Highway 3A crossing. Longer-term progressive erosion could impact the property at the east end of Redfish Road.

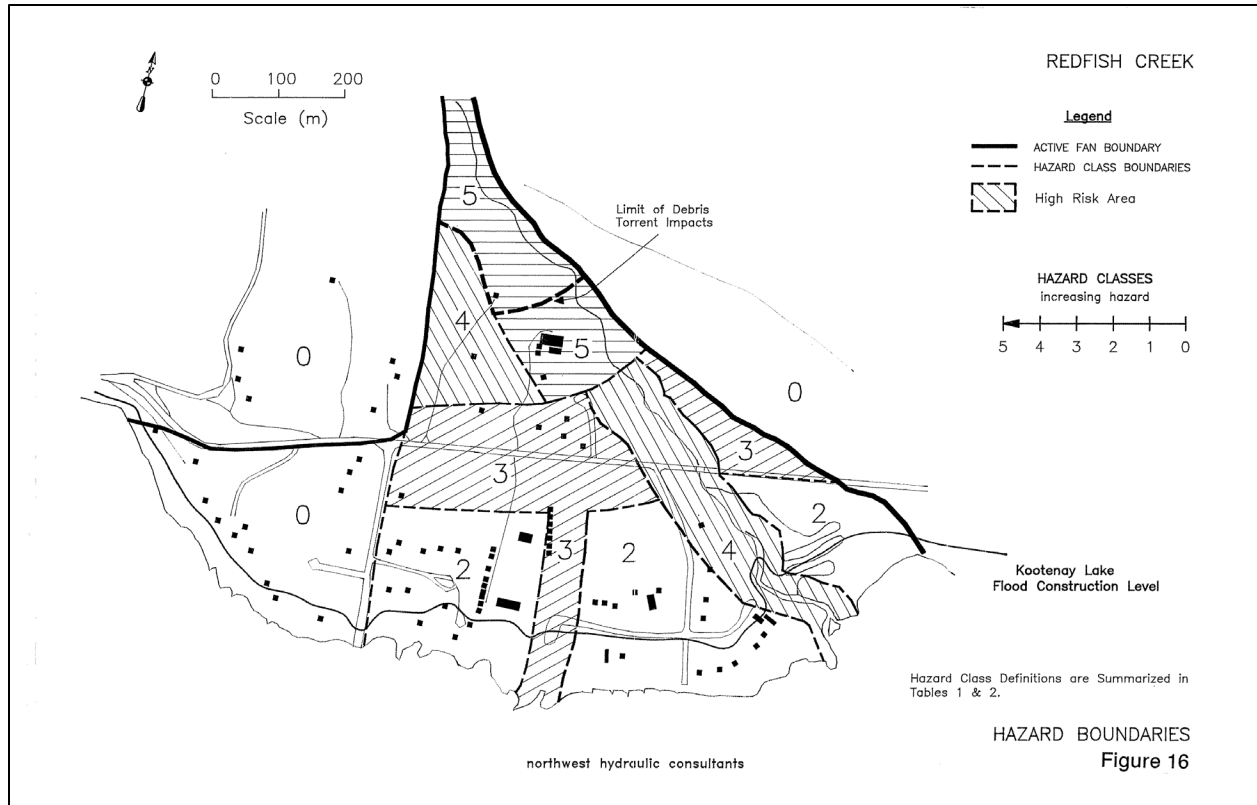
The NHC/Thurber (1990) assessment considered debris torrents<sup>11</sup>, avulsions or channel shifts, and inundation. For each fan-delta investigated, hazard areas were codified between 0 (lowest hazard) and 5 (highest hazard). However, since NHC/Thurber (1990) also included loss of life consequences as a second dimension in their hazard mapping, their hazard maps provided information on relative levels of risk. Specific risk zones were defined as those where individual life loss risk exceeds or falls below specified values. Areas with a hazard (risk) code of 3 or higher were interpreted to have a significant threat to loss of life defined as the annual probability of death of a select individual of > 1:20,000. Figure 6-4 shows the NHC/Thurber risk map for Redfish Creek.

**Figure 6-4. NHC/Thurber's (1990) Redfish Creek individual life risk map. Class 4 and 5 imply individual life loss risk values exceeding 1:10,000. Class 3 1:10,000 to 1:20,000. Class 0, 1 and 2 < 1:20,000.**

After careful review of the NHC/Thurber (1990) study, BGC concludes that the hazards (and likely risks to loss of life) are substantially lower than estimated by NHC/Thurber as determined through BGC's assessment. The main reason for this discrepancy is that NHC/Thurber did not benefit from lidar topography, detailed numerical modelling and an additional 30 years of data that have accrued since their study and the present. In absence of such detailed information and analysis it was likely justified to err on the conservative spectrum. BGC believes that the current work is a credible representation of hazards on Redfish Creek up to the 500-year return period scenarios considered.

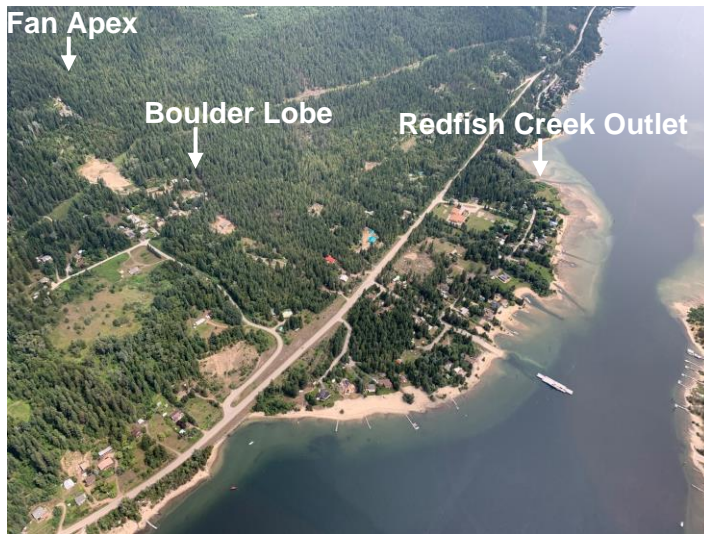
**Photo 3.**

Overview photo taken during helicopter flight looking north-east at Redfish Creek. A boulder lobe located west of the creek is indicated. Locations of fan apex and Redfish Creek outlet into the West Arm of Kootenay Lake are shown. Photo: BGC, July 6, 2019.

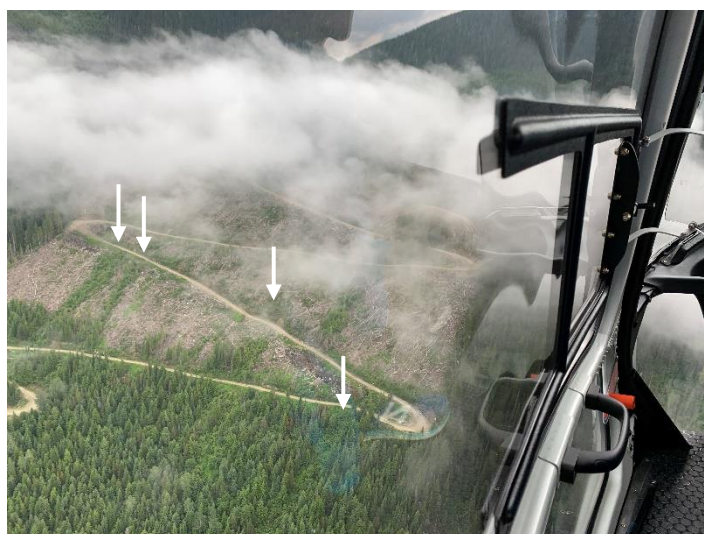
**Photo 5.**

Drawing 05 shows a geomorphic map of the study area, including specific landforms and sediment sources in the watershed. The headwaters of Redfish Creek are located on the mountainous slopes of Mount Yuill (approximate elevation of 2150 m) at the western edge of the watershed and the mountains to the northeast (peak elevation approximately 2350 m). The upper portion of the watershed is characterized by wide U-shaped valleys. The upper reaches of the watershed contain some active talus slopes that supply sediment to the channel. Several small lakes (e.g., Whitelady Lake, Ross Lake) are present on the flatter portions of the tributary valleys. The U-shaped valley transitions into the V-shaped mainstem valley that ultimately flows into the Kootenay Lake valley. Several debris avalanche paths related to logging roads are present, e.g., Photo 5 in Appendix B (see Drawing 05 for locations).

Overview photo during helicopter flight looking northeast at debris avalanche paths on the eastern valley side of Redfish Creek, approximately 5.3 km upstream of lake outlet. Initiation zones are indicated with arrows. See Drawing 05 for debris flow paths. Photo: BGC, July 6, 2019.

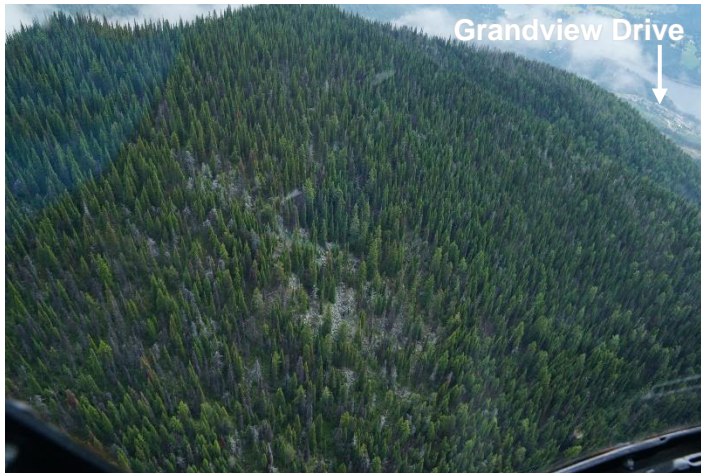
**Photo 6.**

**View from helicopter looking down in southeastern direction (towards Grandview Drive near Laird Creek) at approximate elevation 1900 m on eastern ridge along Redfish Creek. Some bedrock outcrops and coarse talus were observed between the trees. See Drawing 05 for location. Photo: BGC, July 6, 2019.**

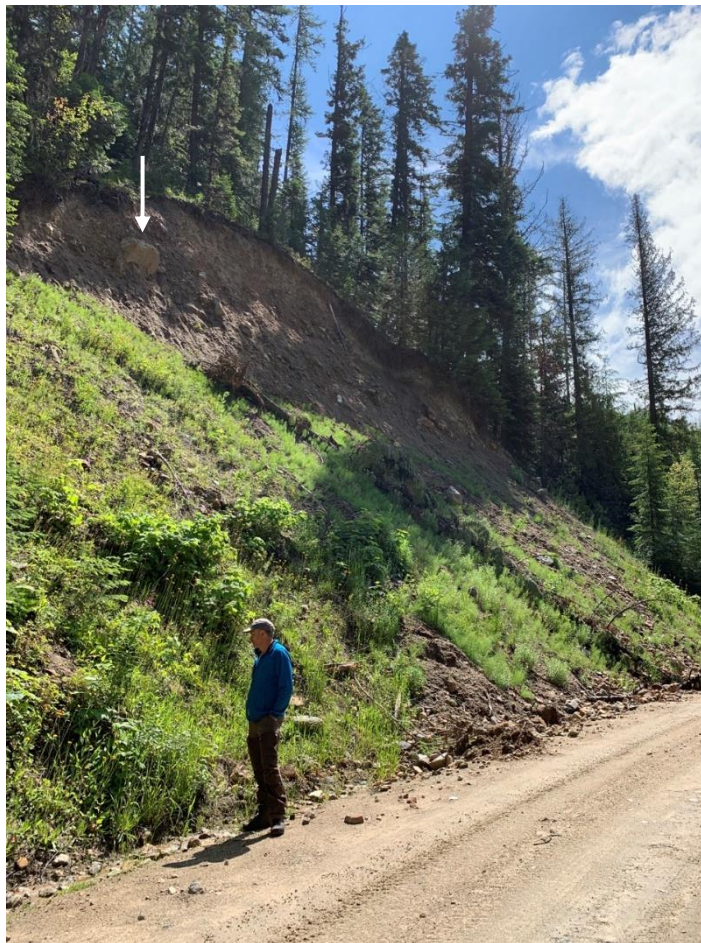
**Photo 7.**

The hillslopes are forested, and logging is abundant throughout the watershed. Apex (2016) estimated that approximately 14% of the total watershed has been logged (Drawing 05). Several debris flows and debris slides have also occurred in the watershed initiating from logging roads. For example, Photos 7 and 8 in Appendix B show till slopes exposed by debris avalanches near the Redfish-Laird Creek FSR. A debris flow path is delineated below these debris avalanches (see Drawing 05). No significant forest fires have been recorded in this watershed since 1919 (FLNRORD, 2019).

**Looking southeast on Redfish-Liard Creek FSR at exposed till escarpment (approximately 20 m tall), possibly related to a debris avalanche that released from here. Note arrow pointing to rounded granitic boulders contained in till. See Drawing 05 for location. Photo: BGC, July 10, 2019.**

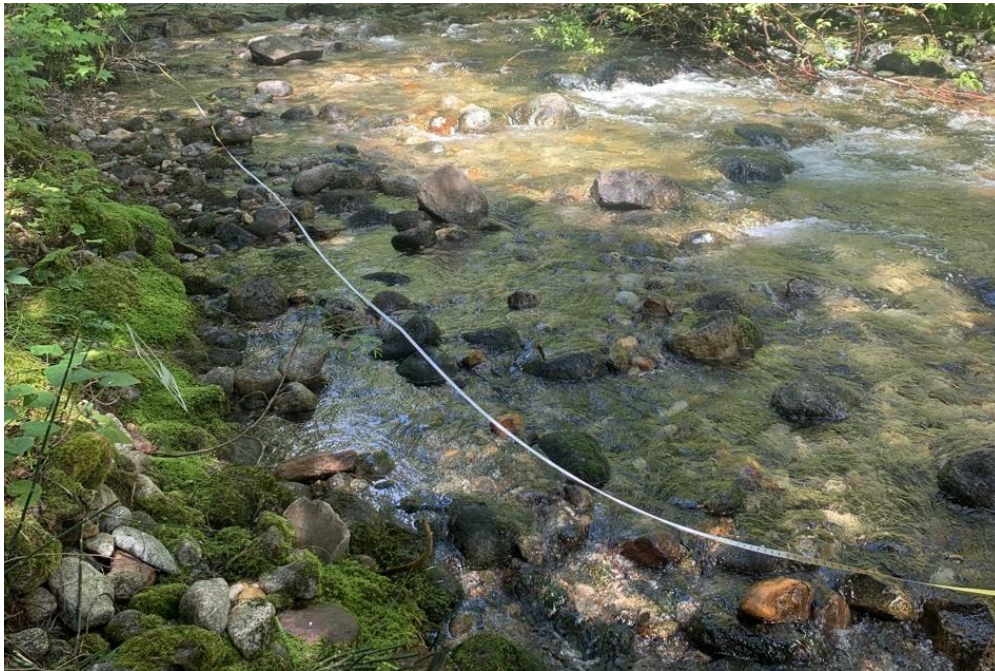
**Figure C-3. Photograph taken of Wolman sampling location Redfish 2. BGC photograph of July 3, 2019.**

The channel gradient decreases downstream, as such, it would be expected that bed material size would decrease as well. Instead, bed material size at Redfish 2 (on distal fan) has a higher proportion of bed material larger than 8 mm as compared with Redfish 1 (above fan apex) where there is generally finer bed material.

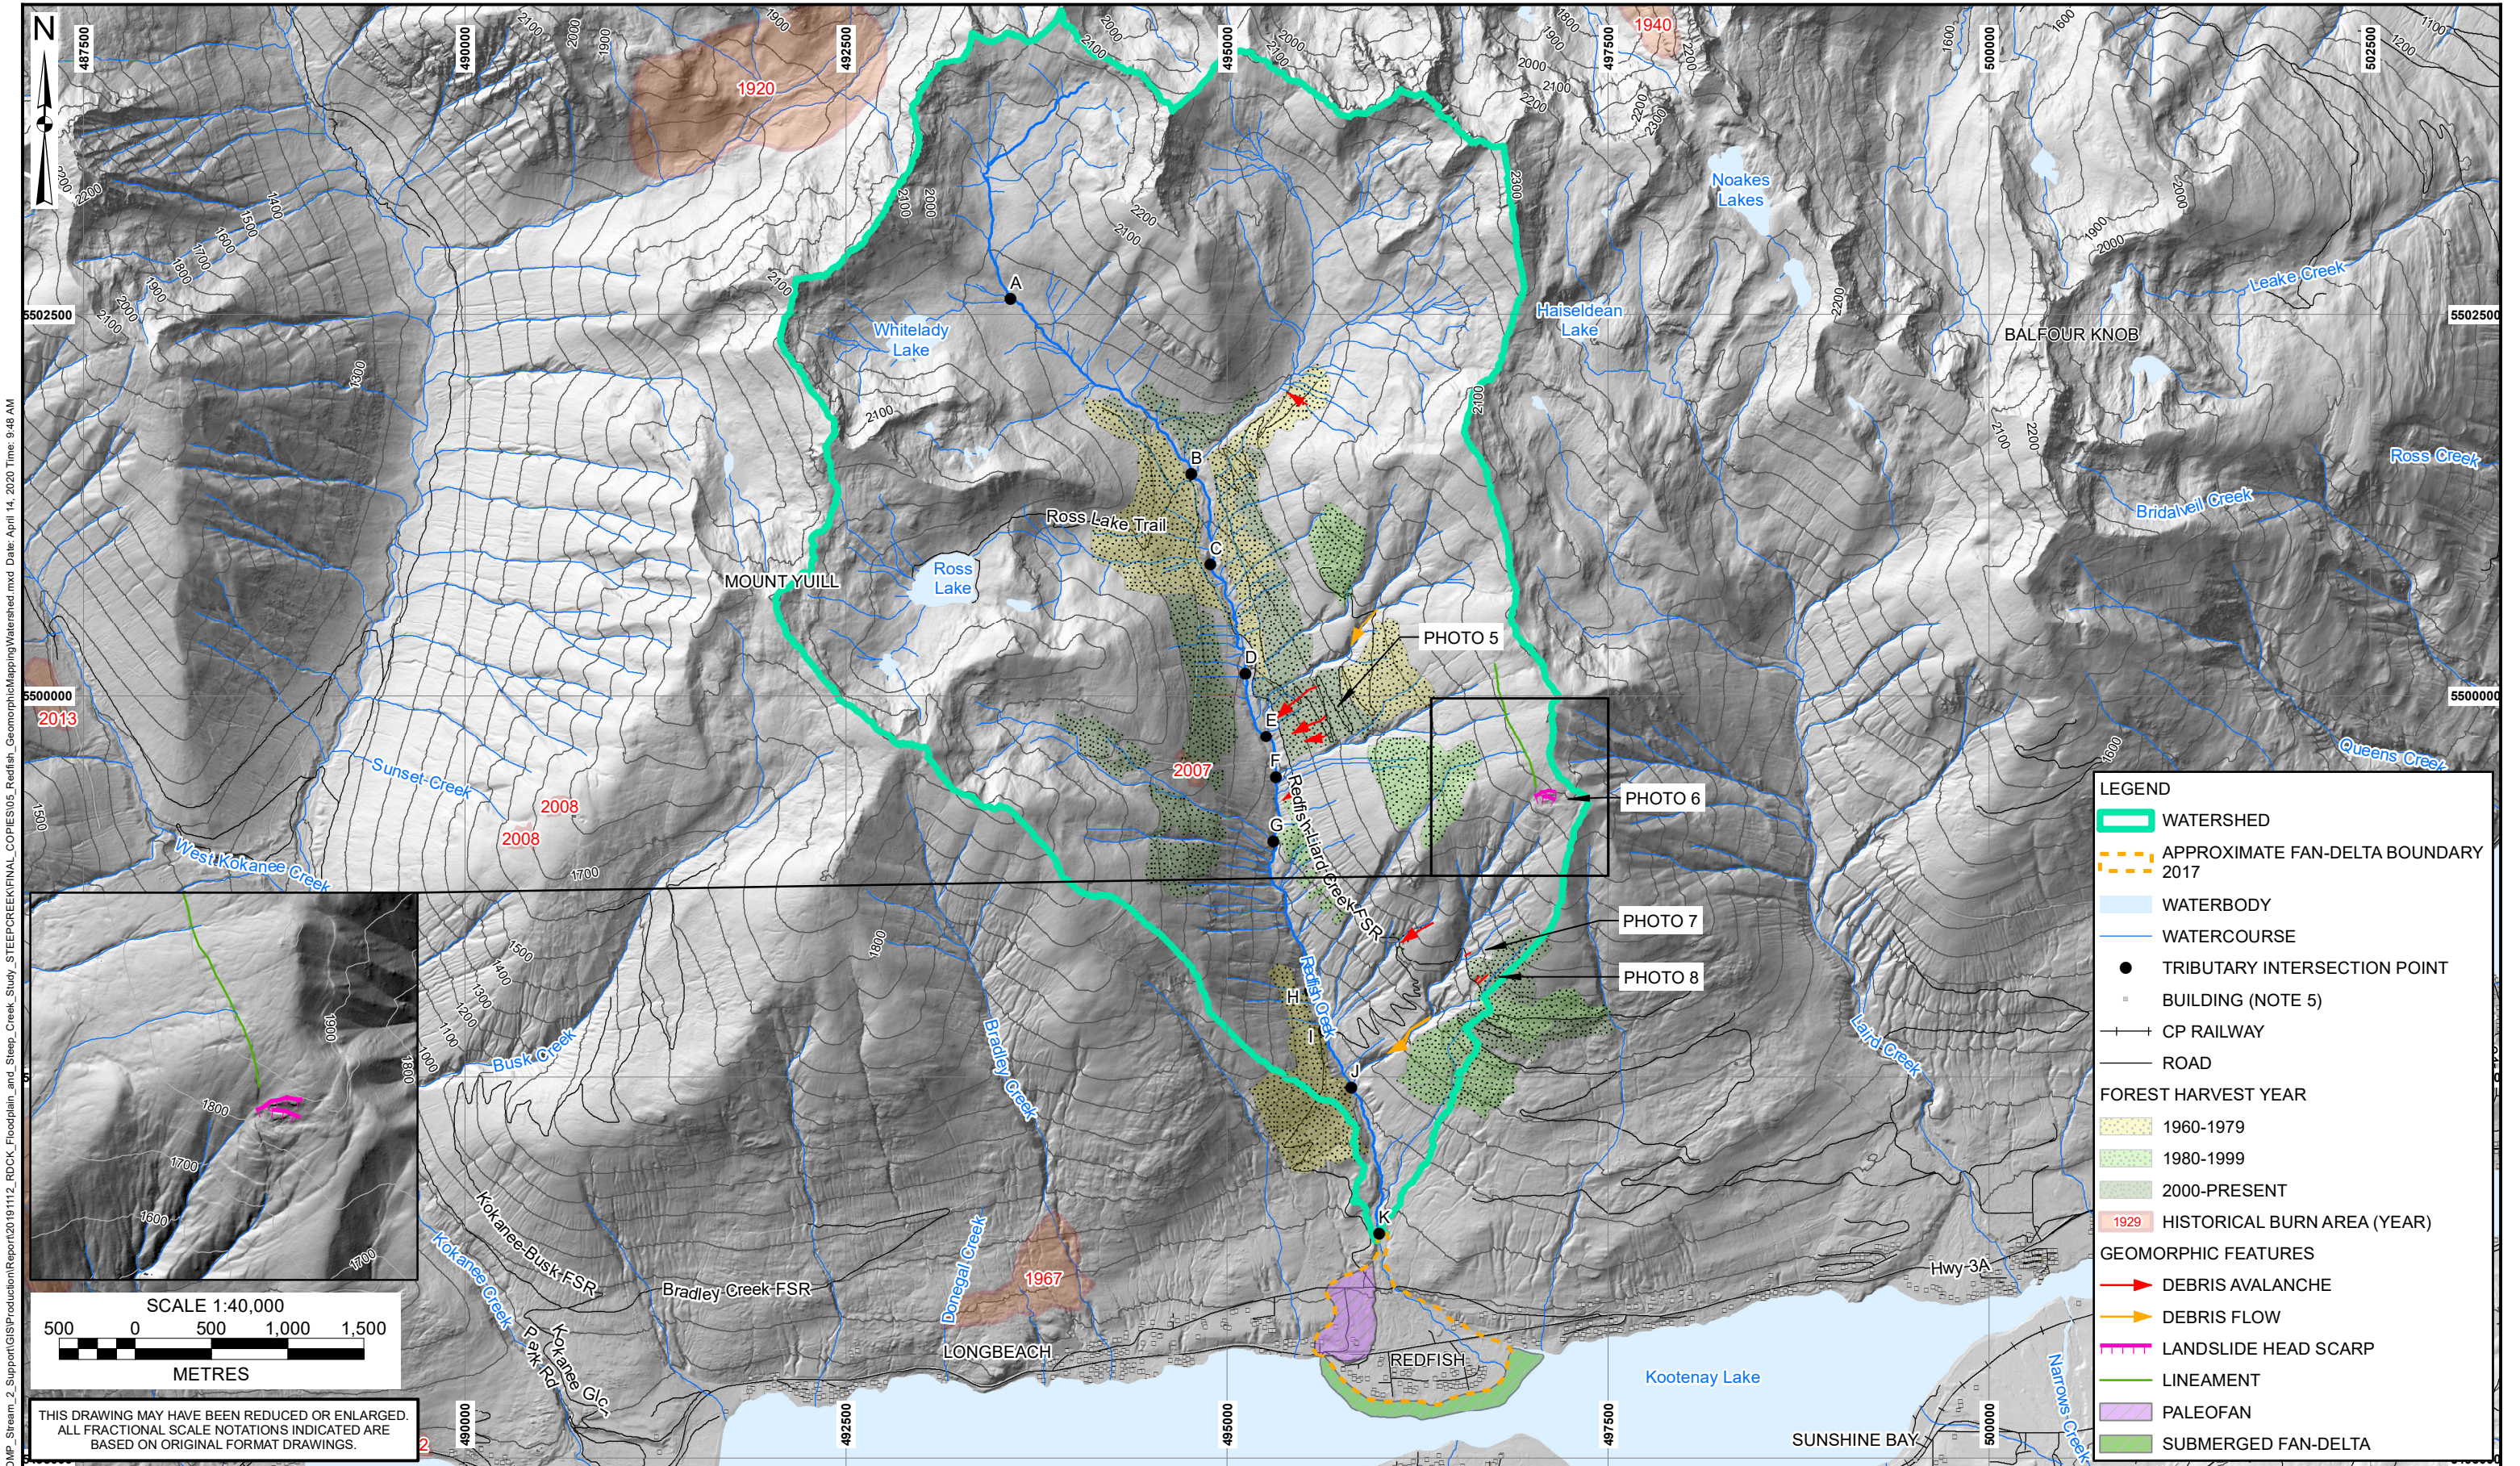
PROJECT: RDCK FLOODPLAIN AND STEEP CREEK STUDY	
TITLE: REDFISH CREEK WATERSHED GEOMORPHOLOGY	
PROJECT No.: 0268007	DWG No.: 05

Based on review of lidar data, BGC identified the presence of tension cracks in bedrock at the crest of an unnamed ridge approximately 3.5 km north-northeast of the fan-delta apex, these are shown as landslide headscarps on Drawing 05 (see inset). While a helicopter reconnaissance did not reveal any obvious tension cracks, some bedrock outcrops and coarse talus were observed (see Photo 6 in Appendix B). Photos 7 and 8 show till slopes exposed by debris avalanches near the Redfish-Laird Creek FSR. A debris flow path is delineated below these debris avalanches (see Drawing 05).
