RDCK FLOODPLAIN AND STEEP CREEK STUDY

Wilson Creek

Final
March 31, 2020

BGC Document No.:
RDCK2-SC-006F

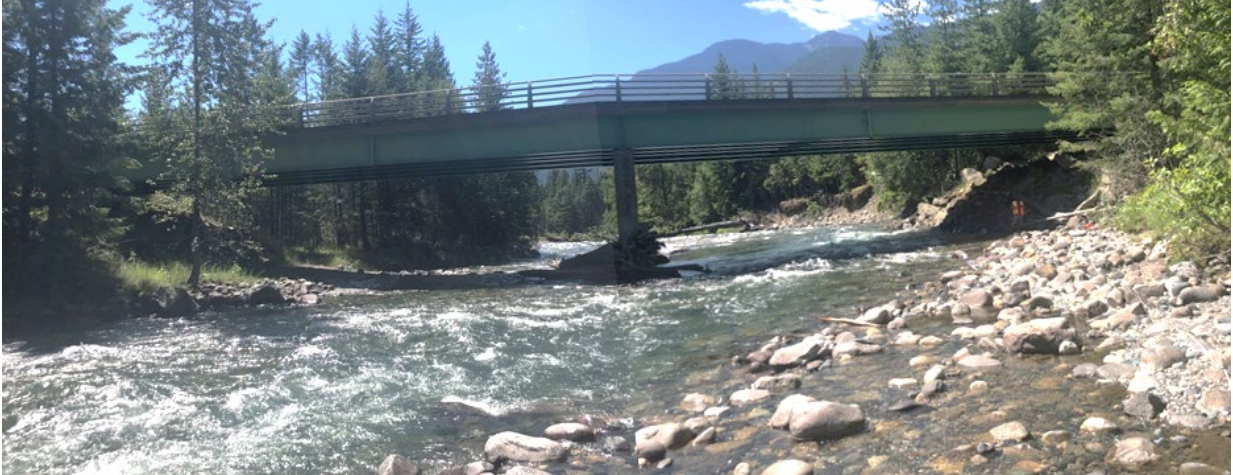
A) Looking downstream at Wilson Highway Bridge.

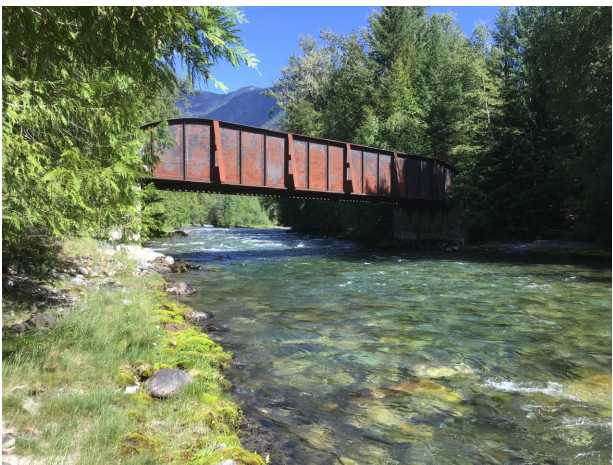
D) On right bank looking upstream at the Nakusp and Slokan Railway Trail bridge.

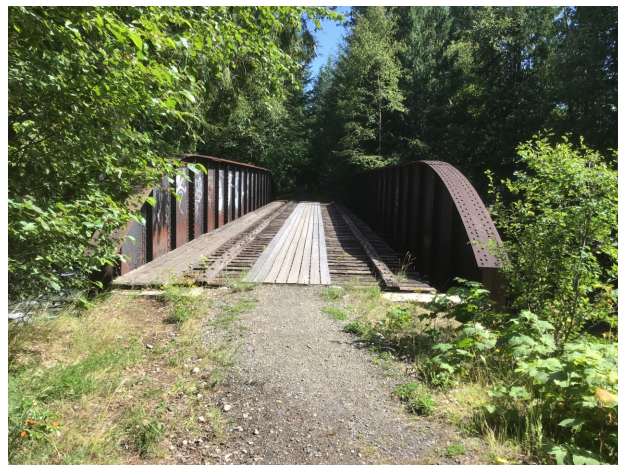
E) Nakusp and Slokan Railway Trail bridge deck.

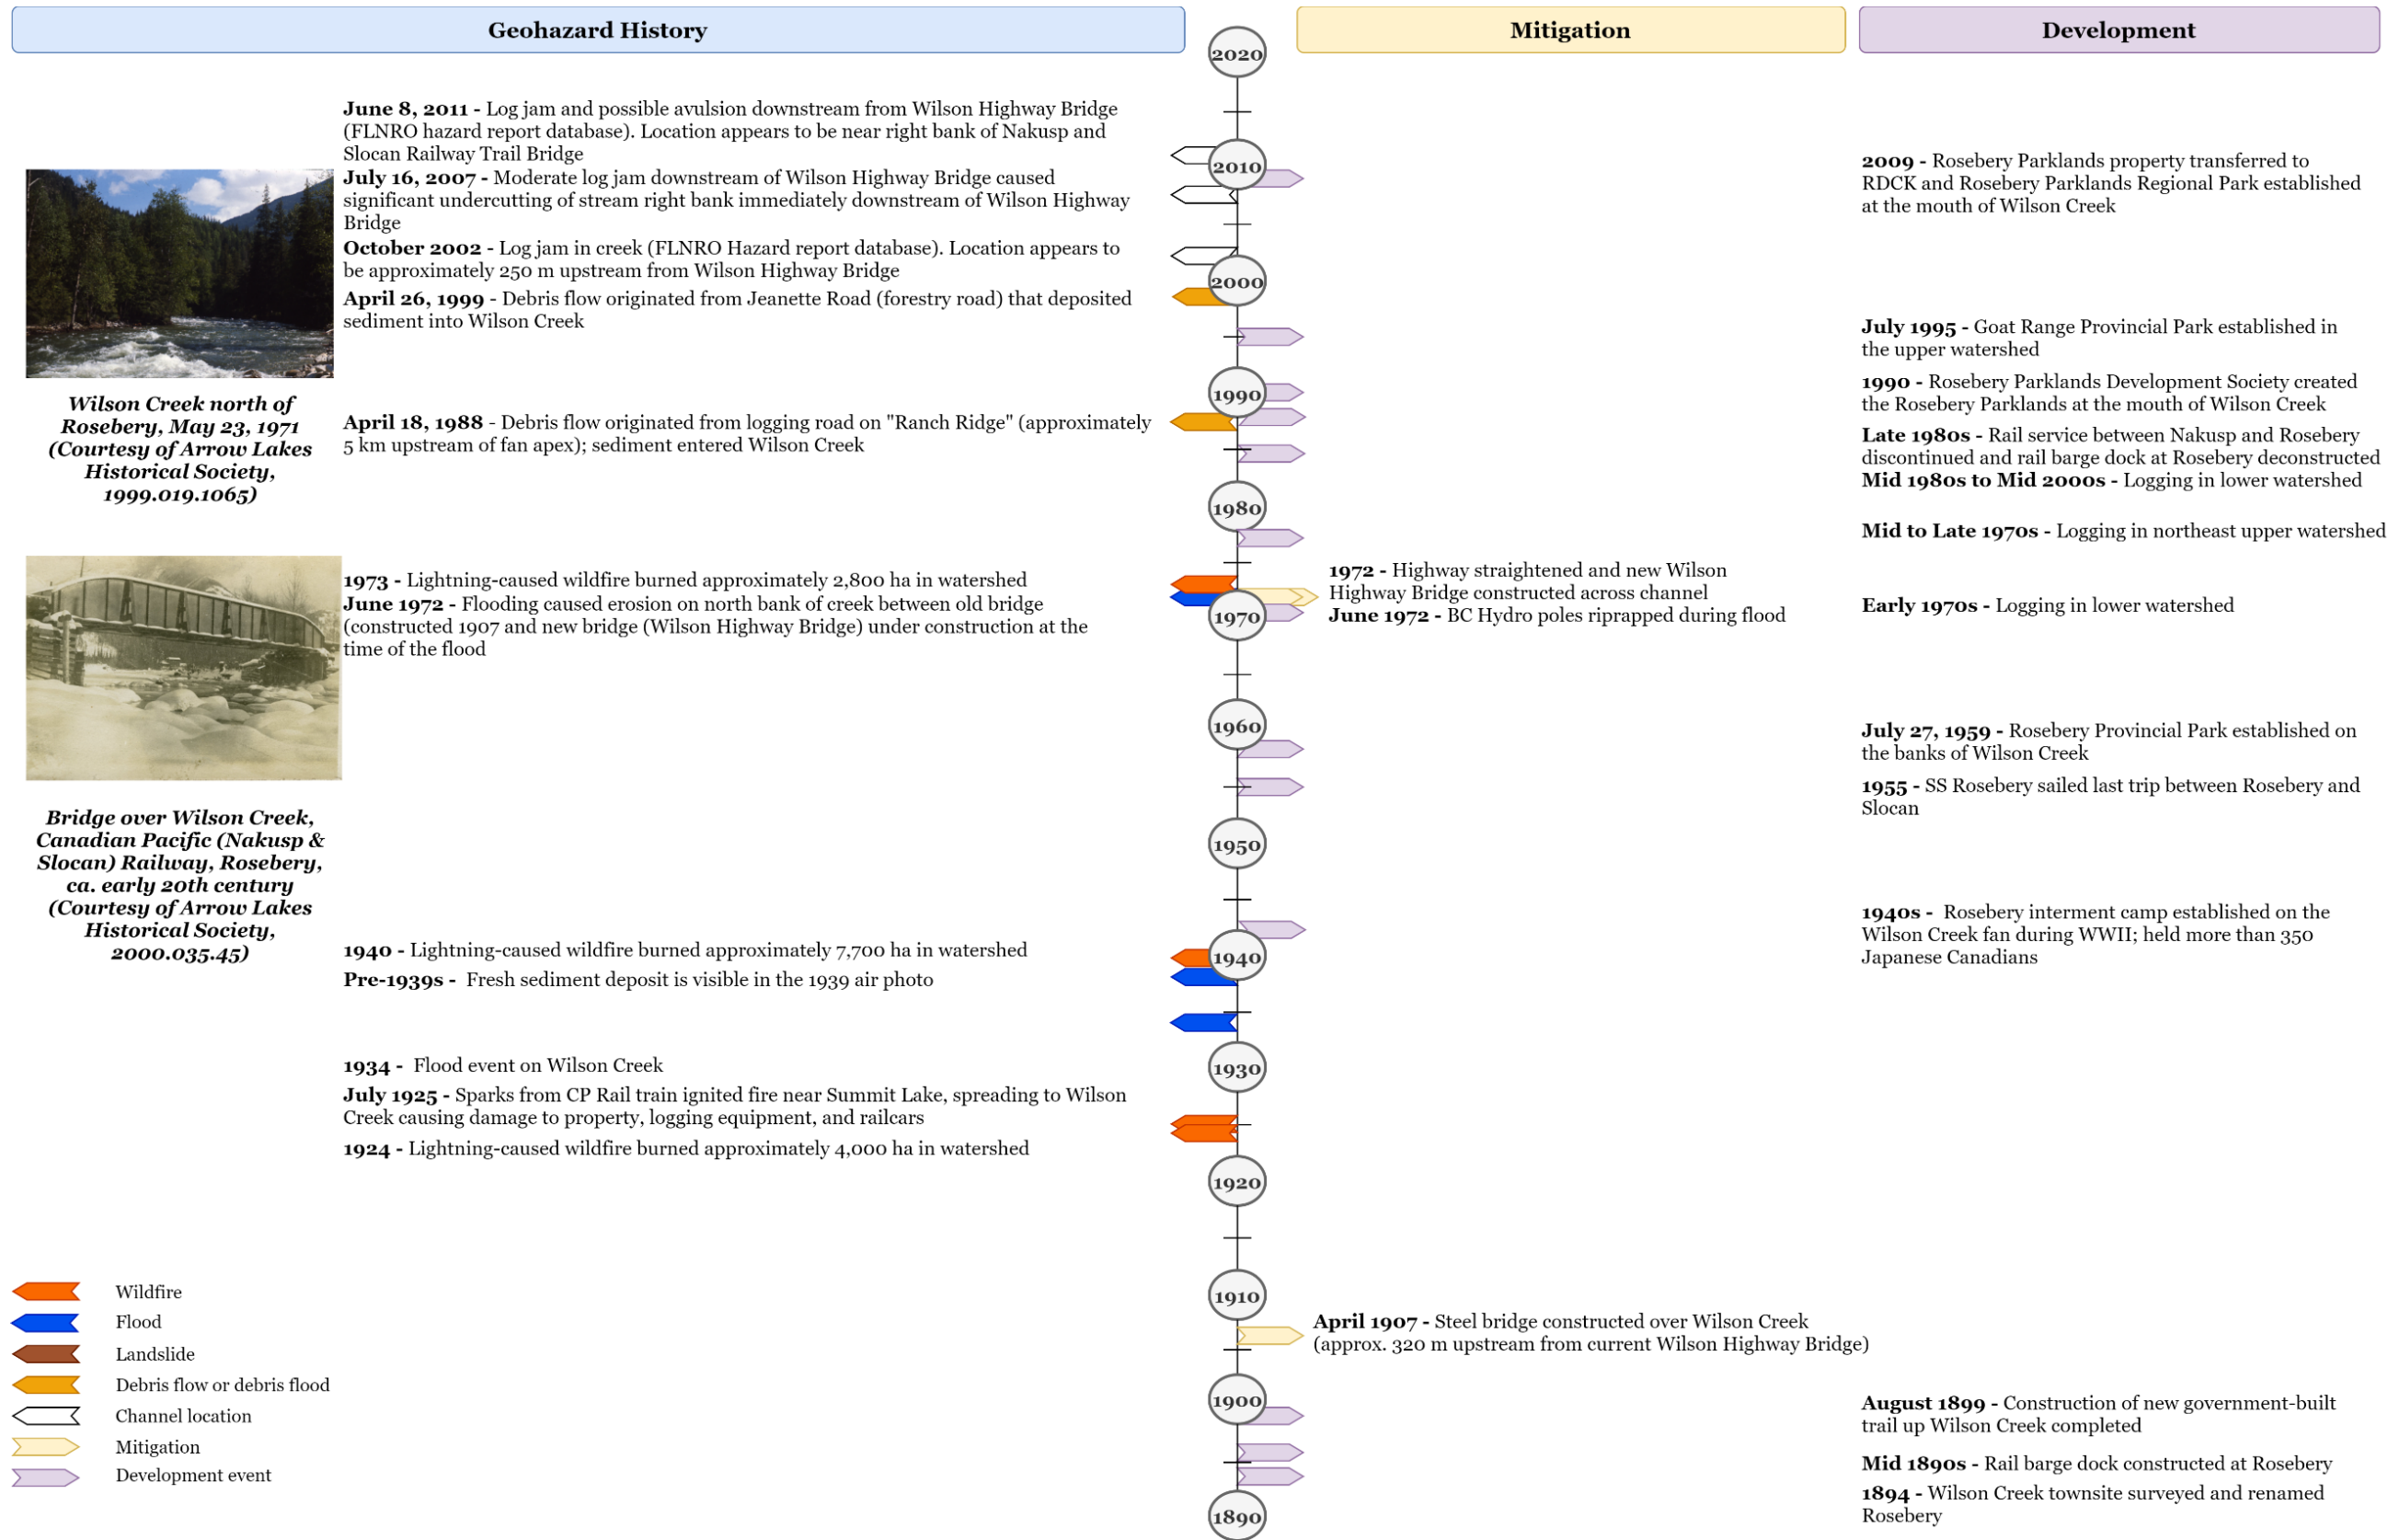
Figure 4-1. Summary of recorded geohazard, mitigation, and development history at Wilson Creek.

- One notable hydrogeomorphic event was recorded in 1972. BGC notes that other hydrogeomorphic events may have occurred that may not be documented by the available records.
- Log jams have been reported in Wilson Creek on the fan-delta.
- The channel location has historically been relatively stable on the fan-delta.
- Extensive logging has occurred in the watershed. These activities are concentrated within approximately 15 km of the fan apex and in the northeast portion of the upper watershed. Landslides have occurred from forestry roads and cut blocks.
- Several large forest fires have burned large areas of the watershed.

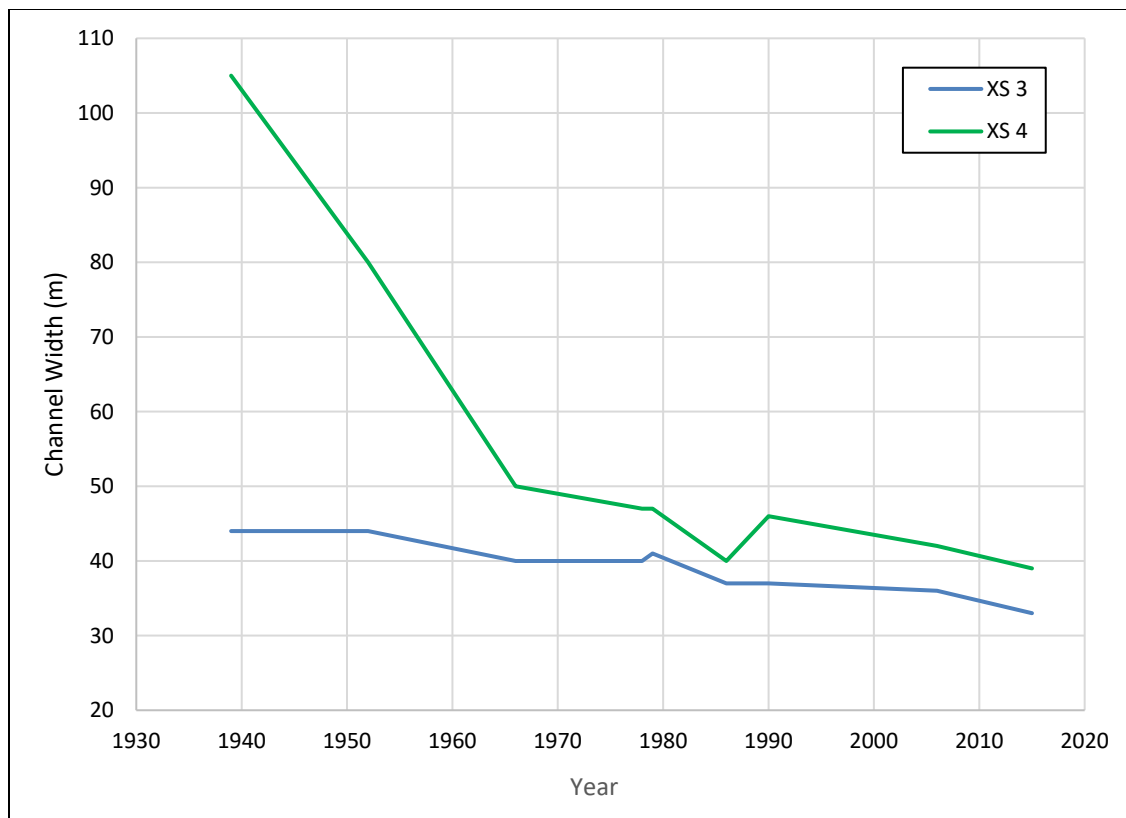
Figure 6-2. Channel widths from 1939 to 2015 at cross-section 3 and 4.

Table 6-6 shows that minimal erosion occurred over time throughout the reach. However, channel conditions did differ significantly in the earliest photo (1939) from other years. The channel was 60 m wider in the 1939 imagery than in 2015 at cross-section 4 (located at a meander bend), and 10 m wider at cross-section 3. The 1939 photo appears to have been obtained soon after a debris-flood event (Table 6-2), and Figure 6-2 shows that the channel progressively narrowed at cross-section 3 and 4 over the period of air photo record as the reach recovered from the disturbance through vegetation colonization.

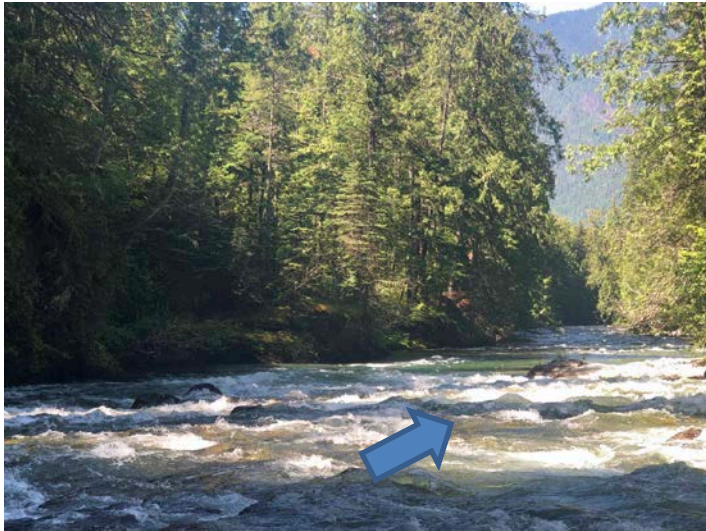
Photo 1.
Standing on the right bank of Wilson Creek looking downstream, approximately 500 m upstream of the fan apex. Photo: BGC, July 26, 2019.

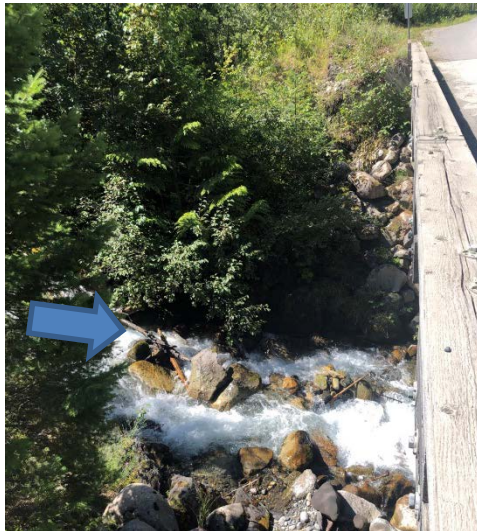
Photo 2.
Standing on Wilson Creek Road East bridge, looking at the left bank of Dennis Creek, a major tributary to Wilson Creek. Photo: BGC, July 26, 2019.

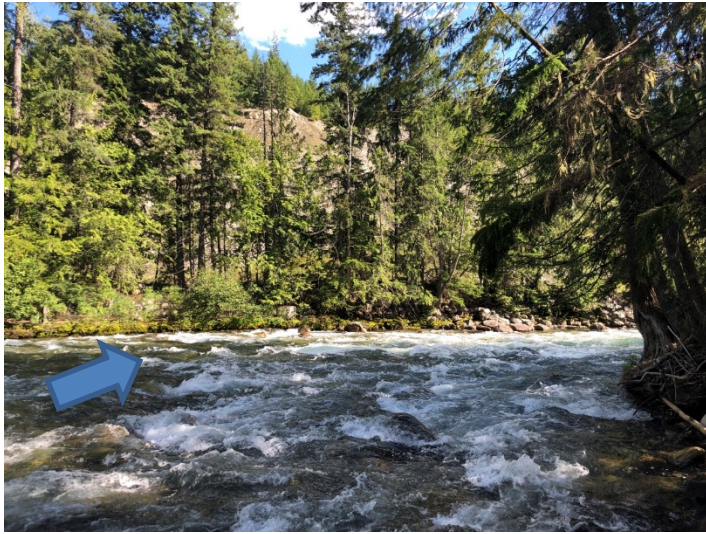
Photo 4.
Standing on the right bank of Wilson Creek in Roseberry Provincial Park, approximately 0.4 km upstream of the Highway 6 bridge. Looking at across to the left bank. Photo: BGC, July 26, 2019.

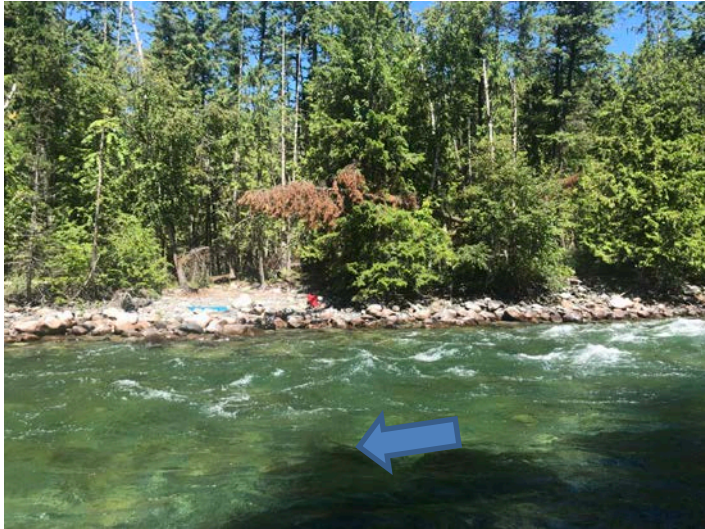
Photo 7.
Standing on the left bank of Wilson Creek looking at Roseberry Provincial Park, approximately 0.3 km upstream of the Highway 6 bridge. Photo: BGC, July 26, 2019.

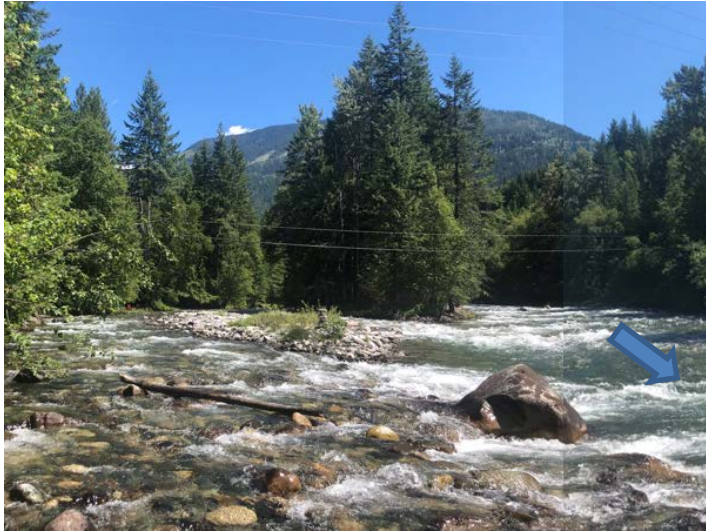
Photo 10.
Standing on the right bank of Wilson Creek looking upstream, just upstream of the Hwy 6 bridge. Photo: BGC, July 26, 2019.

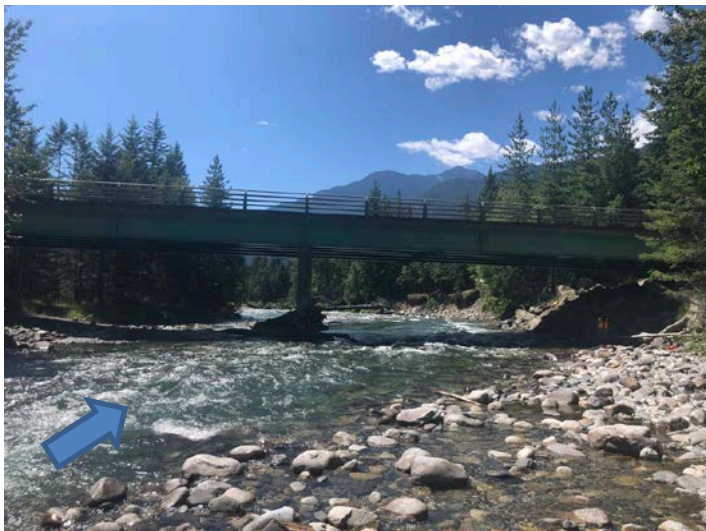
Photo 11.
Standing on the right bank of Wilson Creek looking downstream at the Hwy 6 bridge. Photo: BGC, July 26, 2019.

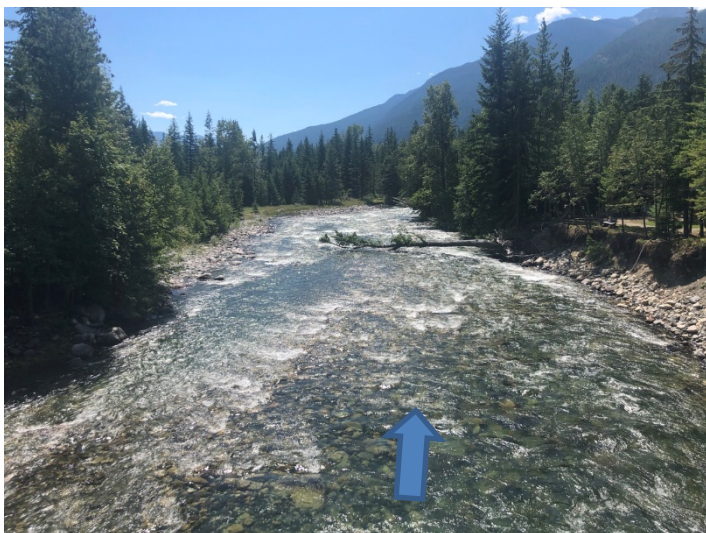
Photo 12.
Looking downstream at Wilson Creek from on top of the Hwy 6 bridge. Photo: BGC, July 26, 2019.

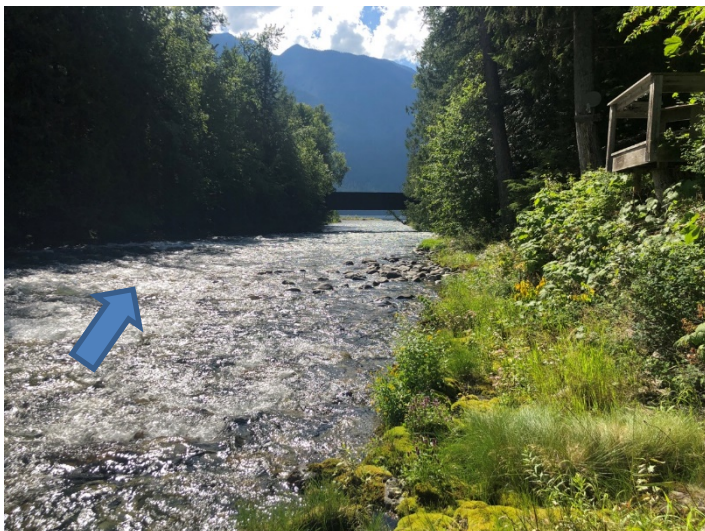
Photo 15.
Standing on the right bank of Wilson Creek looking downstream at Nakusp and Slocan Railway Trail, approximately 0.4 km downstream of the Hwy 6 bridge. Photo: BGC, July 26, 2019.

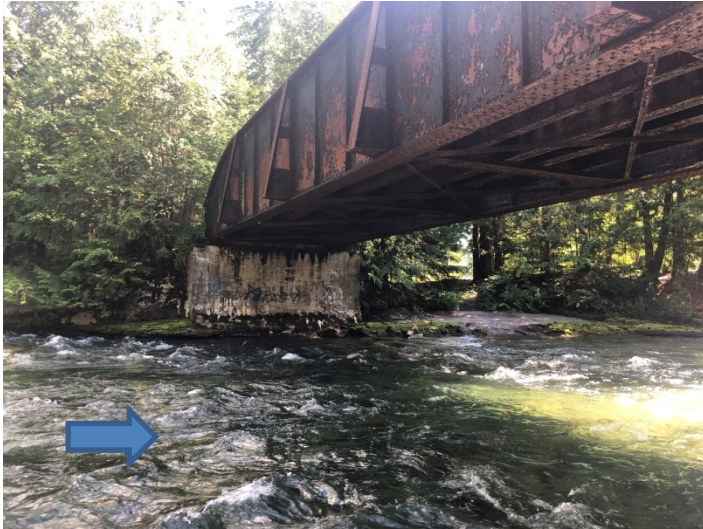
Photo 16.
Standing on the right bank of Wilson Creek looking across at the left bank and the railway bridge. Photo: BGC, July 26, 2019.

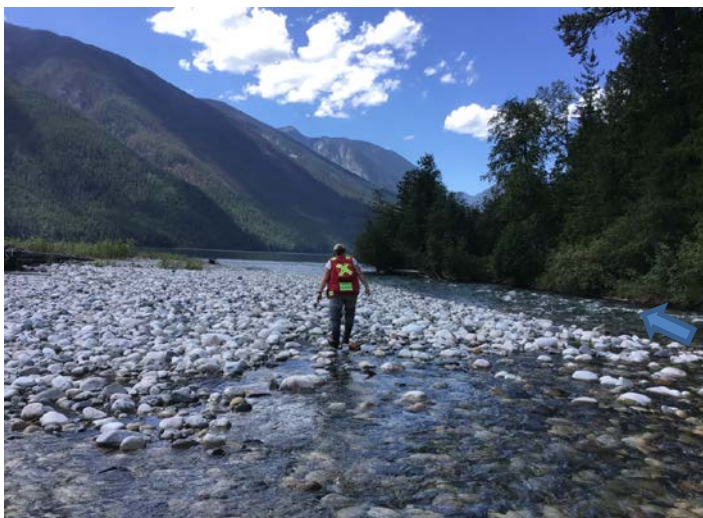
Photo 18.
Standing at the head of cobble deposit at Wilson Creek outlet to Slocan Lake looking downstream at the right bank. Photo: BGC, July 26, 2019.

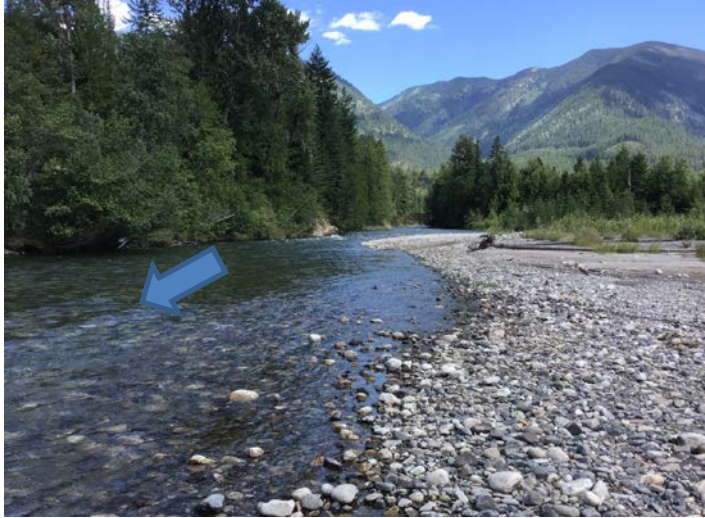
Photo 19.
Standing at the Wilson Creek outlet to Slokan Lake looking upstream at the railway bridge in the distance. Photo: BGC, July 26, 2019.

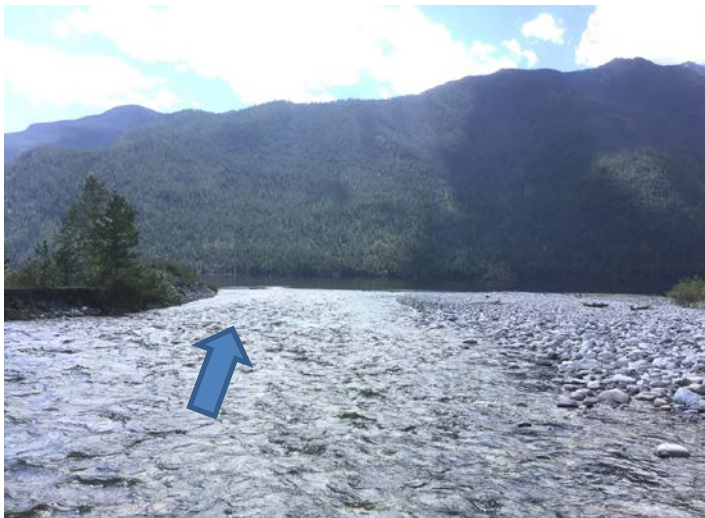
Photo 20.
Standing at the head of mid-channel cobble deposit at Wilson Creek outlet to Slokan Lake looking downstream at the left bank. Photo: BGC, July 26, 2019.

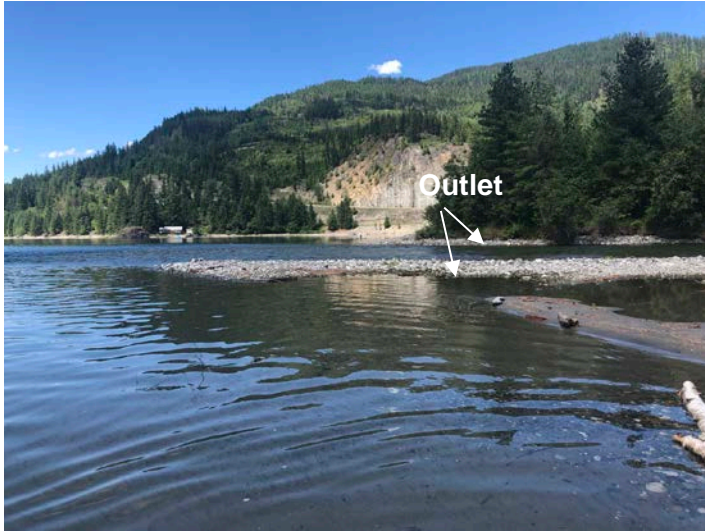
Photo 22.
Slocan Lake at the Wilson Creek outlet. Photo: BGC, July 26, 2019.

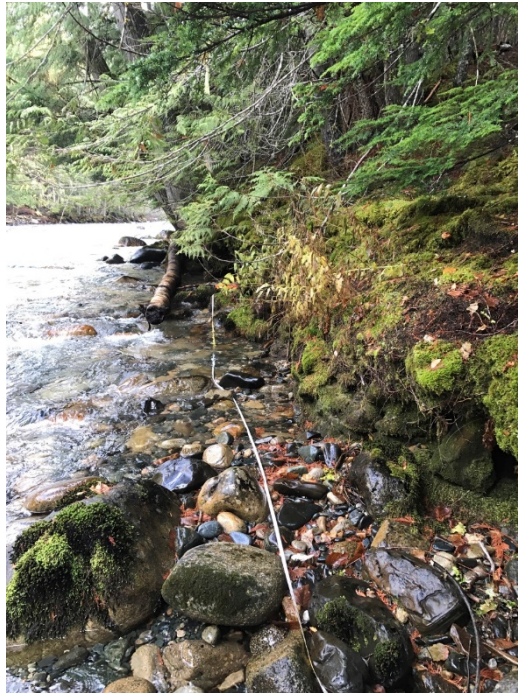
Figure C-2. Photograph taken of Wolman sampling location Wilson 1. BGC photograph of November 19, 2019.

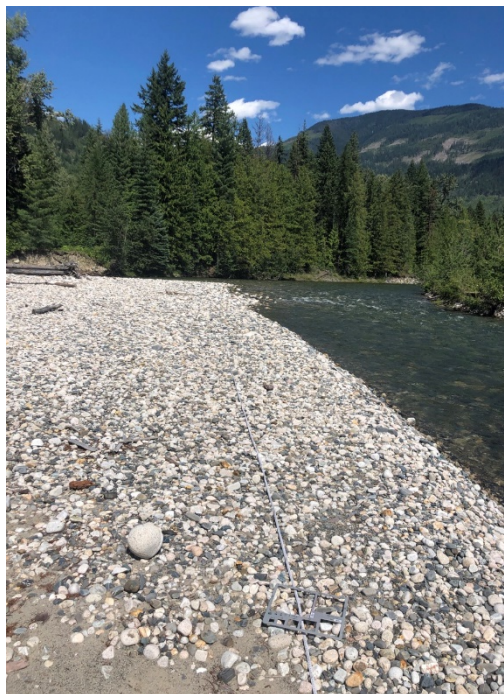
Figure C-3. Photograph taken of Wolman sampling location Wilson 2. BGC photograph of July 25, 2019.

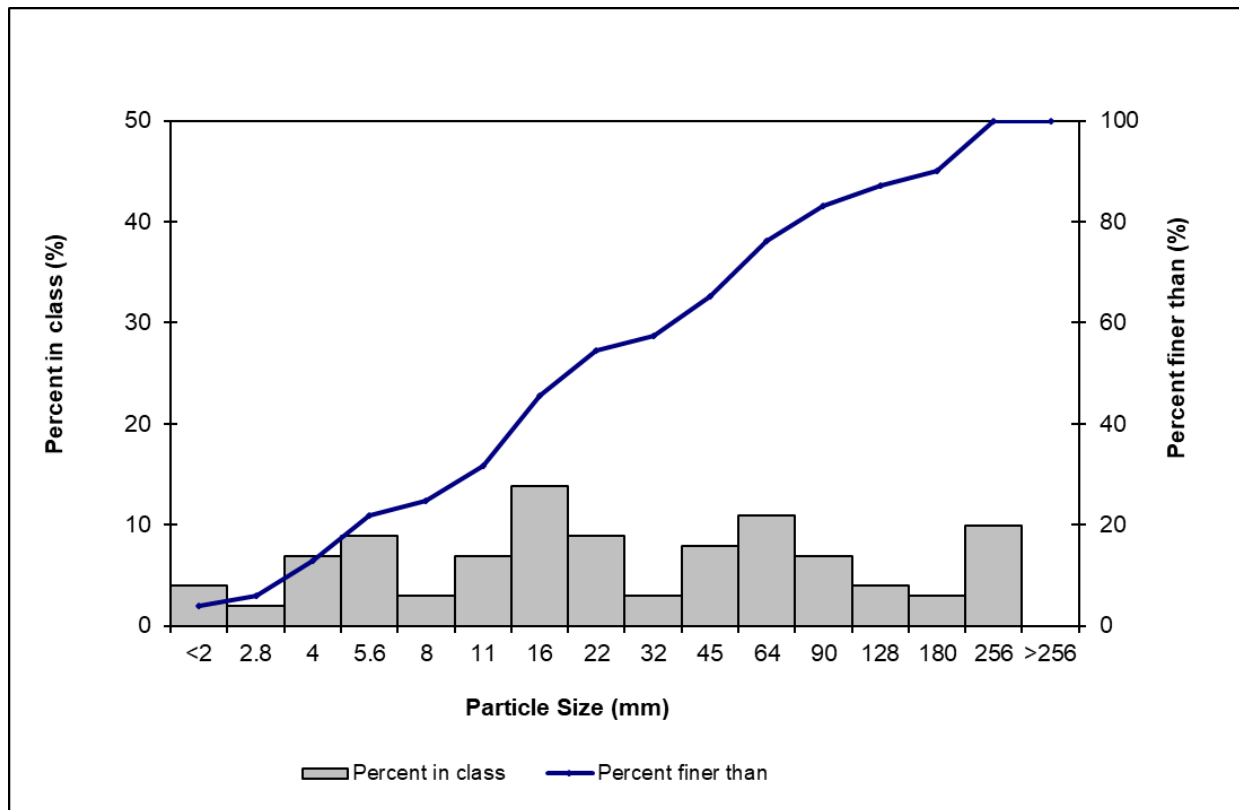
Figure C-4. Wilson Creek grain size distribution at Wilson 1 (at fan apex) from Wolman count.

As expected, given the reduction in channel gradient, bed material size decreases in a downstream direction along the fan. In order to predict sediment size distributions at locations not sampled, linear interpolation between the D_{84} values collected at the sampling locations and distance from fan apex was used.

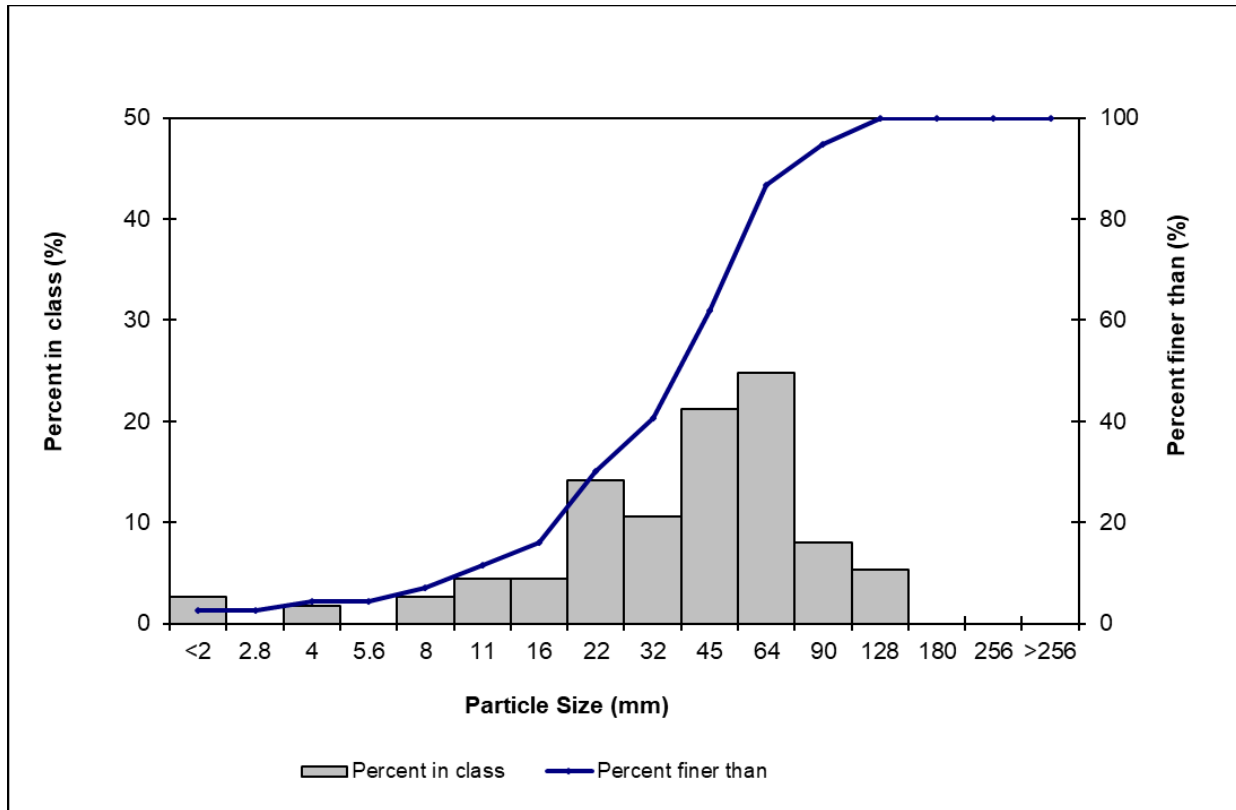
Figure C-5. Wilson Creek grain size distribution at Wilson 2 (outlet to Slocan Lake) from Wolman count.
