BC Ministry of Forests, Lands, and Natural Resource Operations  
and Rural Development

POST-WILDFIRE NATURAL HAZARDS RISK ANALYSIS  
AKOKLI FIRE (N71686)

February 8, 2022

Report Number: 21.510.01.04.02

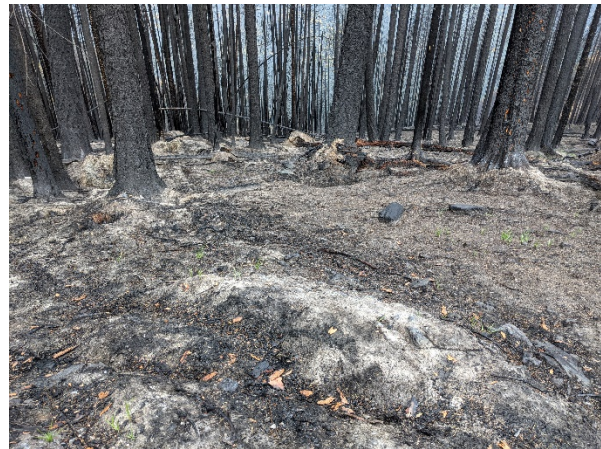
**Photo 10.** Example of high burn severity area

Photos 5 through 8 are heli-overview photos of the site while Photos 9 through 11 are example photos of high burn severity areas at ground sites.

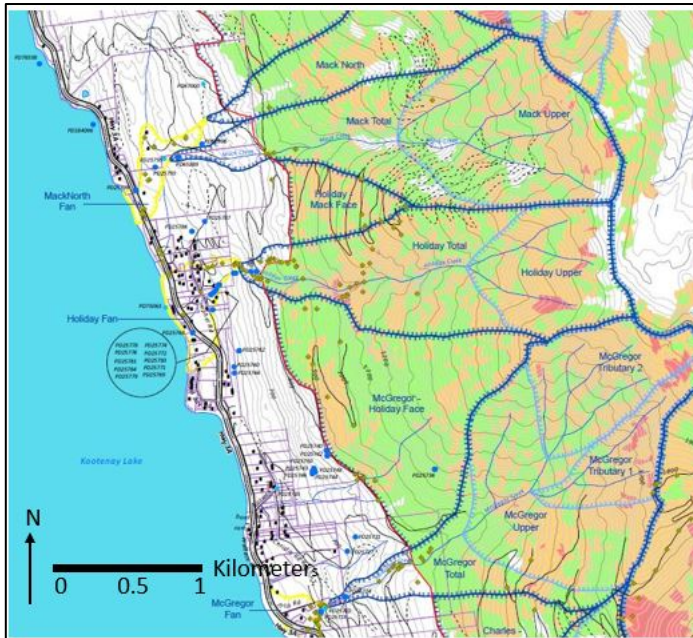
**Figure 2.** McGregor Creek, Holiday Creek, and Mack Creek Burn Severity Map

The burn severity comparison is somewhat different for McGregor Creek, Holiday Creek, and Mack Creek with significantly less high burn severity compared with Kuskonook Creek and Jansen Creek 2003 burn severity (see Table 2, 4, 5, Figure 2, 3).

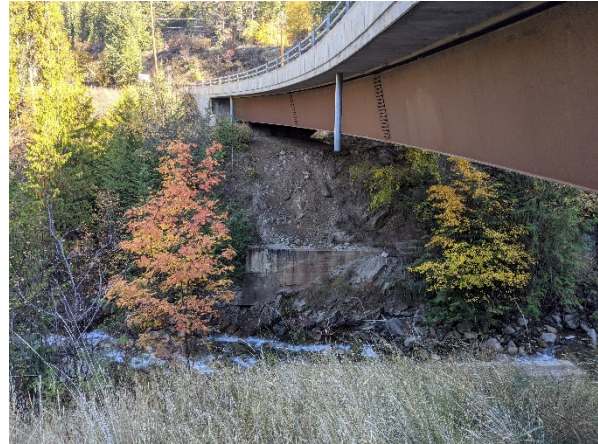
**Photo 13.** MoTI Highway 3A Bridge

The MoTI Highway 3A bridge crossing Akokli Creek has good clearance with local bedrock outcrops near the footing locations (Photos 13 and 14).

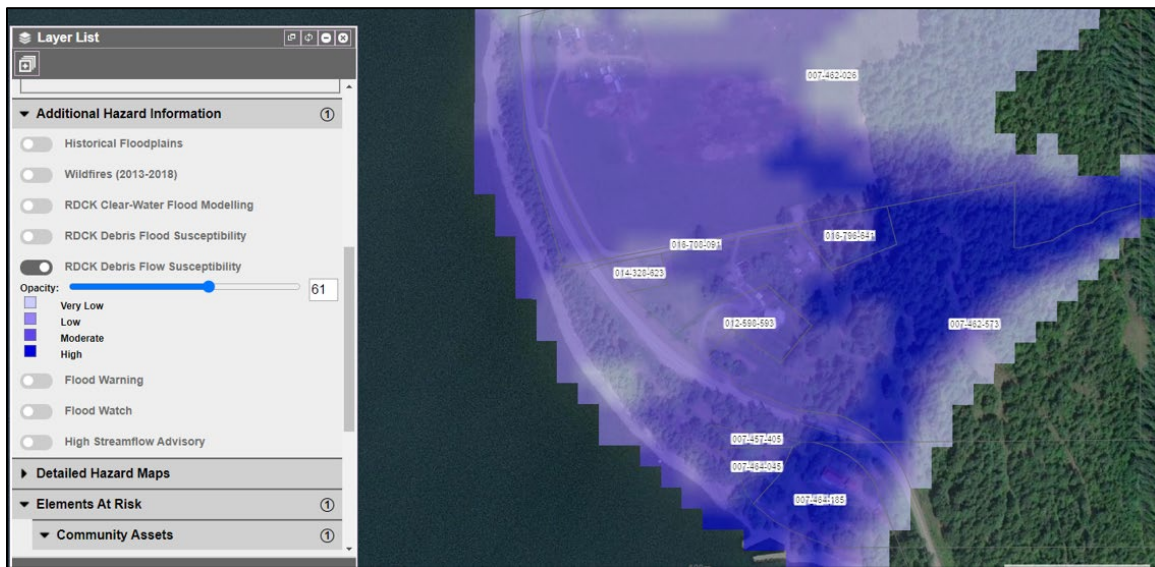
**Figure 4.** Debris Flow Susceptibility Map for McGregor Creek fan – Source: BGC Cambio Community Mapping.

Figure 4 shows the debris flow susceptibility mapping available from the BGC Cambio Community Application (2020).

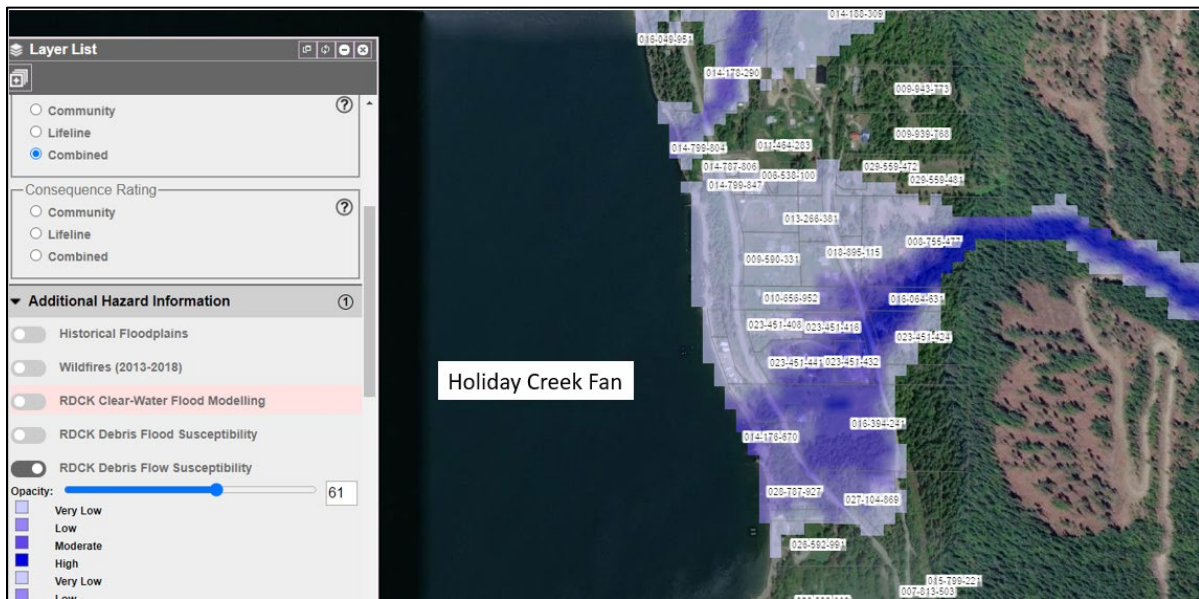
**Figure 6.** Debris Flow Susceptibility Map for Holiday Creek fan – Source: BGC Cambio Community Map (2020)

Figure 6 shows the debris flow susceptibility mapping available from the BGC Cambio Community Application (2020).

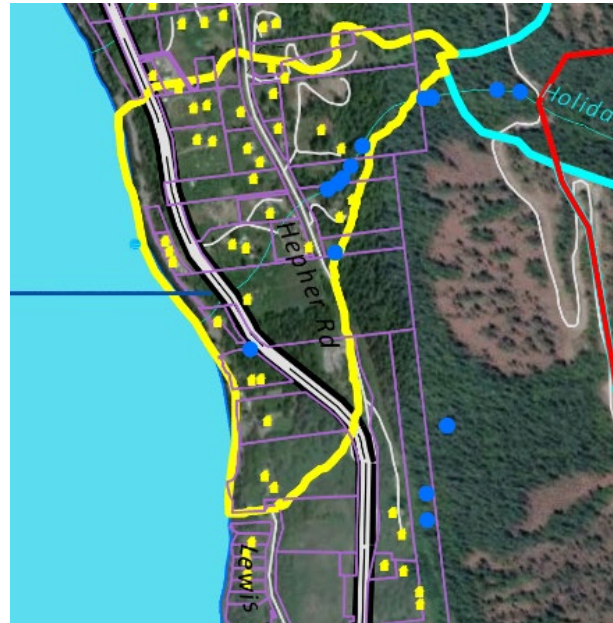
**Figure 7B.** LiDAR based delineation

Figure 7A, taken from the RDCK webmap, indicates that there are eight houses on the east (upslope) side of Hephher Road, 14 houses between Hephher Road and Hwy 3A and three houses between Hwy 3A and the lake. The fan boundaries estimated using LiDAR imagery (Figure 7B) shows similar house numbers except for 9 houses (instead of 3) between Hwy 3A and the lake. The exact fan boundary was not located in the field. The boundaries presented in Figures 7A and 7B should be taken as approximations - houses located near the boundary could still be at risk even if shown to be located outside the delineated fan boundary.

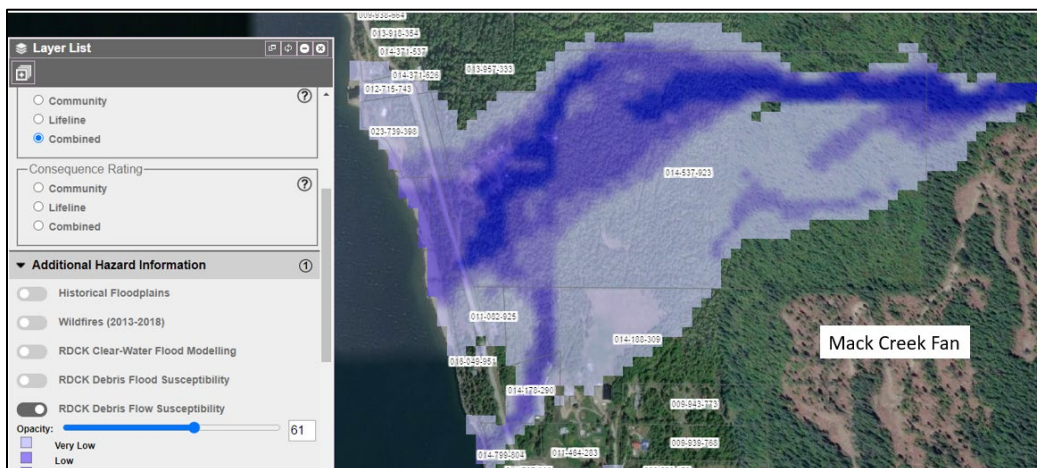
**Figure 8.** Debris Flow Susceptibility Map for Mack Creek fan – Source: BGC Cambio Community Map (2020)

Figure 8 shows the debris flow susceptibility mapping available from the BGC Cambio Community Application (2020). Figure 9 shows the houses on the fan.

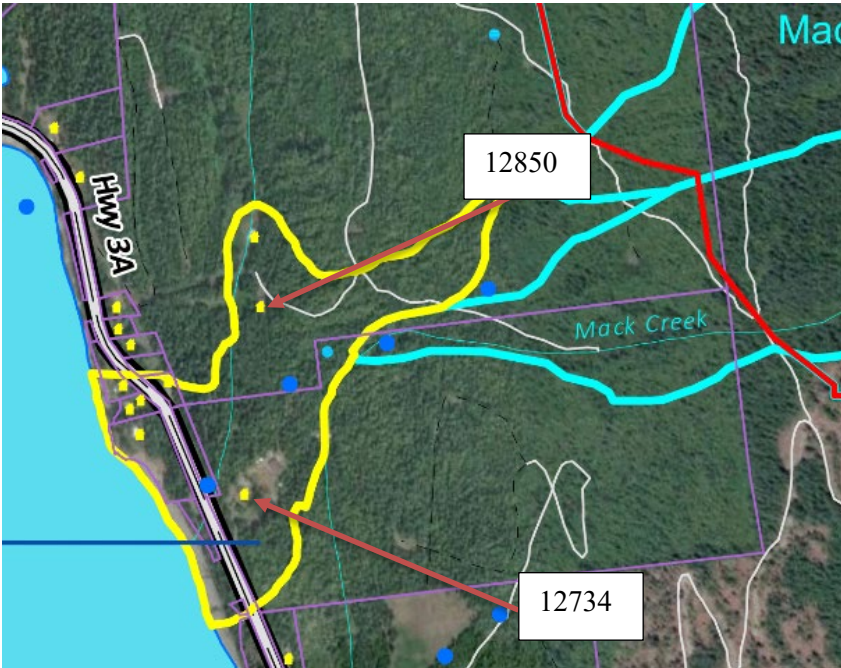
**Figure 9.** Mack Creek Fan showing houses on the fan – fan area is shown in yellow

While the overall fan surface gradient from the apex to the lake is 19%, the gradient from the apex to just above Hwy 3A is 15%. The dwelling at 12734 Hwy 3A is located approximately 400 m from the apex of the fan. The fan surface gradient upslope and proximal to the dwelling ranges from 8% to 14%. The PARTIAL RISK IS CONSIDERED LOW for this house location. This lower gradient and distance between the house and the apex of the fan, as well as the absence of gully features (Photo 29) that could direct flow towards the house renders the likelihood of debris flow material other than shallow slow moving sediment laden floodwaters reaching the houses as low.

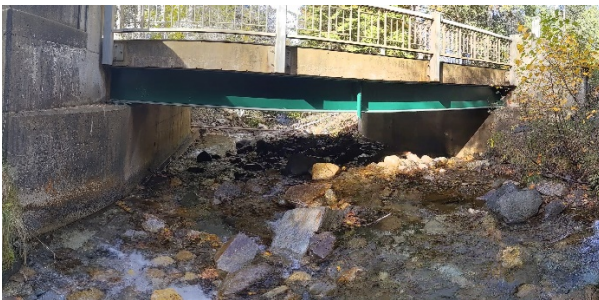
**Photo 31.** MoTI bridge over Lockhart Creek

The MoTI bridge over Lockhart Creek had clearance of 1.5 m at the time of the field review. On the downstream side of the left footing some erosion was occurring adjacent to the footing (Photos 31 and 32).

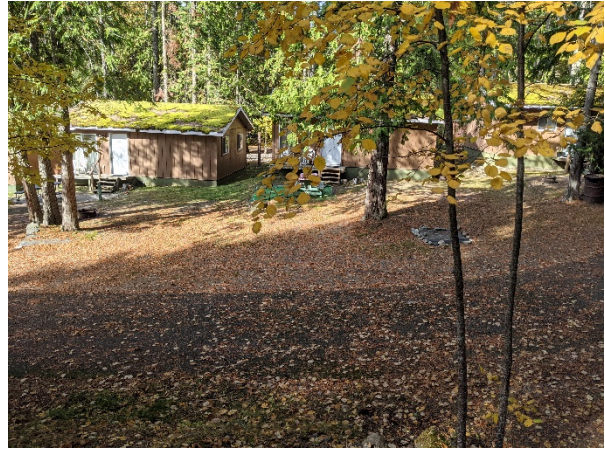
**Photo 34.** Cabins left bank Lockhart Creek

At the Lockhart Creek fan apex there is less than 2 m freeboard (Photo 33) and it is possible extreme flooding with debris could overtop at this location and flow over the left side of the fan (further upstream Lockhart Creek is incised in bedrock). There are five cabins (Photo 34) and an office/ house (Photo 35) between the creek and the access road that would be exposed to flooding and a marina business/restaurant below the highway (Photo 36).

While the incremental post wildfire hazard is considered low, if a large event were to occur the potential for the creek flows to be diverted out of the creek channel at the fan apex is considered high resulting in a MODERATE PARTIAL RISK to the local buildings. Consideration should be given by BC Parks to increase the freeboard at the fan apex to reduce the likelihood of the creek being diverted down the left side of the fan towards the cabins and houses (refer to Recommendations Section 8.2).

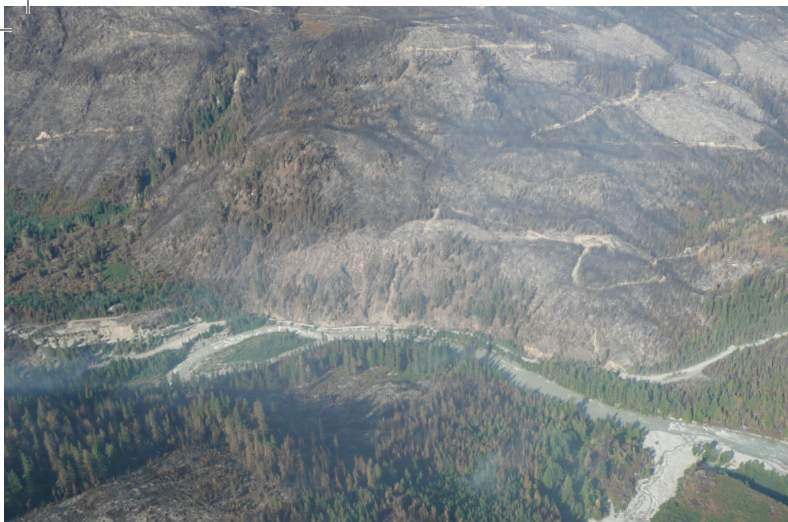
Part of the Elaho River drainage area was burned by wildfire in 2015.

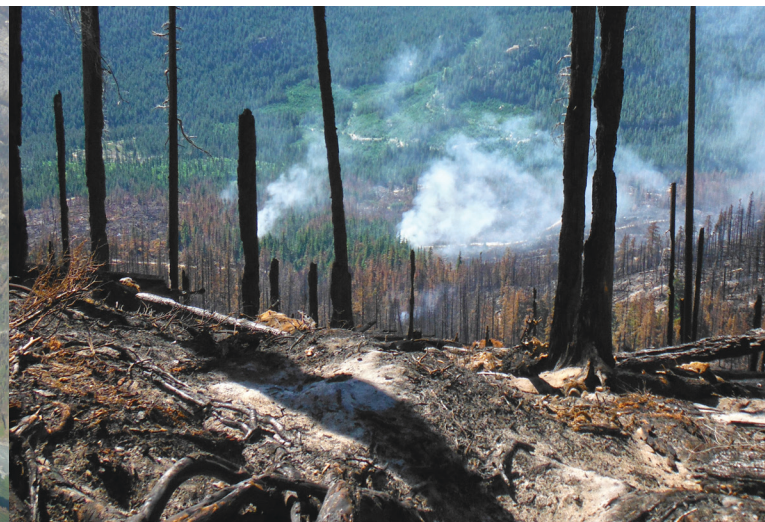
This is the Elaho drainage area in June 2015, showing evidence of how severe the wildfire was in that area.

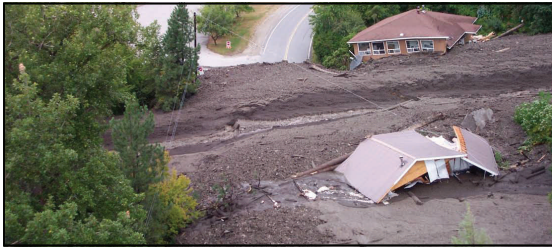
Figure 1. Debris flow material that was deposited on the Kuskanook Creek fan after a rainfall event in August 2004.

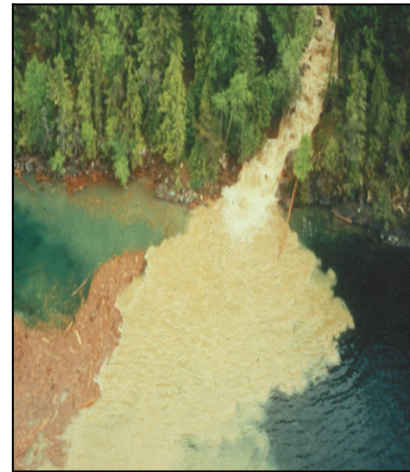
Figure 2. Debris flood on Memphis Creek. Note the large volume of floating debris in the lake and the uncharacteristically turbid water.

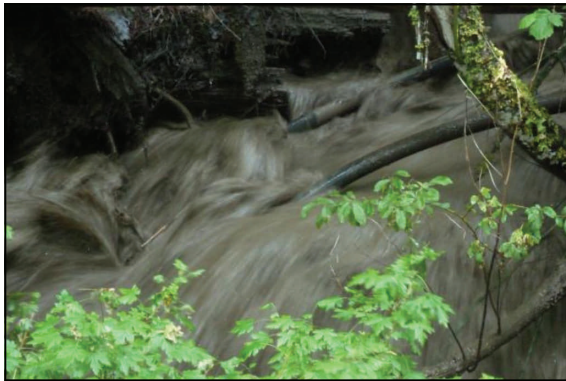
Figure 4. Turbid water in Gar Creek the day before the Johnson's Landing landslide on July 12, 2012.
