January 3, 2023  
Project No.: 2325001

**Re: Steep Creek Hazards Assessment – FINAL**

## **1.0 INTRODUCTION**

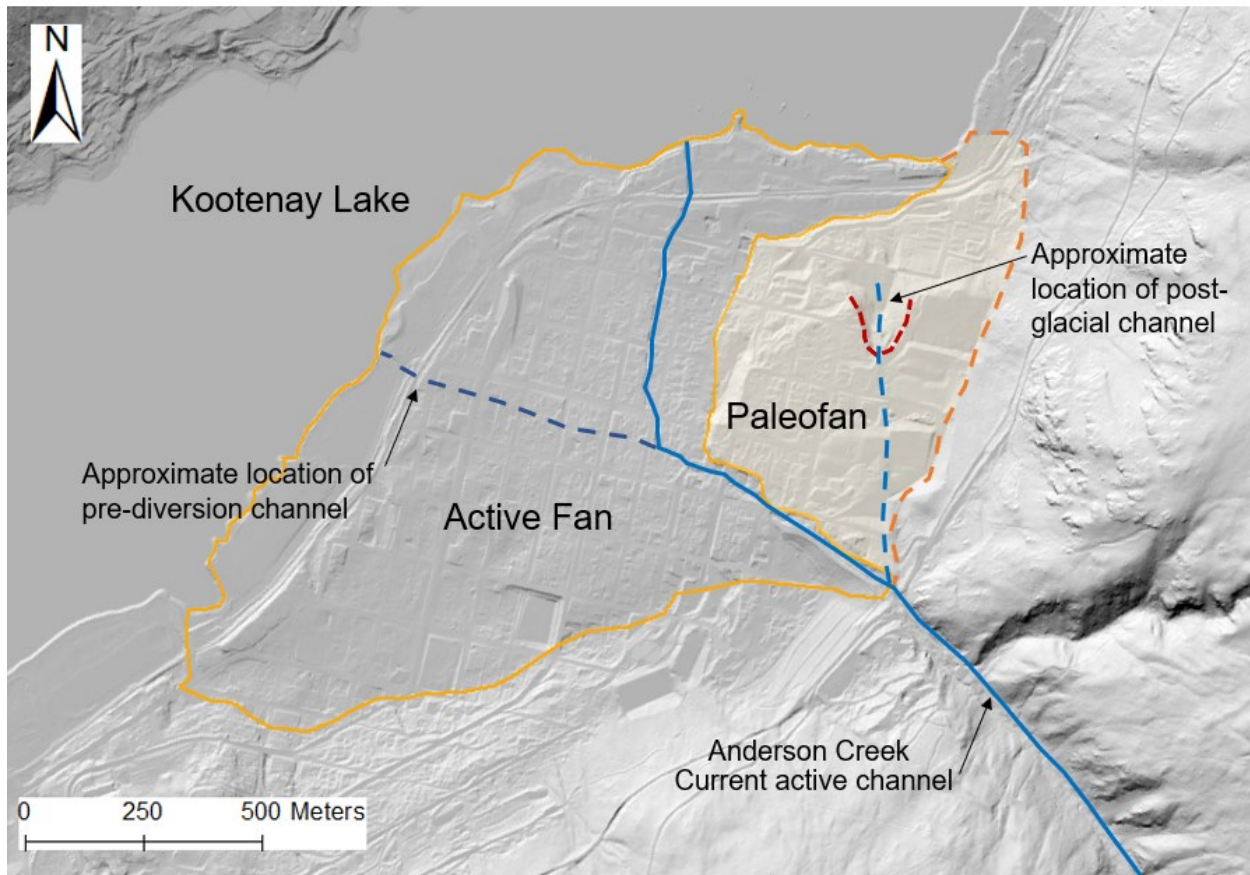
The Anderson Creek fan includes a paleofan<sup>5</sup> on the northern fan portion that BGC interprets to have developed against the receding trunk valley glacier during early deglaciation. Once the glacier had retreated, Anderson Creek flowed towards the North where it carved a notch into the paleofan given the change in base-level then and present Kootenay Lake. Eventually a new channel formed that eroded and obliterated the steep escarpment of the southern paleofan with debris (Figure 3-1). This sequence of events is important to understand the hazard potential of Anderson Creek. Avulsions to the north are now very unlikely as the creek has incised near the fan apex likely due to waning sediment supply such that events with sufficient discharge are unlikely to jump the channel to the north.

**Figure 3-1. Anderson Creek fan area showing active fan (orange), paleofan surface (yellow shading), current channel (blue), interpreted historic channel locations (blue dash), and eroded notch in paleofan (red dash). The active fan has been modified by development on the fan.**

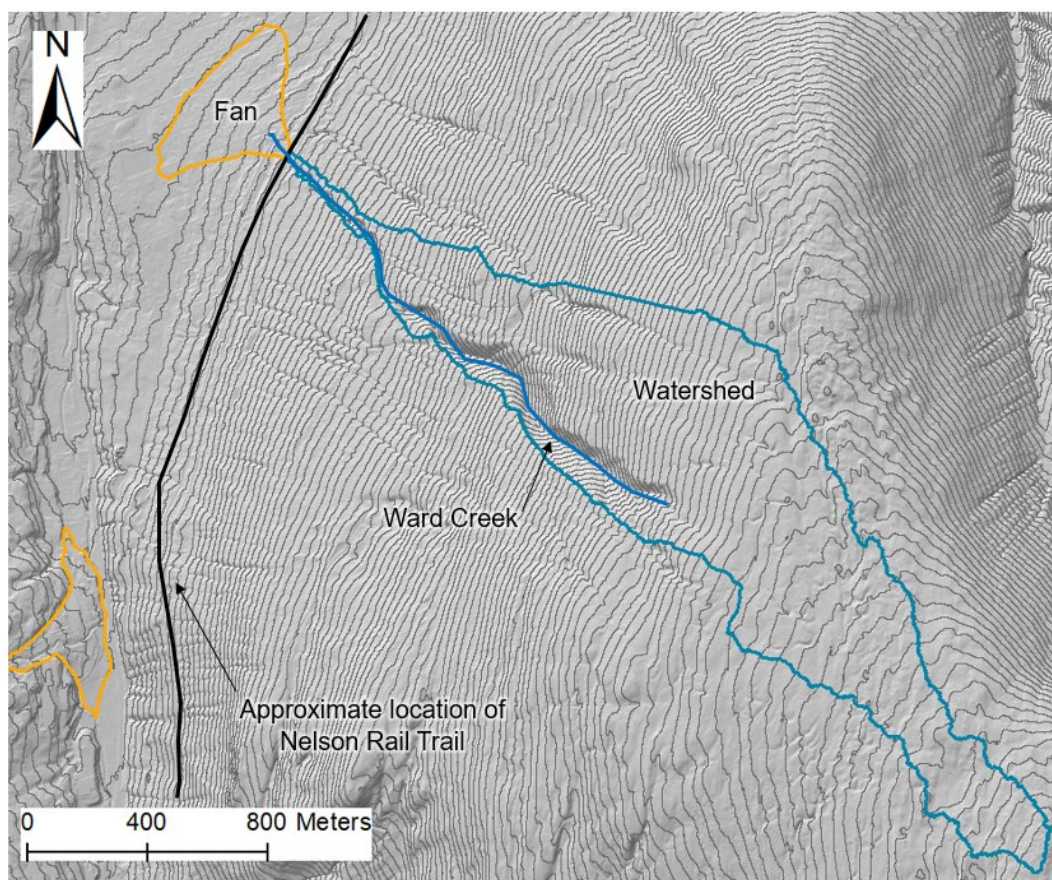
The fan of Ward Creek is poorly visible on aerial images as it has been substantially altered by urban development. BGC delineated the fan using lidar imagery with narrowly spaced contours (Figure 3-8). The fan has an approximate slope of 10° (18%), which is indicative of debris-flow transport. However, in this case, this may be misleading as the natural slopes nearby (in absence of fans) have a slope of 8 to 9°. This implies that the processes that created the Ward Creek fan only steepened it by about 1 to 2°, which does not allow an interpretation of process.

**Figure 3-8. Ward Creek drainage with some key features. Contour interval is 10 m.**

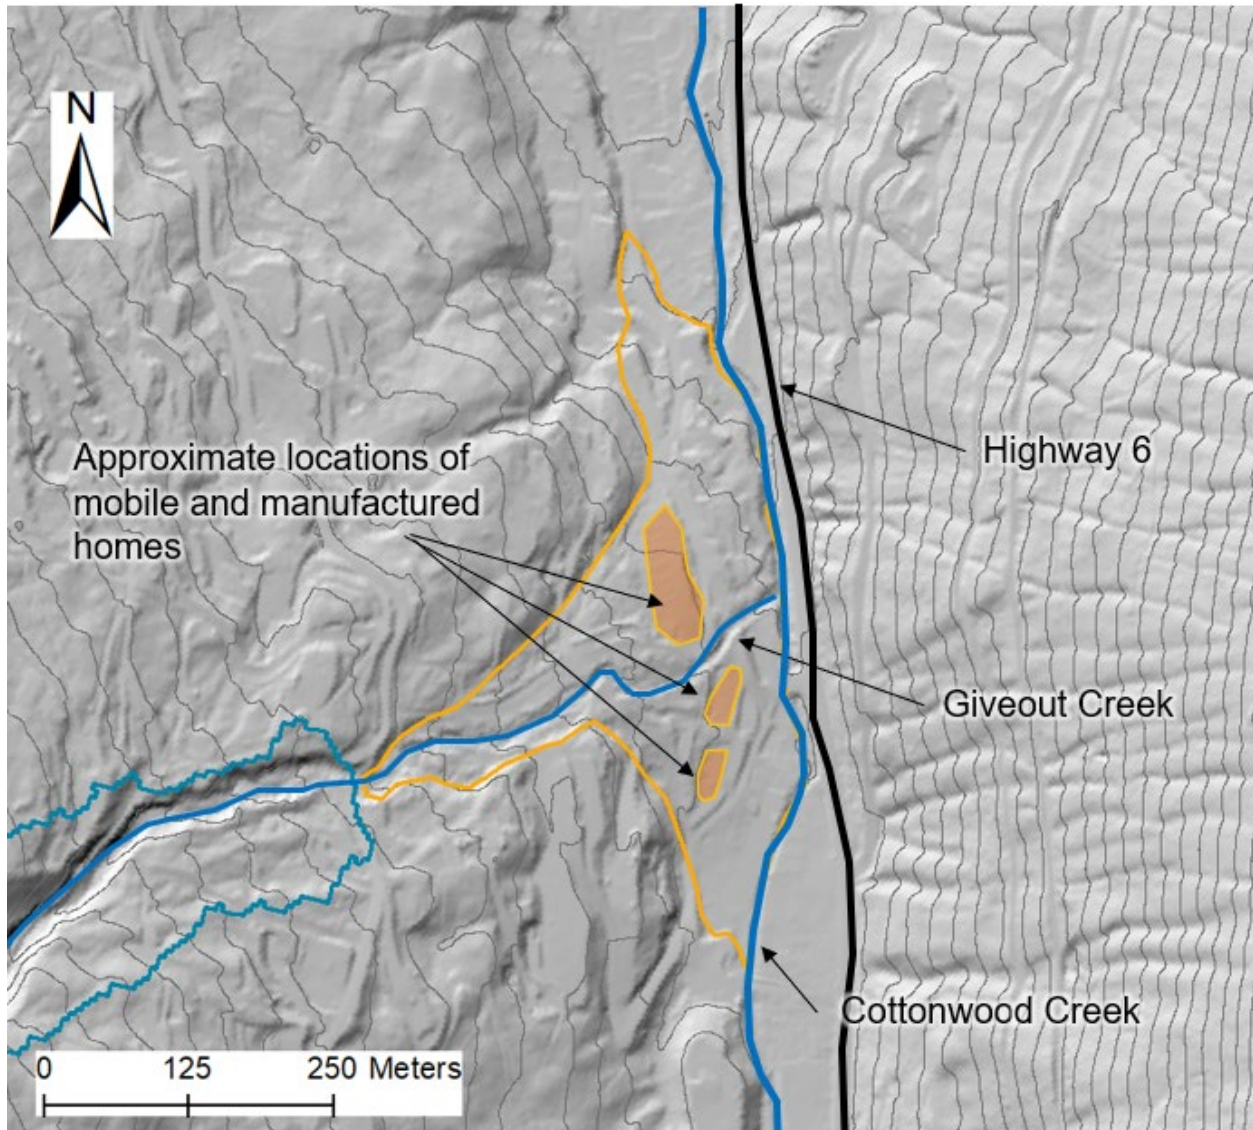
The Giveout Creek fan is inhabited with a combination of mobile and manufactured homes and other residences (Figure 3-14). Mobile and manufactured homes are more vulnerable to the impact forces associated with debris flows than other building construction types. In BGC’s field reconnaissance, BGC noted multiple locations where Giveout Creek is poorly confined to the

**Figure 3-14. Giveout Creek fan (orange outline) and watershed (teal outline) with the approximate location of mobile and manufactured homes (shaded orange). Other buildings and homes are located on the fan but not shown here. Contour interval is 10 m.**
