POST-WILDFIRE NATURAL HAZARD RISK ASSESSMENT

RECONNAISSANCE REPORT

FIRE: N71245 Cultus Creek	FIRE YEAR: 2021	DATE OF REVIEW: August 13, 2021 DATE OF REPORT: March 28, 2022
----------------------------------	------------------------	---

AUTHOR: Tim Giles, MSc, PGeo, Senior Geoscientist, Westrek Geotechnical Services Ltd. (Westrek)

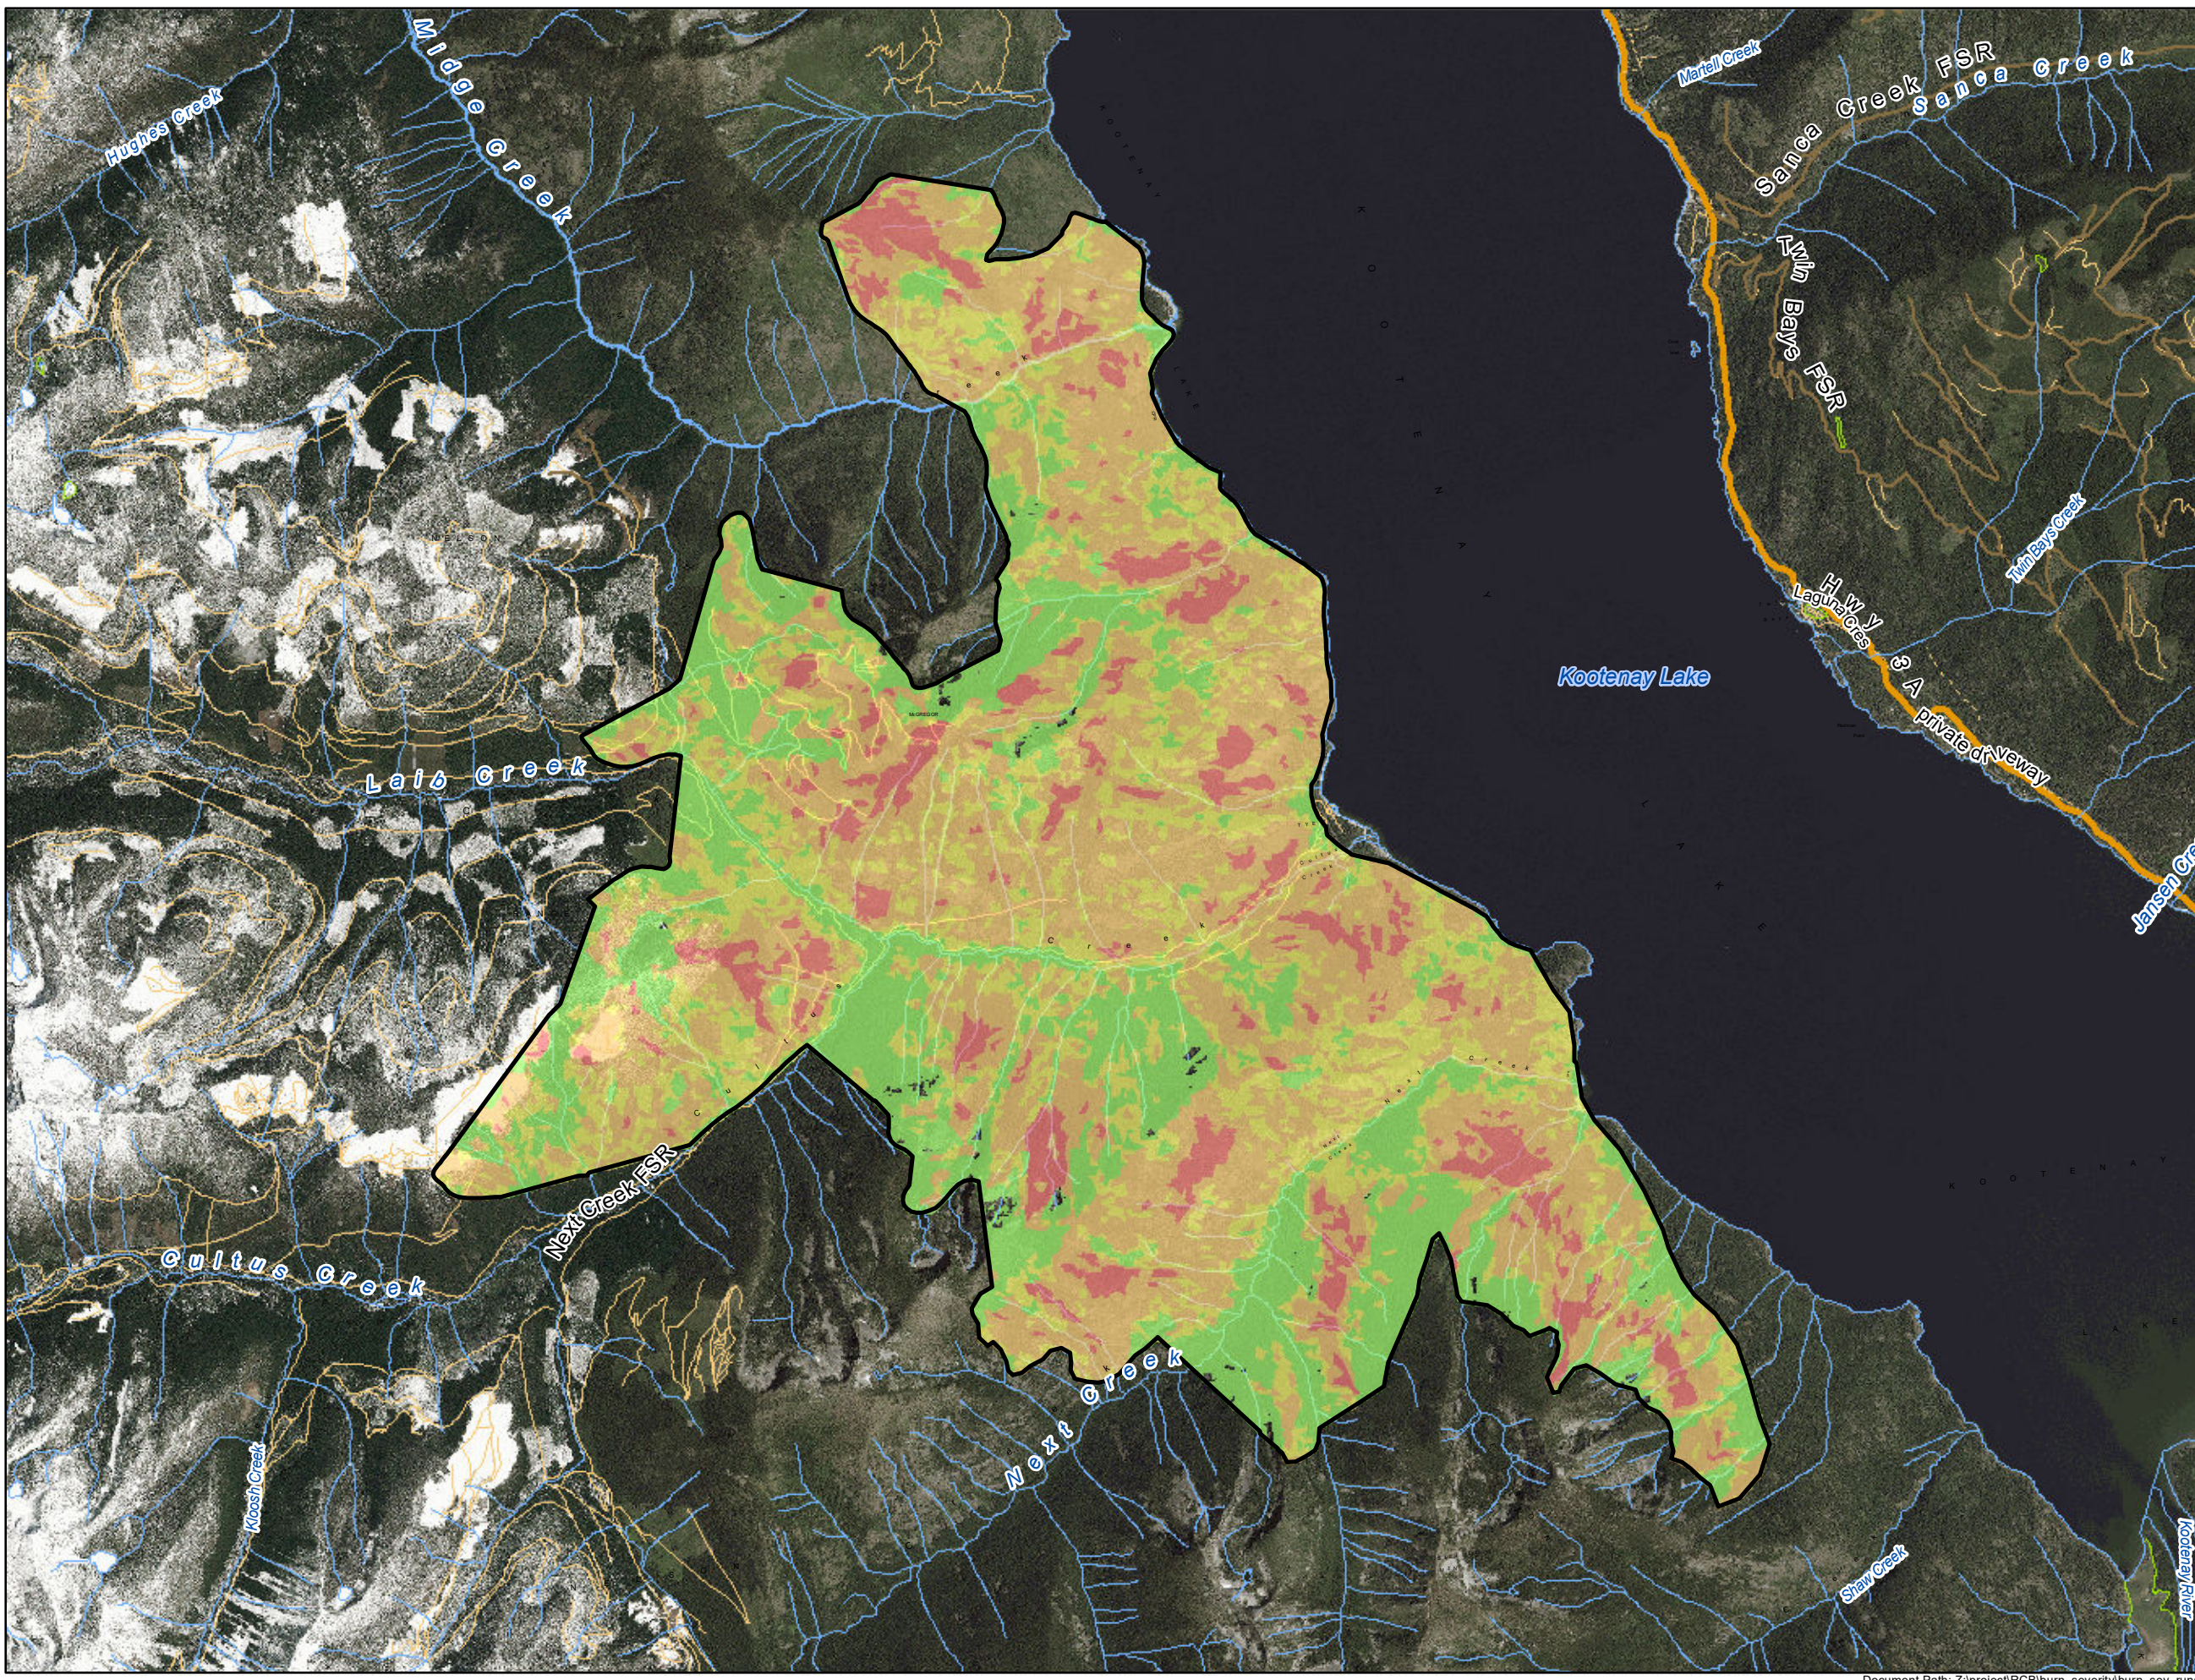
A steep gully at the south end, referred to as Tye Creek (Photos 1, 2 + 3), was significantly burned and further work was completed to determine the expected hydrogeomorphic hazard. The Melton ratio (watershed relief divided by the square root of watershed area) is used to differentiate flood and debris flow watersheds (Wilford 2004¹). The Melton ratio for this gully is 1.067, indicating that the expected hydrogeomorphic event is a debris flow. For the most part, the gradient of the channel varies from 40% and 60%, which will be sufficient to transport a debris flow to the fan. The fan surface has a gradient of around 20%, suggesting debris flows are likely to cross the fan and reach the lakeshore. The fan was mostly unburned,

Photo 1: View looking northwest up the Tye Creek draw (creek in blue, watershed boundary in white). The Cultus Creek valley is visible at the left of the image. The boat basin and most of the recreational properties are on the Cultus Creek fluvial fan.
