May 8, 2023

From: Sarah Crookshanks, P.Geo., Ministry of Forests

Re: Talbott Creek debris slide and debris flood

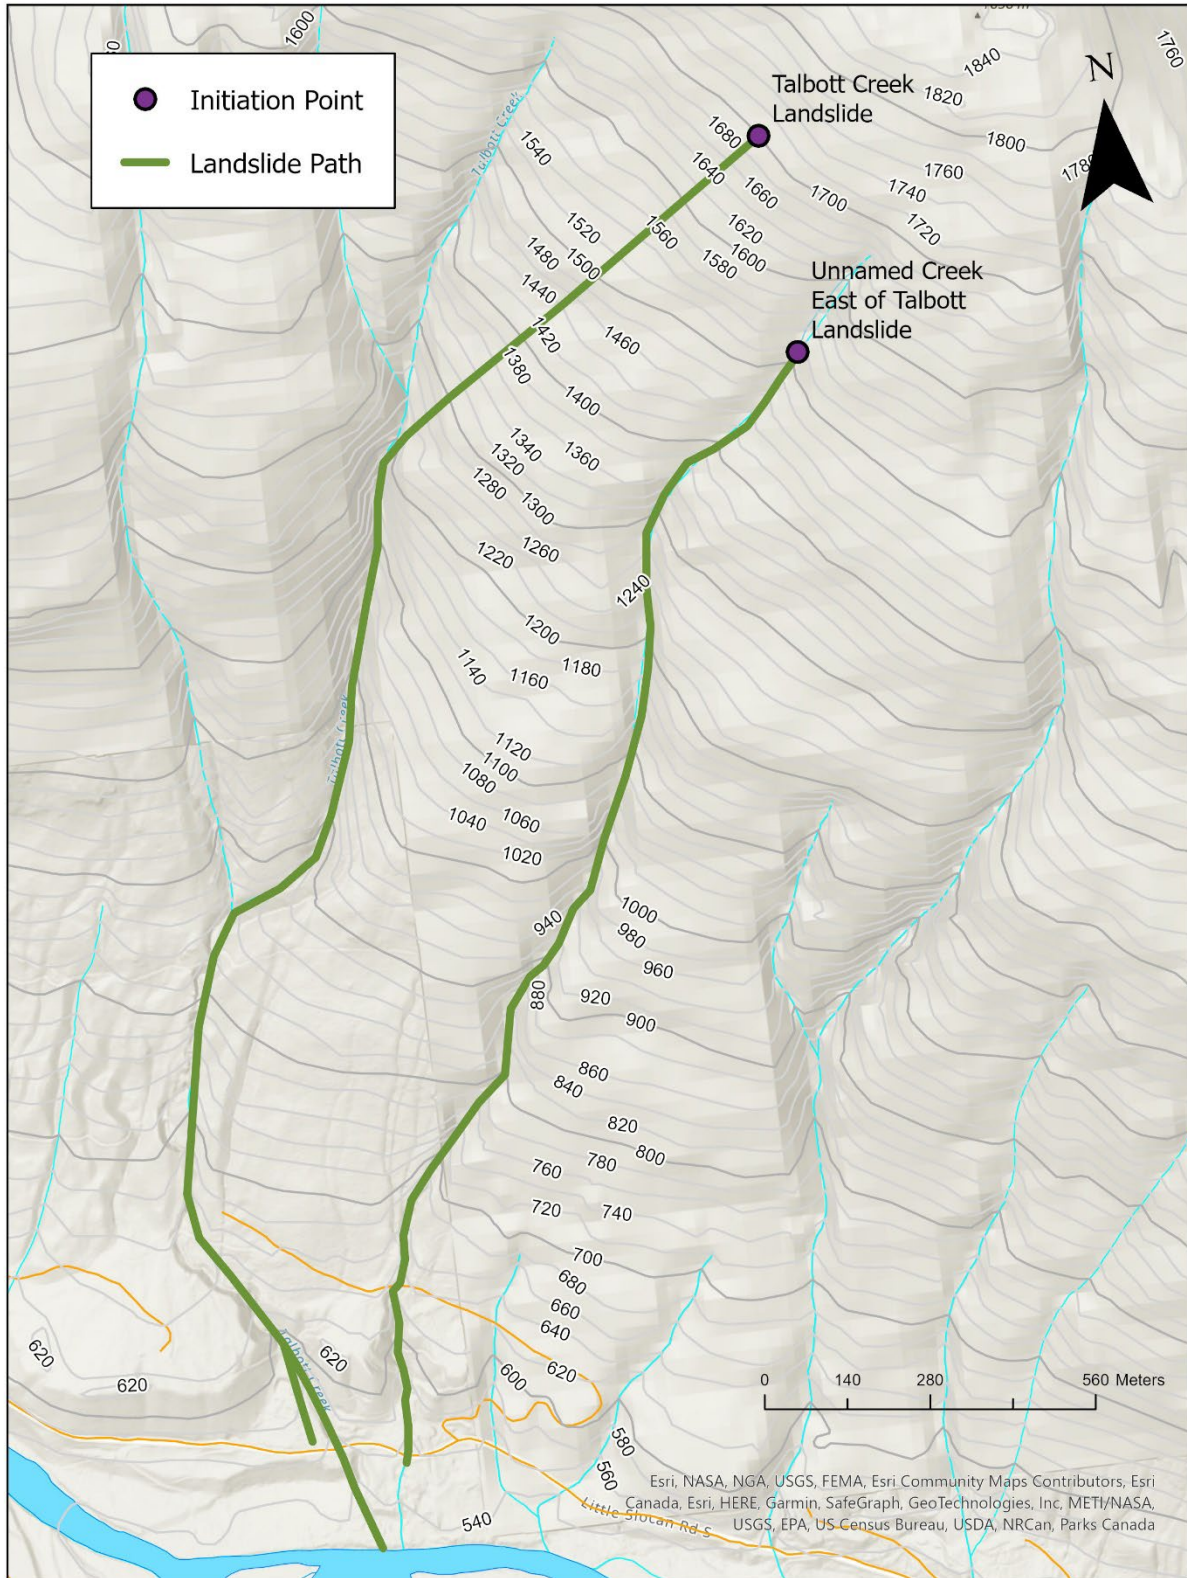
A small gully headwall debris slide in the Talbott Creek watershed resulted in a debris flood that travelled 2.5 km down to valley bottom. The initiation point at 1700 m (49° 35' 0" N, 117° 41' 23" W) and slide path are shown on the map in Figure 1. Photos of the debris slide and ridge top conditions are shown in Figures 2 and 3.

Figure 1. Overview map of the landslide initiation and paths a.
