REGIONAL DISTRICT OF CENTRAL KOOTENAY

RIONDEL WATER AND DRAINAGE SERVICES COMMUNITY ADVISORY COMMITTEE DISCUSSION NOTES

Reference: Condition Assessment for Existing Drainage Infrastructure at Riondel, BC- Rev B

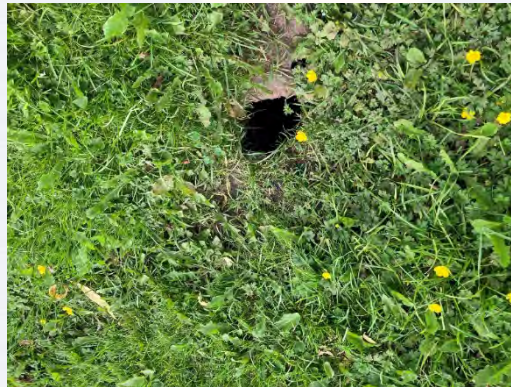
Hole in Exposed Steel Pipe

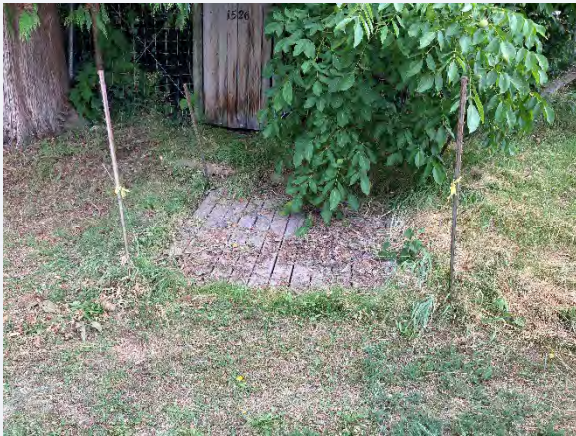
Wood Catch Basin Cover

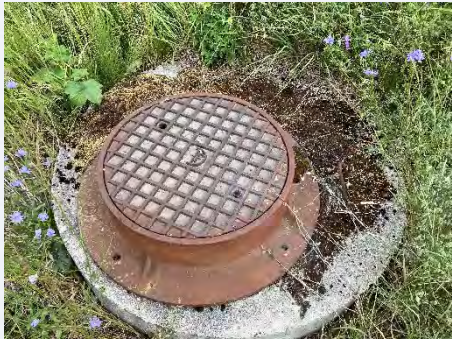
Unsecured Cover – No Grate

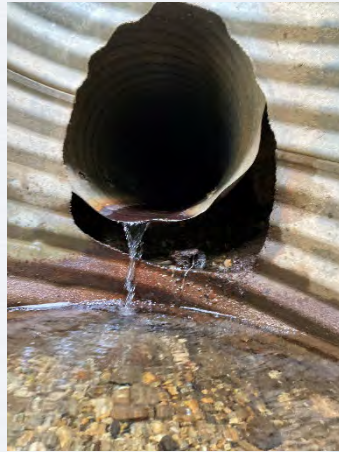
Pipe Miss Aligned

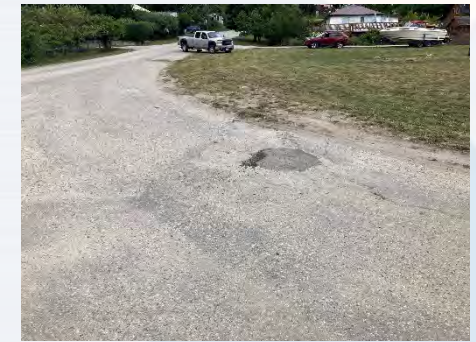
No Catch Basin at Tee
