PROFESSIONAL ENGINEERING SERVICES FOR THE CRESTON VALLEY FLOOD RISK ASSESSMENT

STRATEGIC PLAN DEVELOPMENT

TOWN OF CRESTON

APRIL 2023

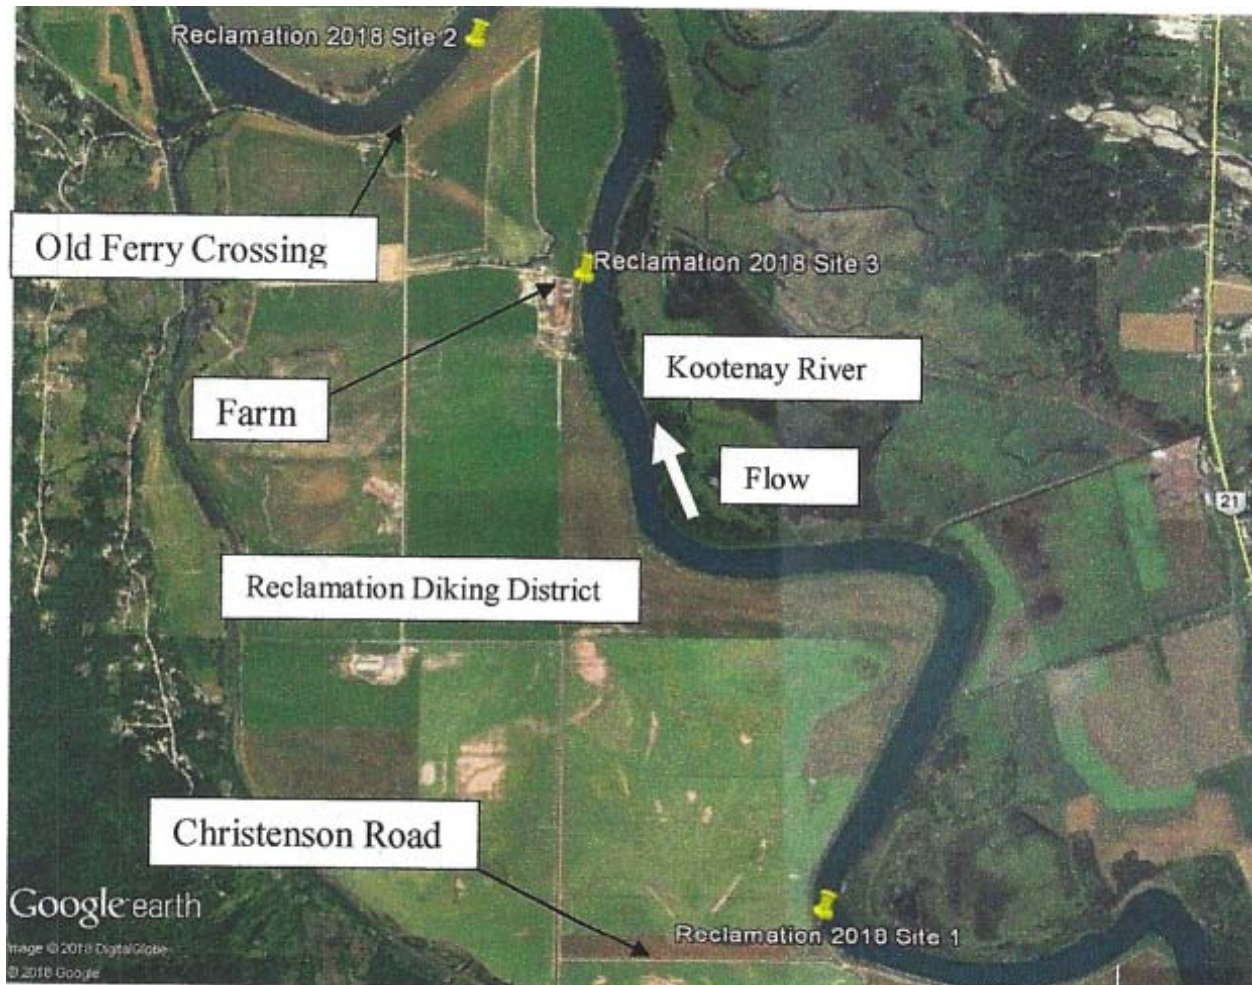
Figure 2.1 Reclamation Diking District Repair Sites by RHL (RHL, 2018)

Rodman Hydrotechnical Ltd (RHL) prepared a report in 2018 containing the recommended dike repairs for the Reclamation Diking District at three locations. According to RHL, the setback dikes are not applicable at the locations of interest due to their location on abrupt bends and/or adjacent infrastructure. Recommended repairs include:

- Re-sloping of the dike flanks to 2H:1V at site 1 (at the end of Christenson Road) and add riprap blanket;
- Re-sloping of the dike flanks to 1.5H:1V at site 2 (upstream of Old Ferry Crossing of Kootenay River) and add riprap blanket;
- Re-sloping of the dike flanks to 2H:1V at site 3 (east of existing farm building) and add riprap blanket.

The recommended riprap is a 600 mm blanket consisting of cobble, gravel, and coarse sand with a D50 of 75 mm and a maximum grain diameter of 200 mm. Where cobble/gravel material is not available, it might be more economical to use blasted rock from local quarries. The proposed riprap gradation is similar to NHC study as follows:

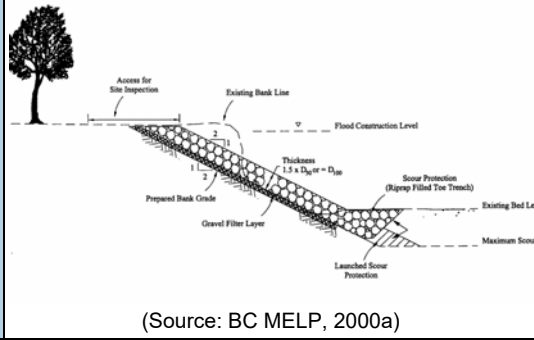
DIKE OR BANK STABILIZATION METHOD	ADVANTAGES	DISADVANTAGES	GENERAL RANGE OF APPLICABILITY	GEOMORPHIC RESPONSE	ENGINEERING EFFECTIVENESS	HABITAT CHARACTERISTICS
STRUCTURAL OPTIONS						
<p>Riprap</p>

<p>(Source: BC MELP, 2000a)</p>	<p>In general, these methods are widely tested and used, while deformable bank lines are less well understood. Riprap has proven to be extremely resilient and effective at protecting dikes against erosion mechanisms.</p>	<p>Can cause the channel width to decrease, creates a static bank line, and can in some cases, but not all, lead to acceleration of bank erosion in downstream bends.</p>	<p>Generally applicable to all types of channels.</p>	<p>Stops local bank erosion; causes local scour and channel deepening. Can be susceptible to flanking if upstream channel migration occurs.</p>	<p>Durable, high level of confidence in method. Provides long-term bank protection.</p>	<p>Same as longitudinal stone toe except without minimal benefits to riparian community (no bio-engineering).</p>

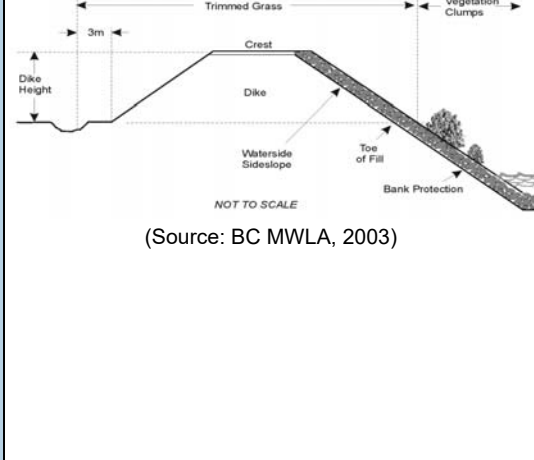
<p>Vegetated Riprap</p>

<p>(Source: BC MWLA, 2003)</p>	<p>More natural and aesthetically pleasing than traditional rock riprap. It provides habitat for fish and wildlife by creating shade, cover and small organic debris input to the watercourse. It is flexible and not affected by slight movements from ground settlement, shifting, frost heave or toe erosion. It is cost-effective in comparison to other hard erosion control techniques. Can negate or reduce the amount of habitat alteration compensation required by regulators. It has minimal maintenance requirements. *</p>	<p>Requires local supply of rock riprap, otherwise it would be very expensive to haul in materials. It requires local supply of suitable native live materials. Need to ensure that navigability of the channel is not impeded. Specialized equipment might be required if there are access restrictions.* Needs watering during dry periods until vegetation has been established.*</p>	<p>In case of having a dike, it is only applicable to an overwidth dike or below the toe for the regular dikes.</p>	<p>Same as Riprap.</p>	<p>Same as Riprap.</p>	<p>Same as longitudinal stone.</p>

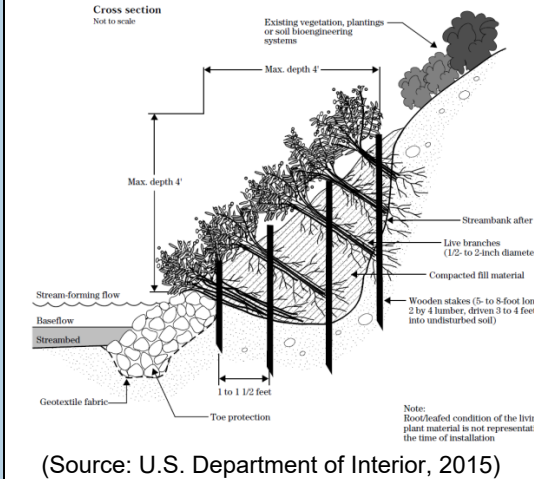
<p>Longitudinal Stone Toe with Bio-Engineering on Banks</p>

<p>(Source: U.S. Department of Interior, 2015)</p>	<p>Thoroughly tested and used in a wide range of conditions. Vegetation provides aesthetic benefits, shading, and reduces bank line velocity during high flows.</p>	<p>Decreased channel width and increased depth. Creates a local static bank line. In some cases, longitudinal stone toe can lead to accelerated bank erosion of downstream bends. In arid climates, Koir fabric or bio-D blocks are needed to provide suitable conditions for vegetation to grow, and vegetation may need to be replanted to provide the desired benefits. Needs watering during dry periods until vegetation has been established.*</p>	<p>Well suited to protect against toe erosion where mid and upper banks are fairly stable due to vegetation and cohesion. All types of channels throughout the U.S.</p>	<p>Same as Riprap.</p>	<p>Durable, high level of confidence in method provided that the elevation of the top of the riprap stone toe is adequately established to provide complete toe protection.</p>	<p>Prevents lateral migration and the establishment of new depositional zones where vegetation could become established. Reduces local sediment supplied from bank erosion. The steep bank angle on the outside of the bend limits fish cover, except for the riprap interstitial spaces. The point bar remains connected to the main channel and remains static. The flow velocity and depth are greater than typically found in natural channels along the outside bank of a river bend. Bio-Engineering provides shading and minimal benefits to riparian community.</p>

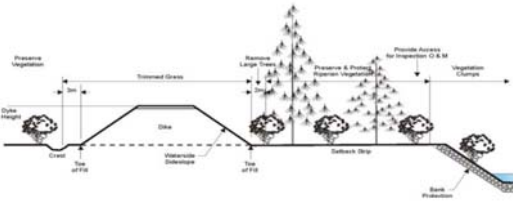
DIKE OR BANK STABILIZATION METHOD	ADVANTAGES	DISADVANTAGES	GENERAL RANGE OF APPLICABILITY	GEOMORPHIC RESPONSE	ENGINEERING EFFECTIVENESS	HABITAT CHARACTERISTICS
STRUCTURAL OPTIONS						
Setback Dike and Vegetation Buffer Zones

<p>(Source: BC MWLA, 2003)</p>	<p>Greater area for lateral migration. Infrastructure is protected by relocation.</p>	<p>Can be a higher cost than other methods; lateral migration may continue to new infrastructure location with the same erosion issue as before.</p>	<p>Applicable to all ranges of river conditions, except at sharp meanders where aggressive bank migration is observed.</p>	<p>Can encourage current geomorphic processes to continue, such as lateral migration and the creation of new flood plain and riparian areas. Opportunity to connect to historical channels and oxbows. For incised channels, this may provide an opportunity to establish new inset flood plain and riparian zones.</p> <p>Effectively protects riverside infrastructure by moving it from the erosion zone. Level of confidence is medium to high and depends on the amount of setback.</p>	<p>Lateral river movement creates broader flood plain and a more favorable riparian zone habitat. Lateral bank movement should result in deposition of sediment downstream. The river will establish bars and low surfaces, where vegetation can become established. Longer meander bends may establish greater pool depth and eroding banks with vegetation falling into the channel, providing fish cover and habitat complexity.</p> <p>The vegetation promotes greater area of undisturbed habitat.</p>

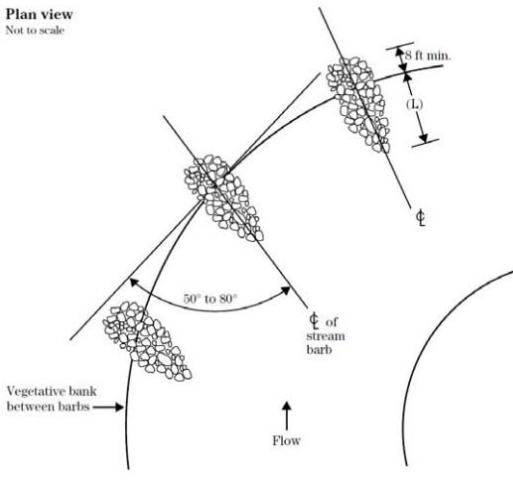
Spur (Vane) Dike

<p>(Source: AMEC, 2012)</p>	<p>Spur dikes modify channel alignment and provide erosion protection for riverside structures. Provides variable velocity and depth habitat. Can induce sediment deposition.</p>	<p>The bank line between spur dikes can erode when the spur dike spacing is too large. Over time, the channel deepens, increasing flow capacity. Local channel narrowing can occur. The extent of channel deepening and narrowing cannot be predicted with great reliability. The bank line is fixed, thus interrupting fluvial processes.</p>	<p>Most commonly used in shallow, wide streams with moderate to high suspended sediment load. Spur dikes are used widely for protecting highway bridge crossings in the United States. Usually used on outer banks along long radius bends.**</p>	<p>Spur dikes block the flow up to bank height, thus shifting the thalweg alignment to dike tips. Peak flow capacity can be reduced initially until the channel adjusts. The channel adjusts to the presence of spur dikes by forming a deeper, narrower cross section with additional scour downstream from each spur dike. Sediment deposition can occur between spur dikes.</p>	<p>Level of confidence is medium. Can halt local bank erosion. Spur dikes are more durable than bendway weirs and can remain functional if there are small changes to the upstream entrance conditions. Future maintenance (adding riprap on the spur dike tips) may be required, especially in gravel and sand bed streams.</p> <p>Sediment deposition between structures may allow establishment of riparian vegetation and backwater areas. Channel deepening and tip scour could locally lower the riverbed. Depending on site-specific conditions, transverse features could allow for overbank flooding conditions improving the health of the riparian zone. Local scour could provide habitat diversity and deep habitat during low-flow conditions.</p>

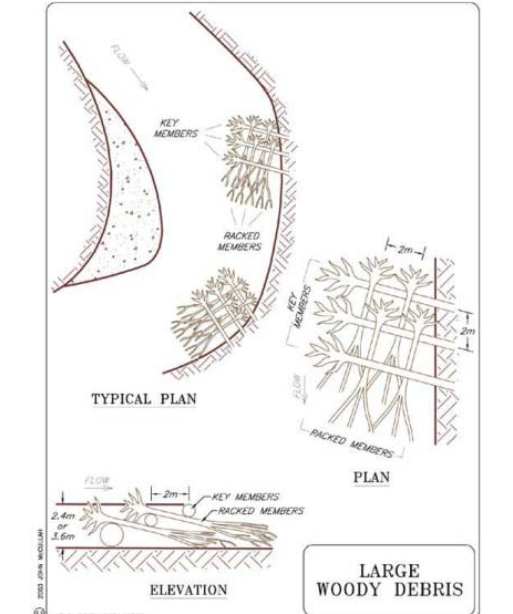
Large Woody Debris (LWD)

<p>(Source: U.S. Department of Interior, 2015)</p>	<p>Can create in-stream cover, pool formation, deflect flows, retain gravels, and create complex hydraulics. LWD is a natural material.</p>	<p>The length of benefit is usually between 5 and 15 years, depending upon the durability of the available tree species. They can also create hazards to boaters and other recreationalists when still attached to the bank, or when washed downstream with trailing cable. They can cause some erosion issues downstream if they are washed away. They may cause changes to the opposite bank.</p>	<p>LWD is used in many areas of the world, but is not used much in the arid Southwest, where tree species do not last more than about 5 years. Mostly applicable on long uniform bends in alluvial channels to prevent toe erosion or scour.**</p>	<p>Creates pools, generates scour and substrate sorting, and increases depth and velocity complexity. Can promote side channel formation and maintenance. Can lead to sediment deposition, including formation of islands, in rivers with large sand loads.</p>	<p>Level of confidence is medium. Some design guidelines are available. Short design life span for some southwestern U.S. tree species such as cottonwood.</p> <p>Adds complexity to the system. Sediment deposition can create areas where new riparian vegetation becomes established. Can create variable depth and velocity habitat. Reliability for providing fish habitat is high for a while logs/root wads remain intact (5-25 years). Can provide structure and habitat for fish. Can provide low-flow refugia habitat during low-flow periods.</p>

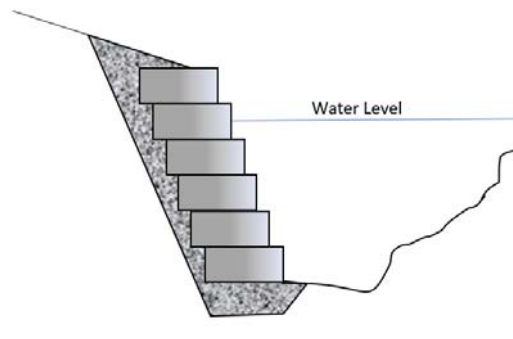
DIKE OR BANK STABILIZATION METHOD	ADVANTAGES	DISADVANTAGES	GENERAL RANGE OF APPLICABILITY	GEOMORPHIC RESPONSE	ENGINEERING EFFECTIVENESS	HABITAT CHARACTERISTICS	
STRUCTURAL OPTIONS							
Retaining Wall

Effective for limited space or near structures/slopes that are sensitive to movement and loading.	Generally, an expensive option and may require some in-stream work.	Applicable to shallow rivers where the stabilization work footprint must be minimized at the top of slope.	Stops local bank erosion; causes local scour and channel deepening. Can be susceptible to flanking if upstream channel migration occurs.	Durable, high level of confidence in method. Provides long-term bank protection.	No benefits to riparian community.
NON-STRUCTURAL OPTIONS							
Dike Maintenance		These options are not as expensive as other options while playing a significant role in dike failure risk mitigation.	They usually involve personal judgment, continuous effort, and owner cooperation. Landowners should be educated for an effective result.	Essential for all dikes.	N/A	Provides long-term bank protection.	Removing the vegetation from the dike or discouraging burrowing animals has adverse effect on habitat.
