Development Permit Application

Referral Form – RDCK File DP2406A

10377 Highway 3A, Sanca

Environmental Report

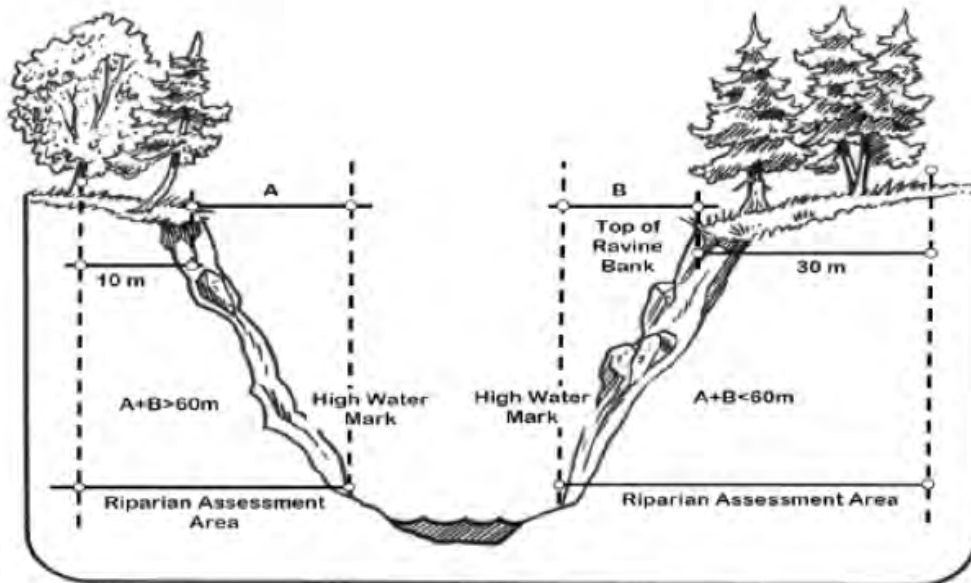
FIGURE 1: (for illustrative purposes only) **RIPARIAN ASSESSMENT AREA:** means the area within 15 m of the high water mark of a watercourse; within 15 m of the top of the ravine bank in the case of a ravine less than 60 m wide; and within 5 m of the top of the ravine bank in the case of a wider ravine that link aquatic to terrestrial ecosystems and includes both existing and potential riparian vegetation and existing and potential upland vegetation that exerts an influence on the watercourse. This DPA applies only to residential, commercial and industrial designations.

1. Riparian assessment areas (Figure 1) for fish and wildlife habitat and drinking water, including:
 - a. All areas within 15 metres of the high water mark of a watercourse, including the natural boundary of a lake;
 - b. within 15 metres of the top of the ravine bank in the case of a ravine less than 60 metres wide; and
 - c. within 5 metres of the top of the ravine bank in the case of a wider ravine that links aquatic to terrestrial ecosystems and includes both existing and potential riparian

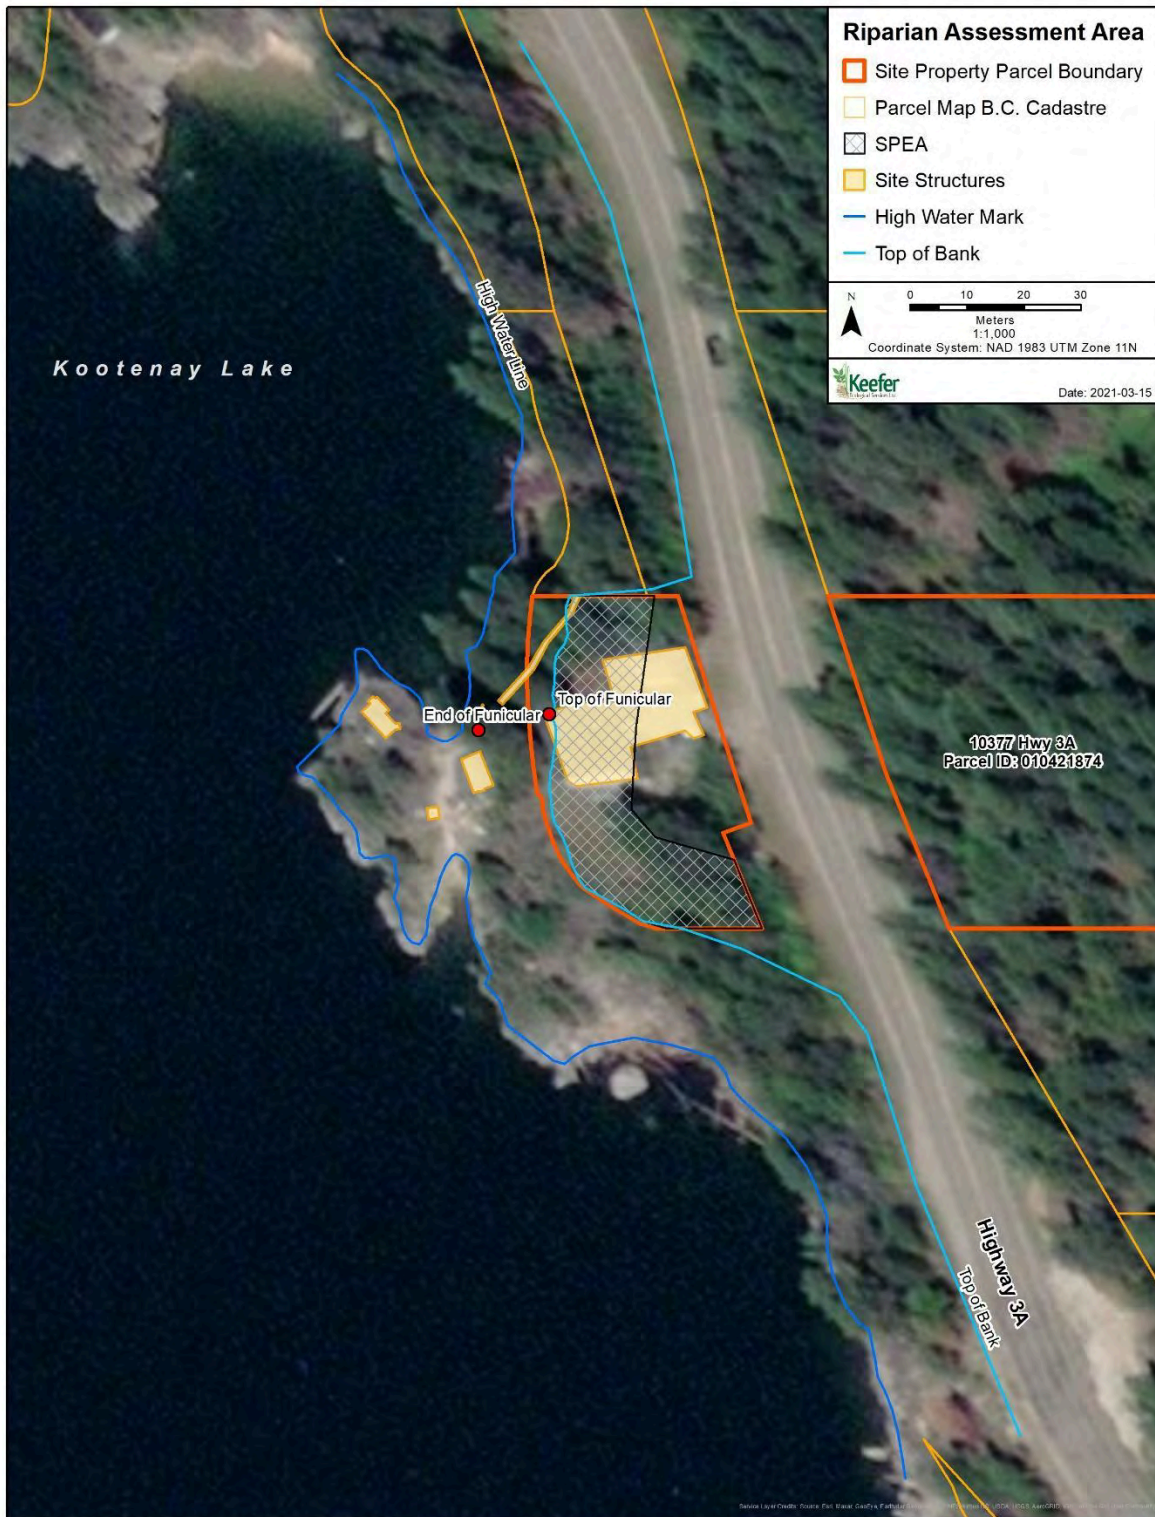
Figure 1. SPEA determination for the assessed property.

SPEA Width Calculation: The SPEA was determined to be 15 m as directed by the RDCK for Electoral Areas A per the Official Community Plans (Regional District of Central Kootenay, 2021) for maintaining riparian function and protecting aquatic habitat. The riparian area measurement was based on mapping provided by the surveyor, using the location of the high-water mark (Figure 1).

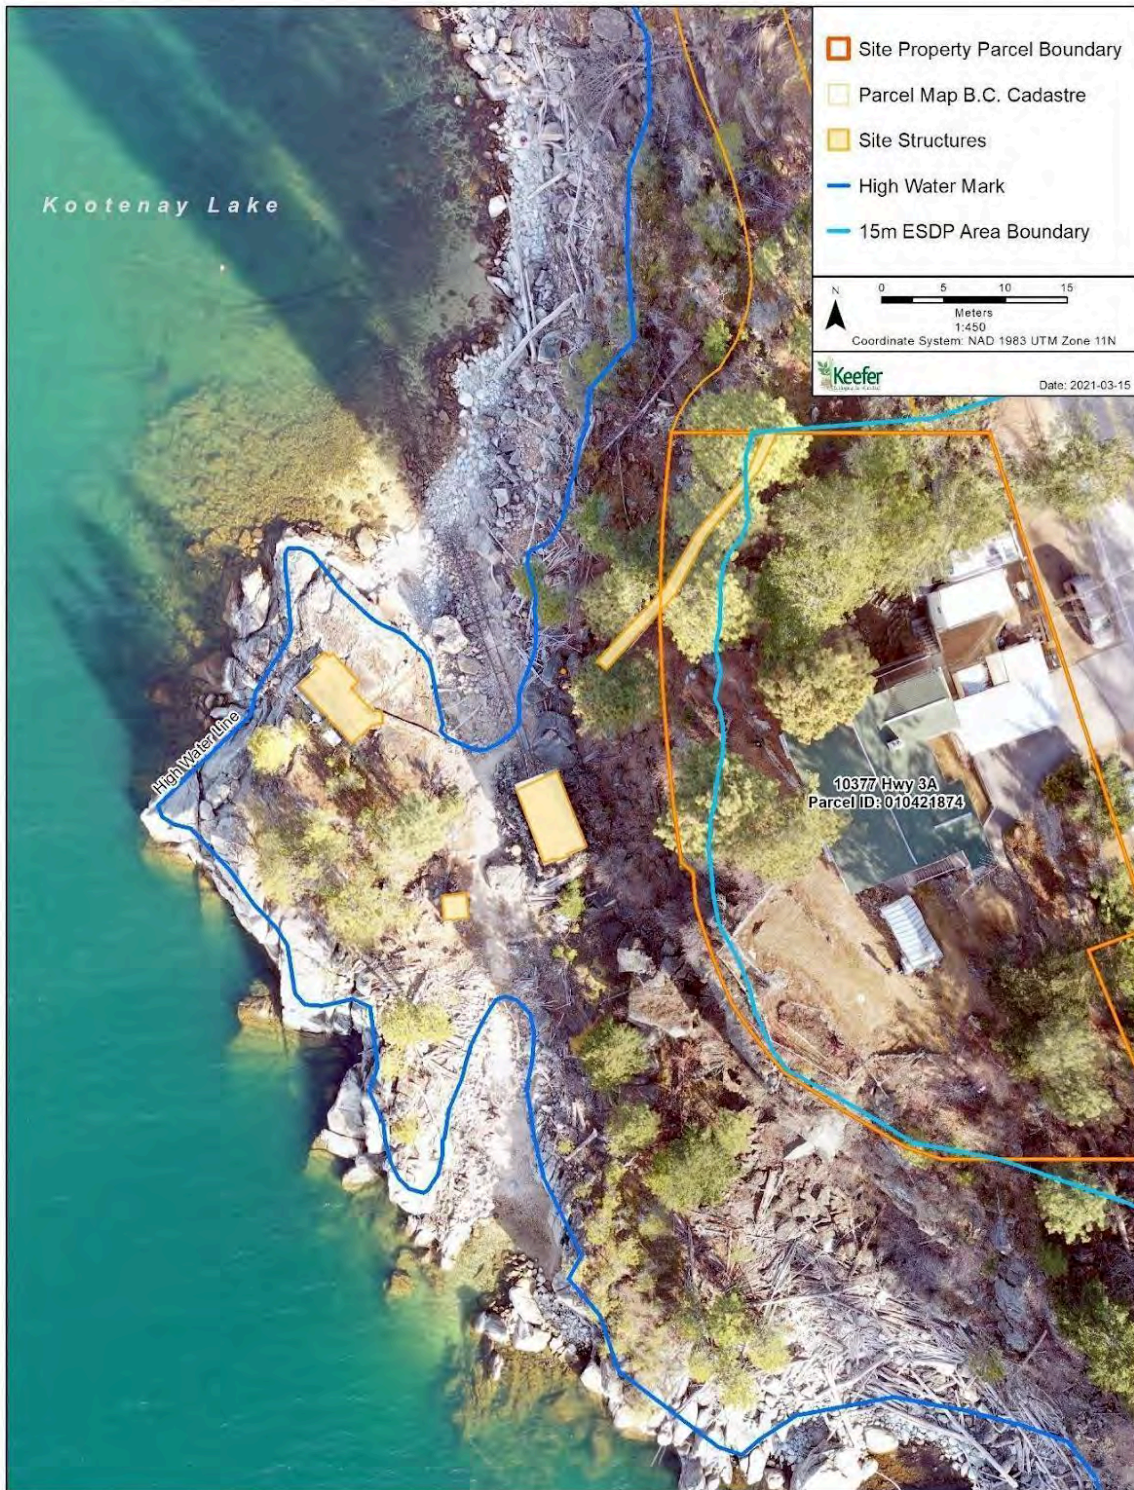
Figure 1. Existing development of the assessed property.

A two-storey house on a concrete foundation currently exists on the upper portion of the assessed property, immediately west of Highway 3A. The house was constructed in 1963 and has likely experienced several renovations since that time. On the south side of the house is a small greenhouse and the septic field. On the north side of the house, a wooden staircase connects the upper portion of the assessed property to the lower portion where a boat house, rail system, deck and storage shed are located. A cliff approximately 30 meters (m) in height separates the upper and lower portions of the assessed property. Other existing infrastructure found in the lower portion of the assessed property includes a decommissioned hydro pole and scrap wiring, other decommissioned electrical equipment (e.g., light on the shoreline), and several water lines that run from the waters edge up the cliff to the house above (Figure 1).

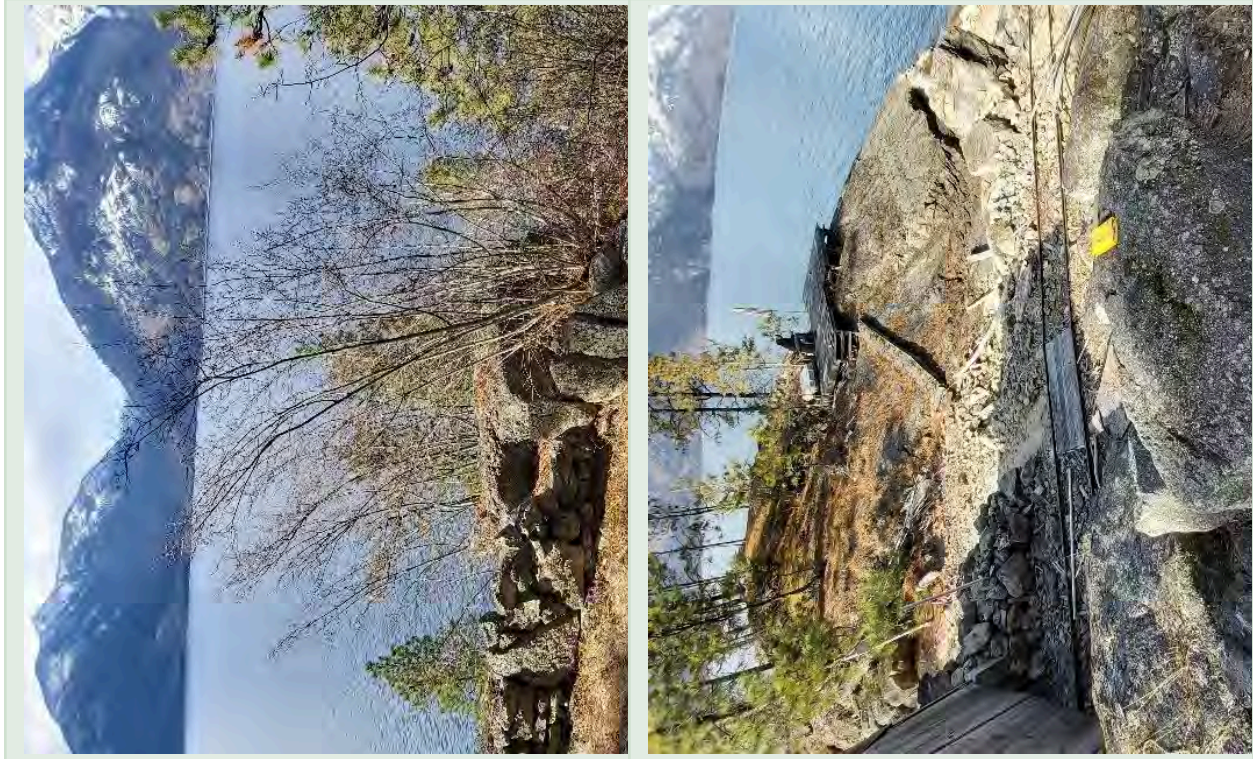
Figure 2. Top (left) and bottom (right) points of the proposed funicular.

The proposed development includes the installation of a funicular (a cable and rail system) intended to connect the upper and lower portions of the assessed property from a point on the western edge of the upper portion to a point above the high water mark in the lower portion (Figure 2), and a floating dock extending from gangway secured into the bedrock along the western shoreline, where a non-permanent deck area built of wood currently exists (Figure 3).

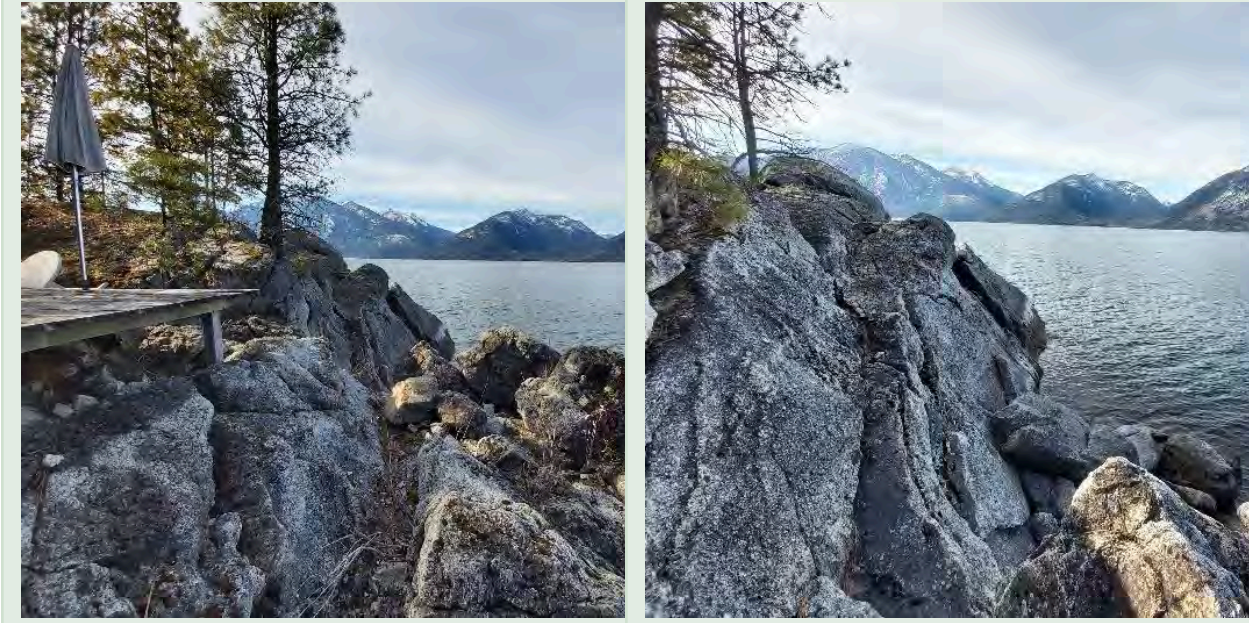
Figure 3. Location of proposed floating dock and gangway.

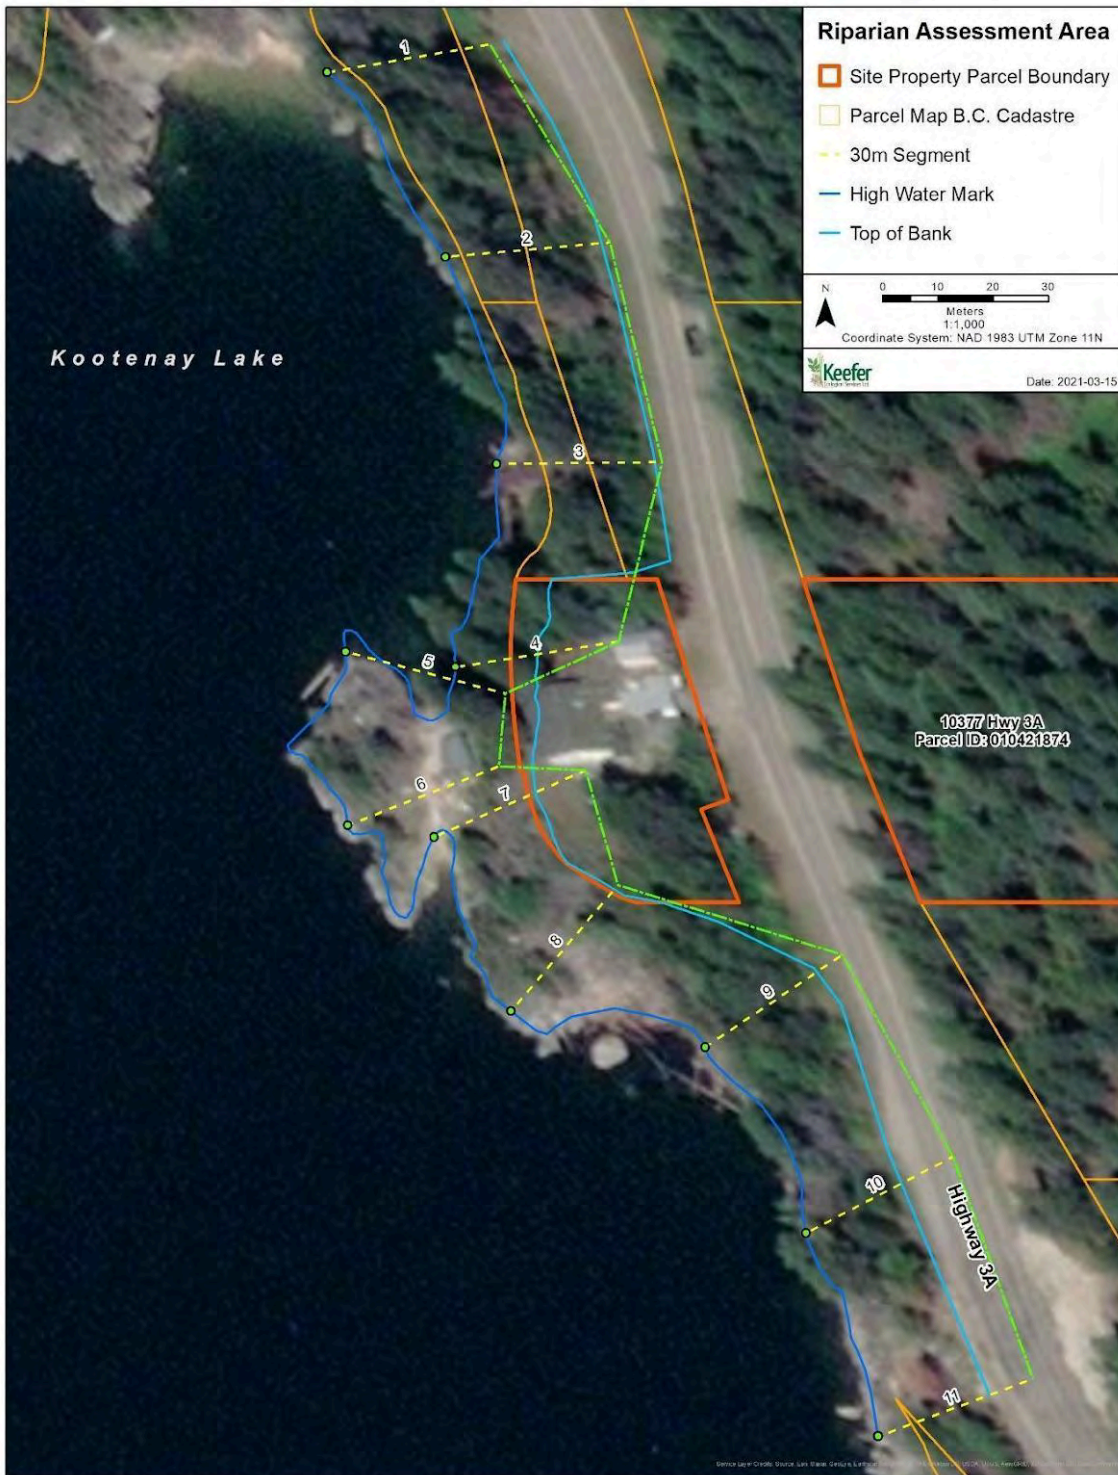
Figure 4. Riparian area assessment boundaries.

The vegetation category is assessed within a 30 m wide area starting from the middle of the assessed property and going 200 m both upstream and downstream along the bank where the development will occur. Within the 30 m and 200 m assessment boundaries, the distance from the top of bank (TOB) to the first permanent structure was estimated at 40 m intervals (Figure 4). An air photo was used to undertake this measurement prior to inspecting the site in person. While on site, KES utilized a drone to improve the quality of the available aerial photos of the site for the purposes of this assessment.

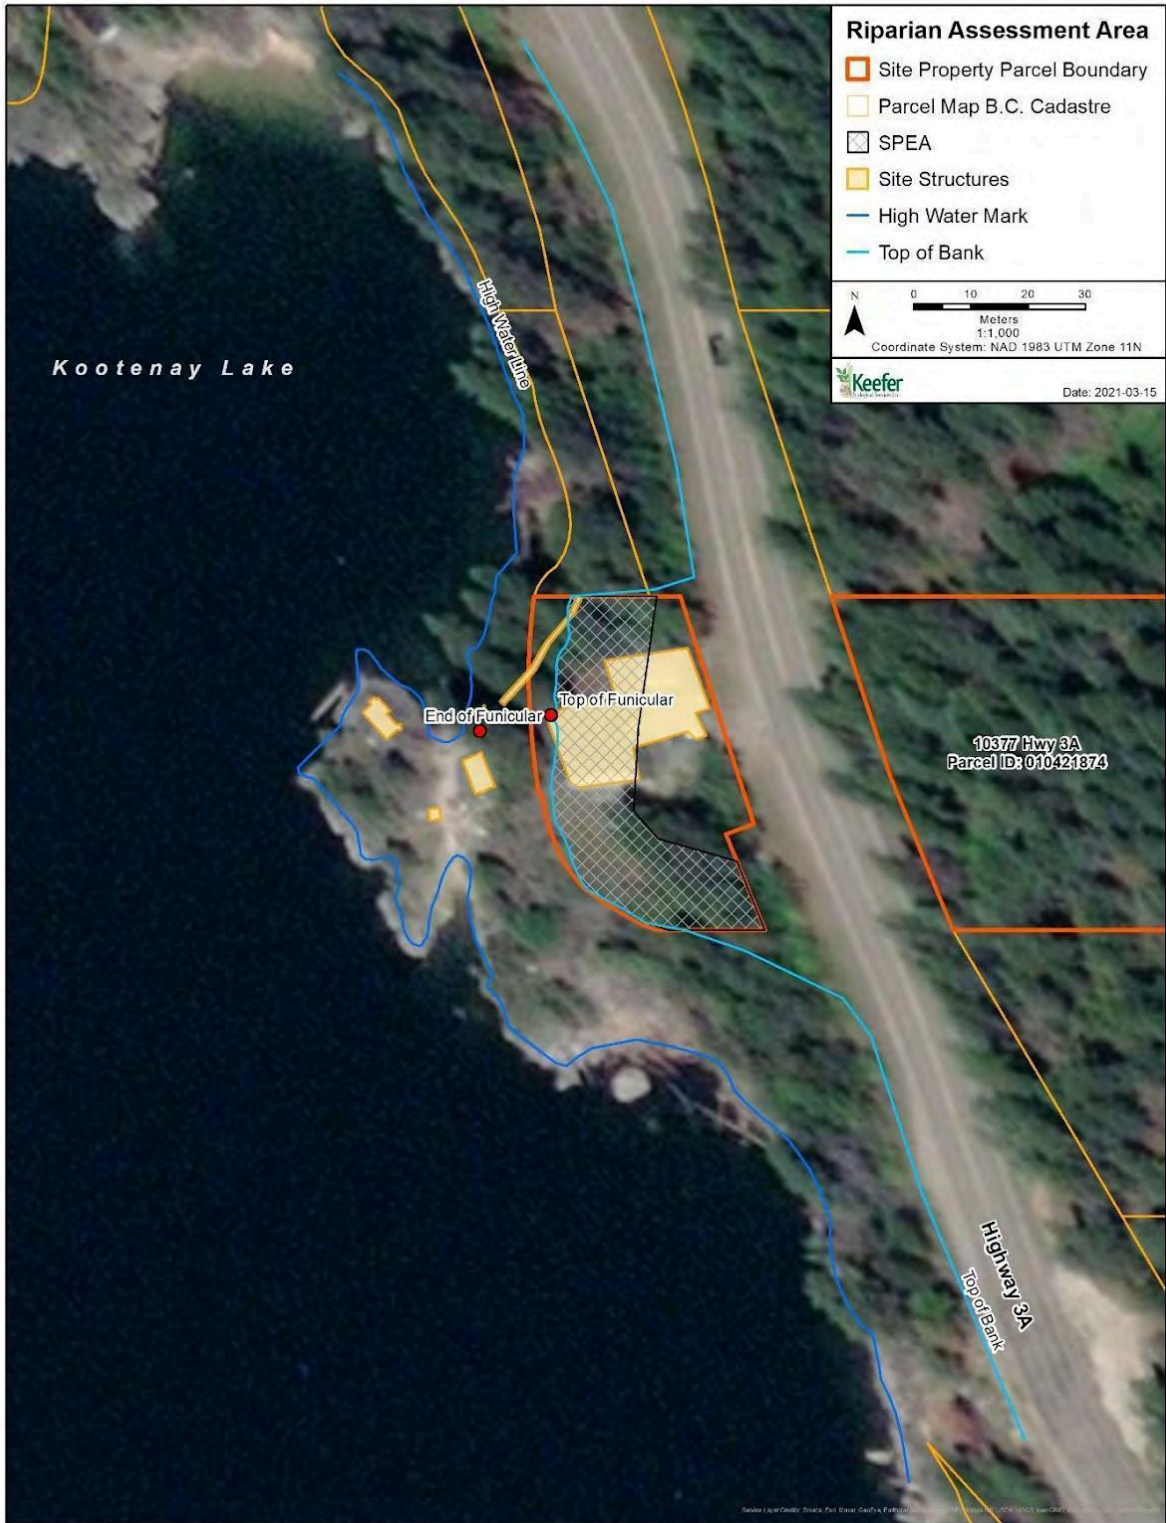
Figure 7. SPEA determination for the assessed property.

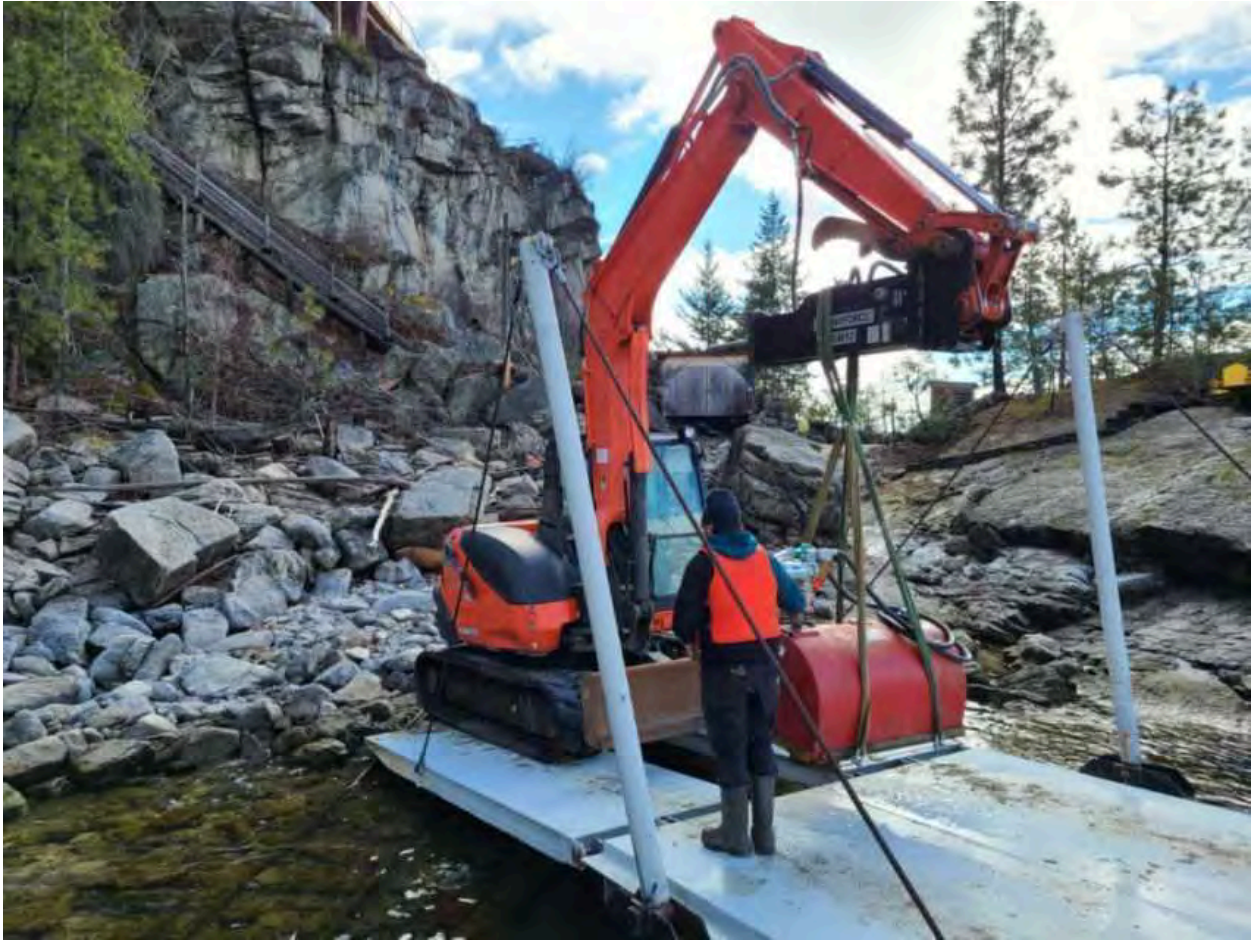
Figure 1. Excavator and fuel tank are unloaded on the north shore from a barge.

Date	Actions
March 4, 2022	• Excavator unloaded on-site (Appendix A: Figure 1)

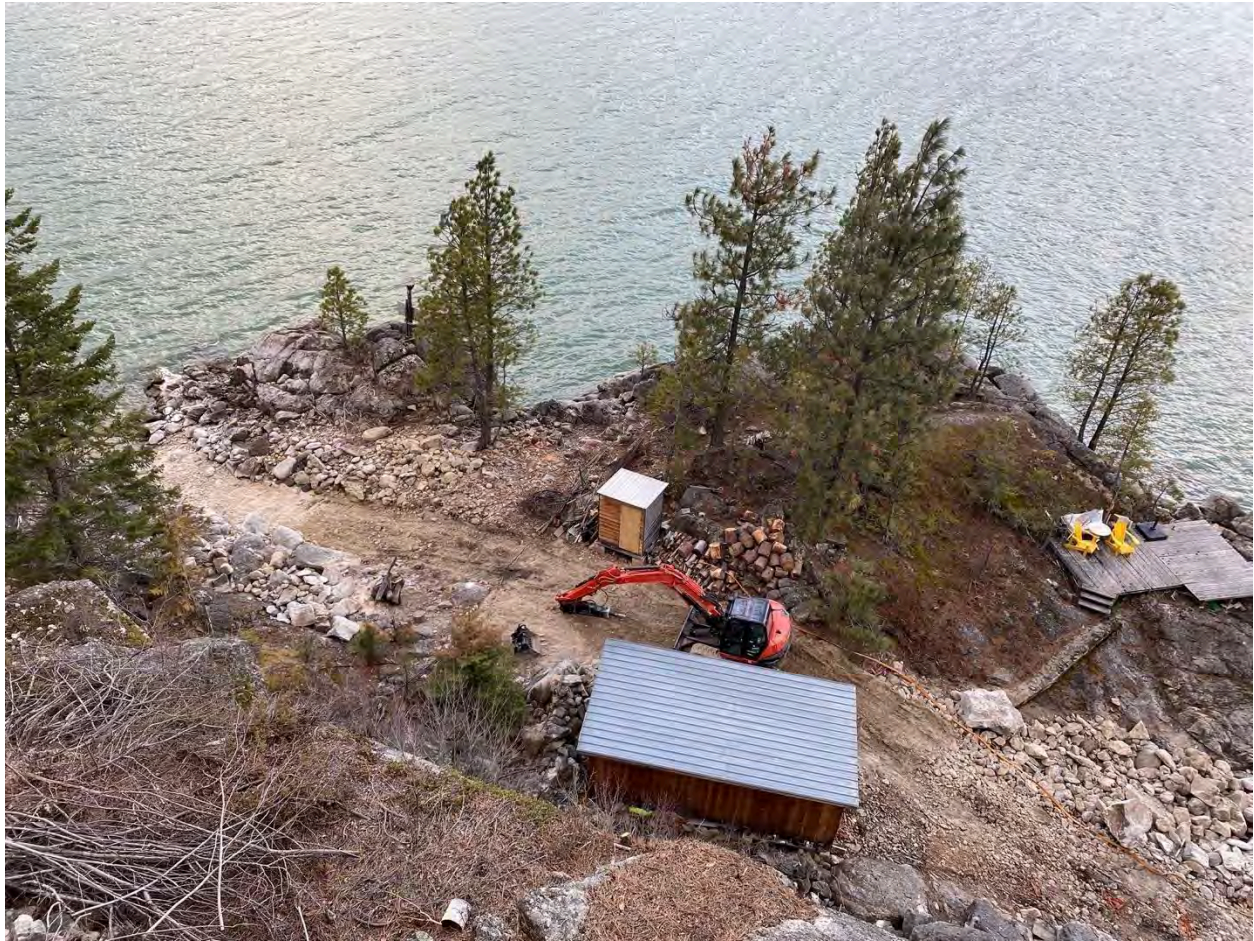
Figure 2. Overhead view of the south channel after the path was widened and cleared of debris.

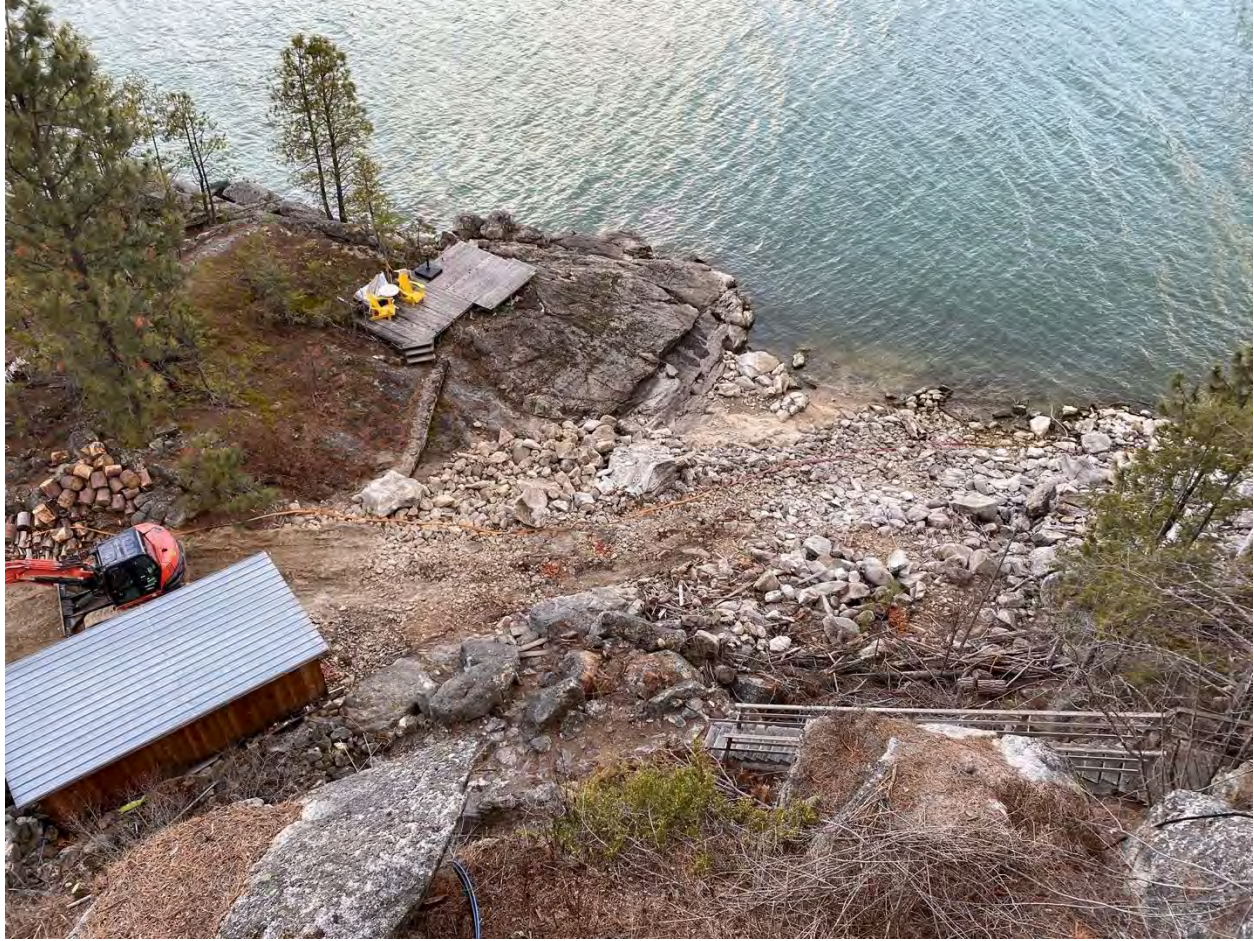
Figure 3. Overhead view of the north channel after the path was widened and cleared of debris.

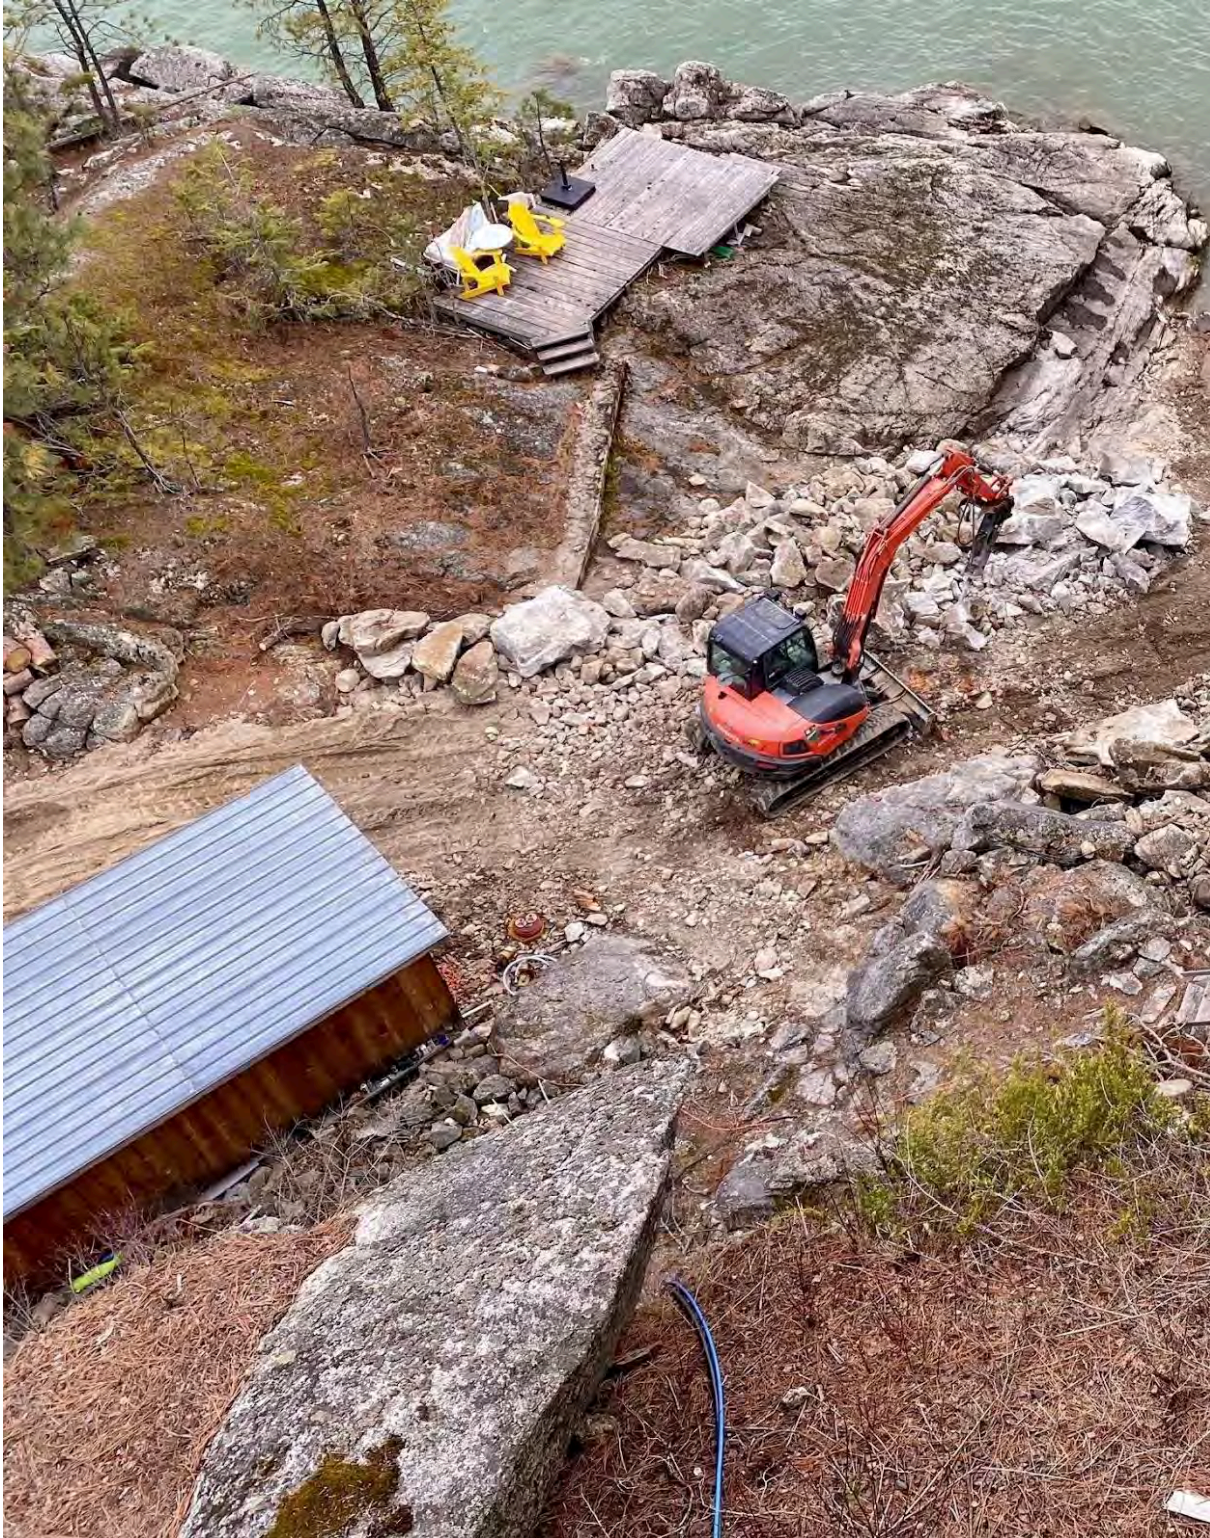
Figure 4. Cleaning the north channel to remove large boulders.

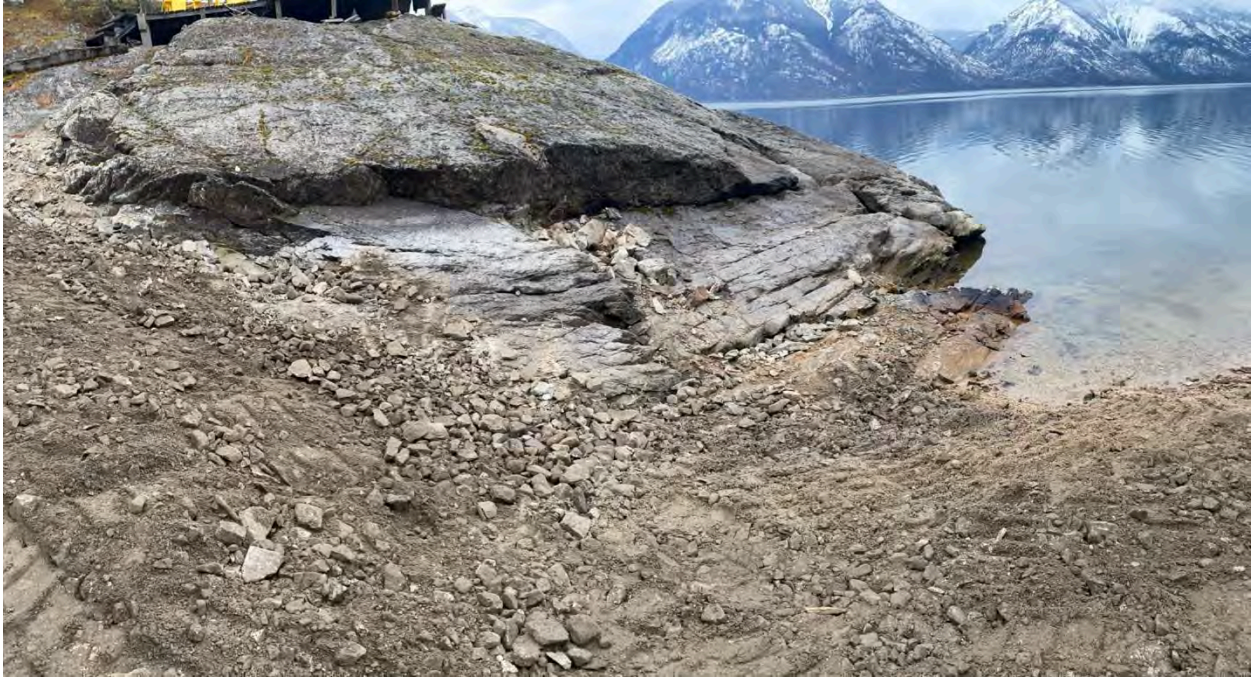
Figure 5. Northern shoreline facing west following boulder and rock removal.

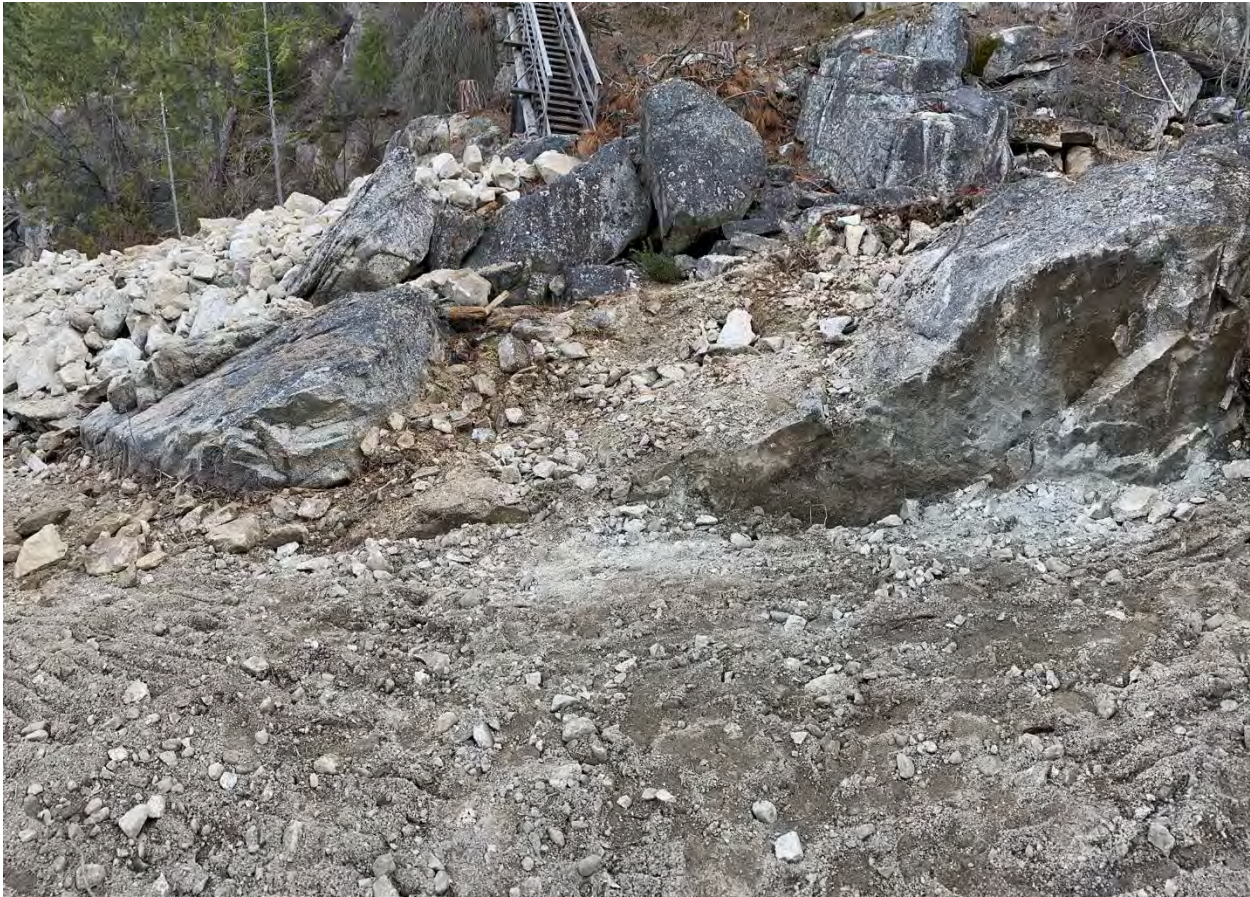
Figure 6. Northern shoreline facing east following boulder and rock removal.

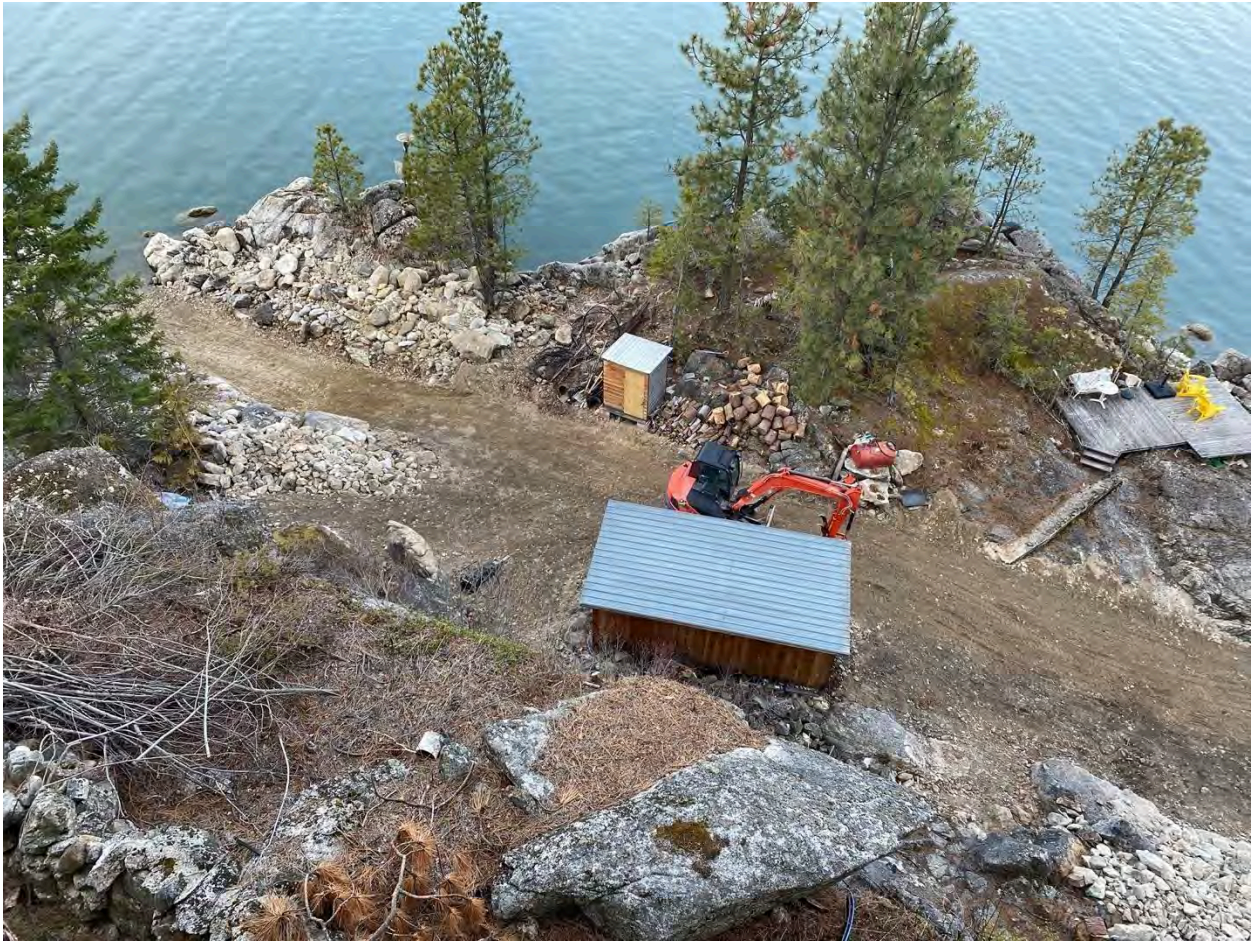
Figure 7. Overhead view of the south channel following boulder and rock removal.

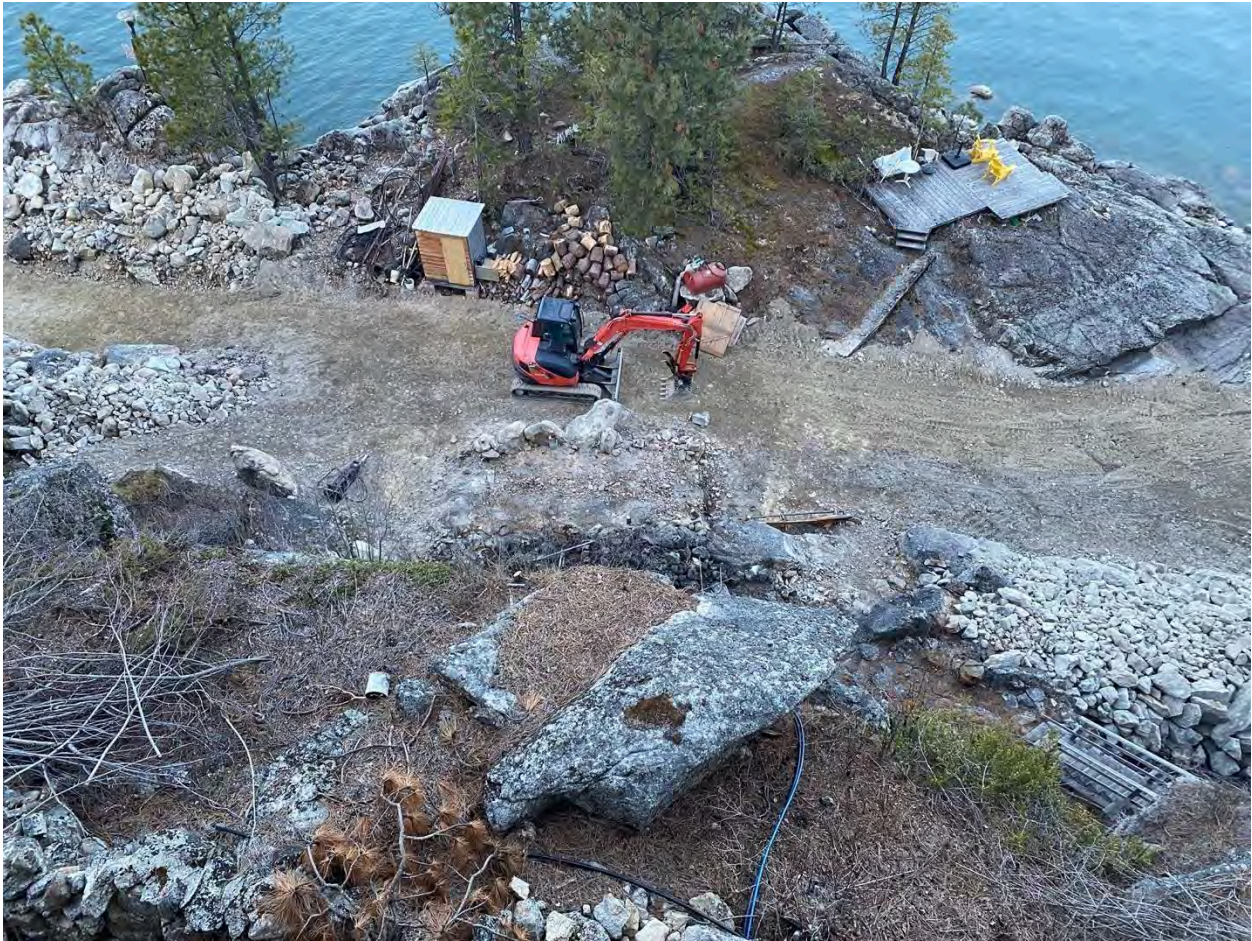
Figure 8. Overhead view showing the location of the dismantled boathouse.

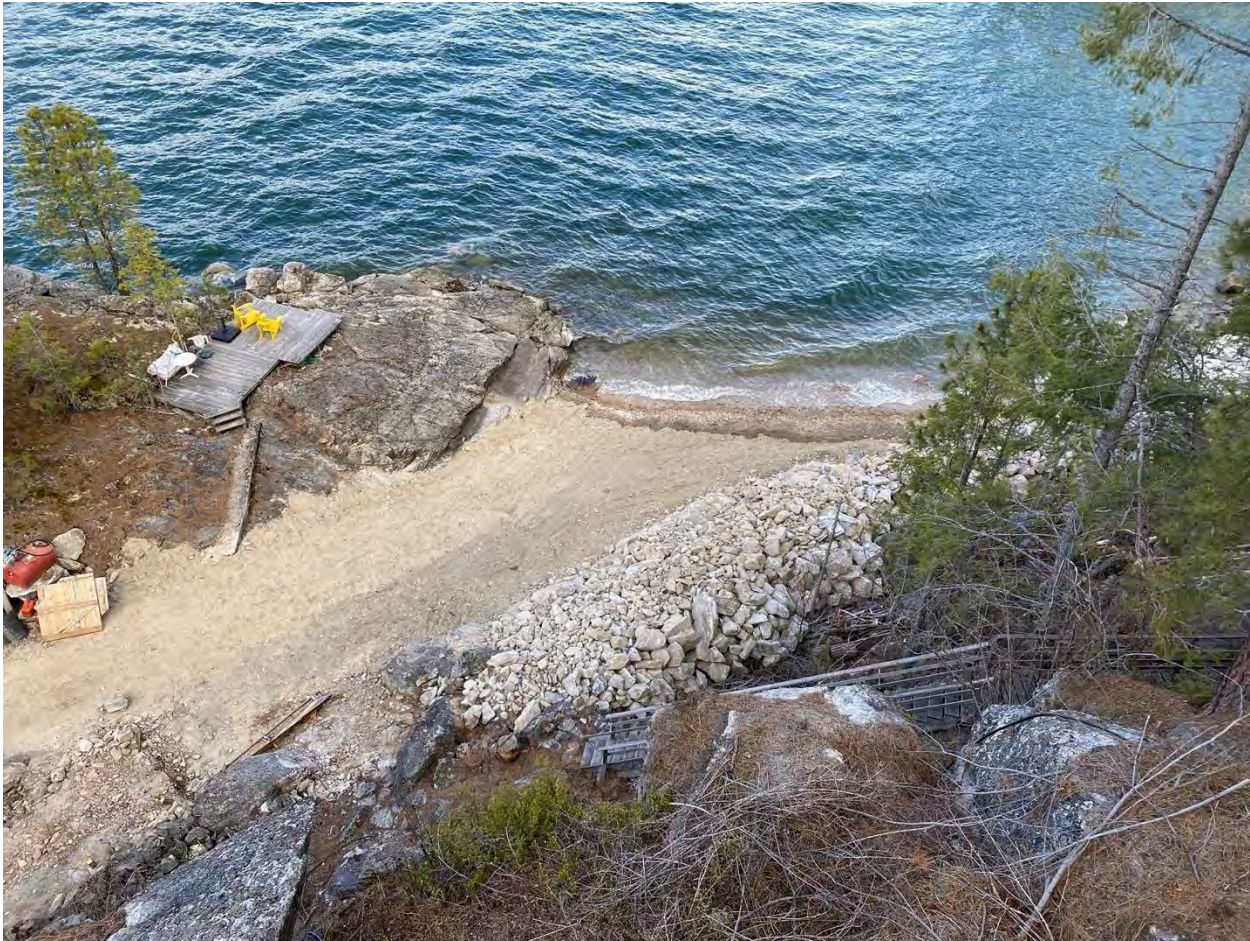
Figure 9. Overhead view of the north channel showing foreshore cleared of boulders and debris.

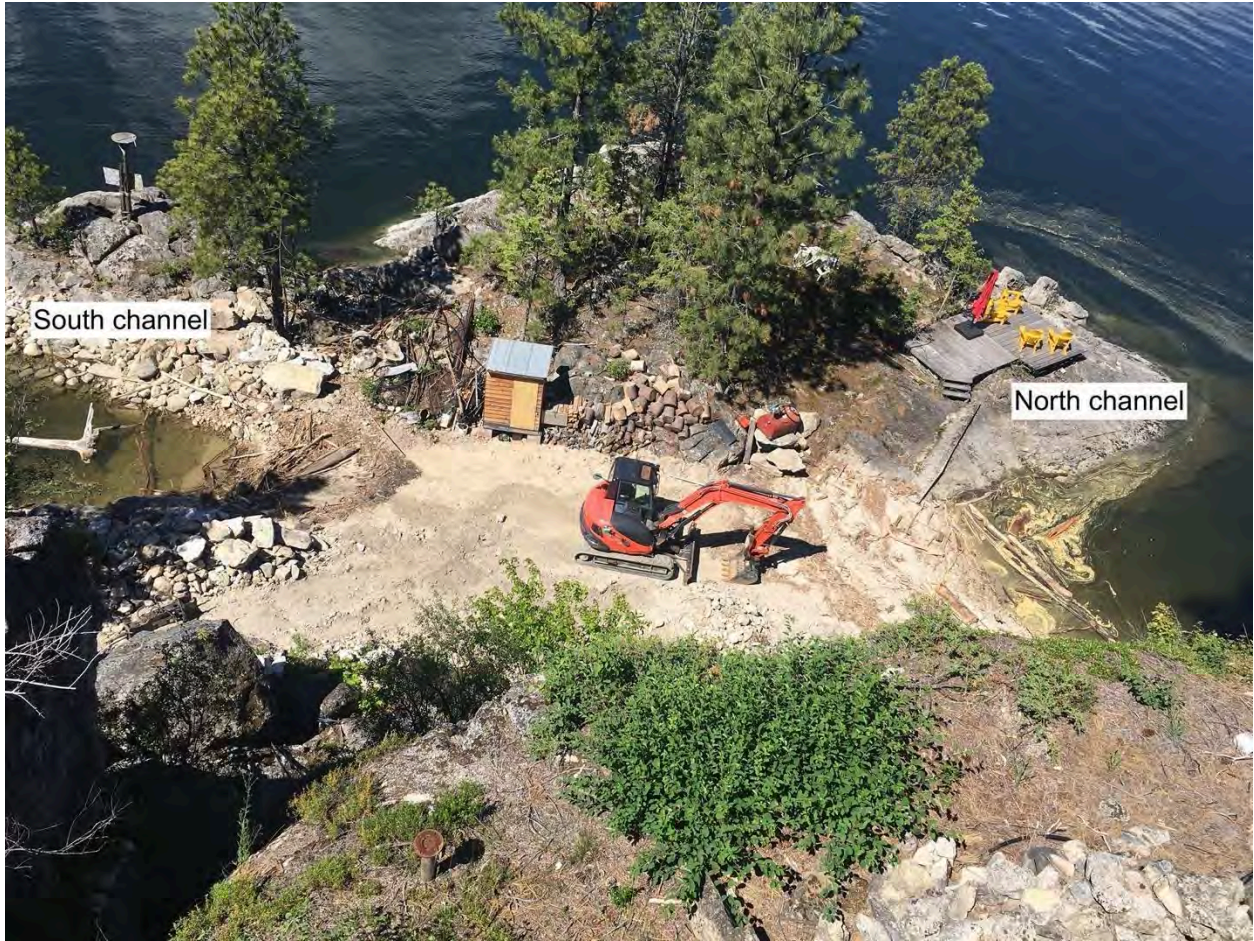
Figure 10. Overhead view of the site following construction activities.
