Development Permit Application

Referral Form – RDCK File DP2406A

10377 Highway 3A, Sanca

Environmental Report

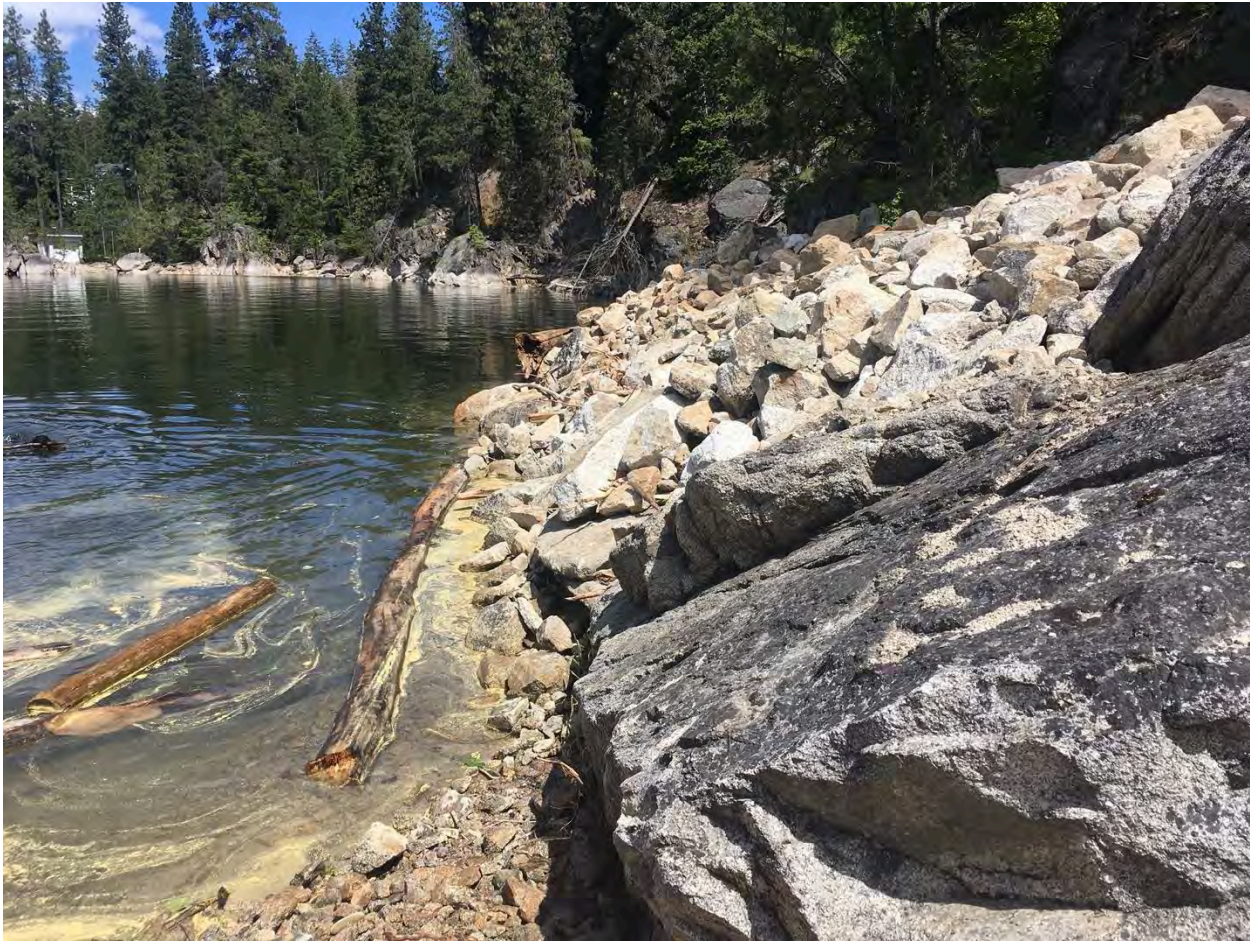
Figure 13. Rock berm along the eastern shore of the north channel.

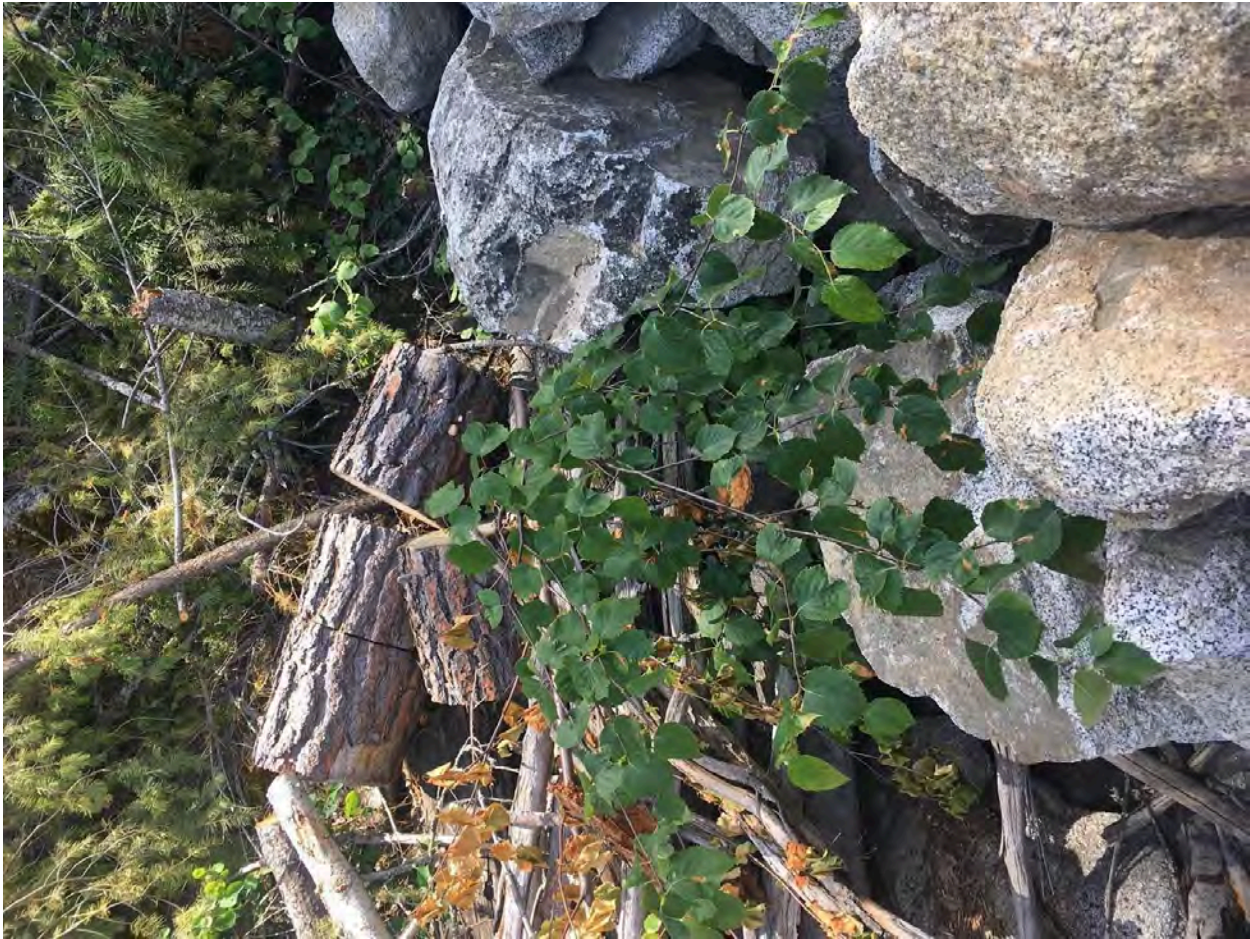
Figure 14. A young paper birch tree unharmed by the rock berm.

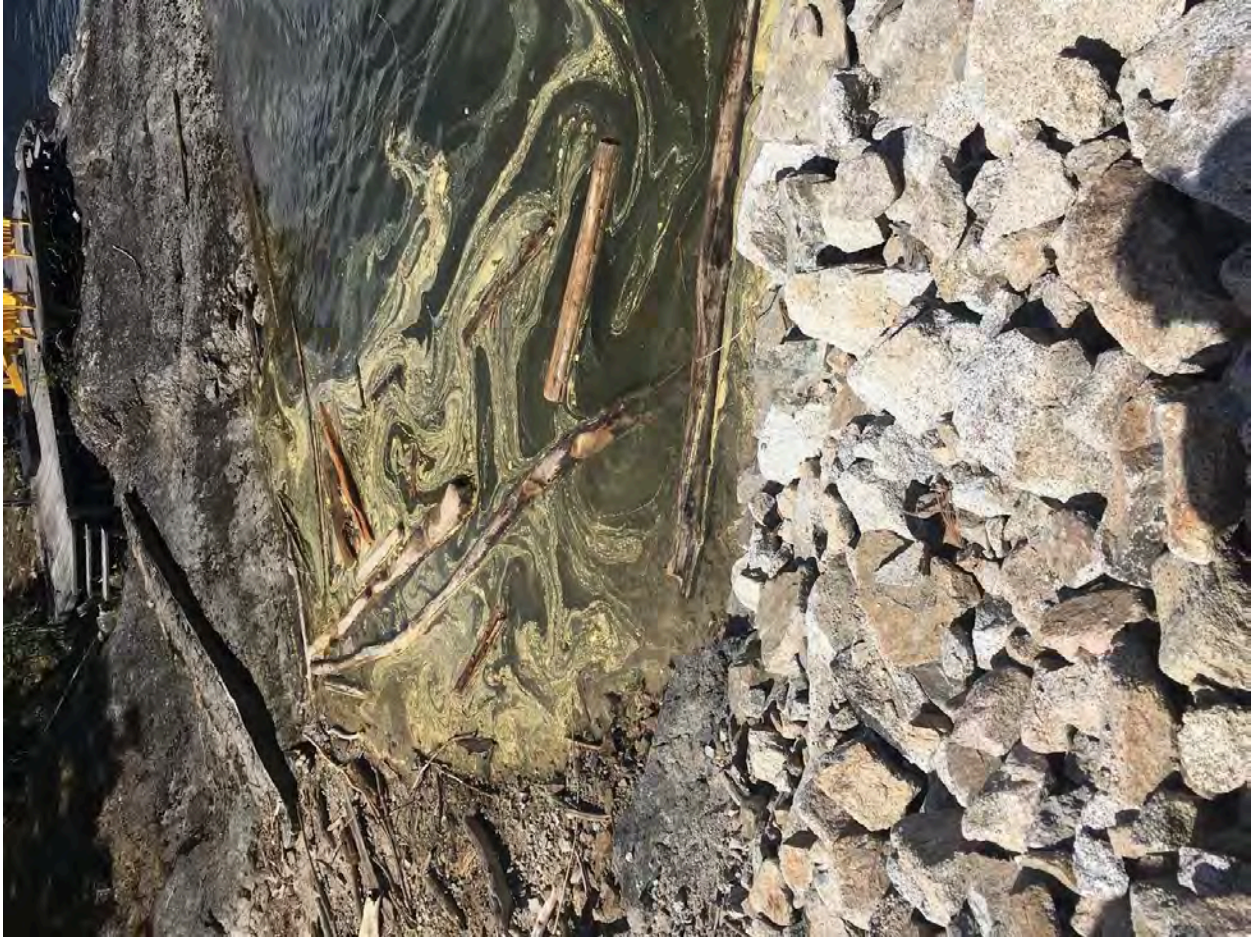
Figure 18. Location of the recommended construction of a machine access slope.

During construction, a path should be created at the southern end of the berm by pulling rock fragments from the top portion down to allow access for the machine to ascend the rock berm (Appendix A: Figure 18). Once stably on top, the machine should safely deconstruct the pile by moving rocks to the eastern side of the berm and stockpiling rocks to be returned to the foreshore. When placing rocks around the birch tree, care must be taken to ensure its continued survival (Appendix A: Figure 14). If the removal of the birch is necessary for safe rock removal, then birch plugs must be planted in replacement (see the Vegetation section below).

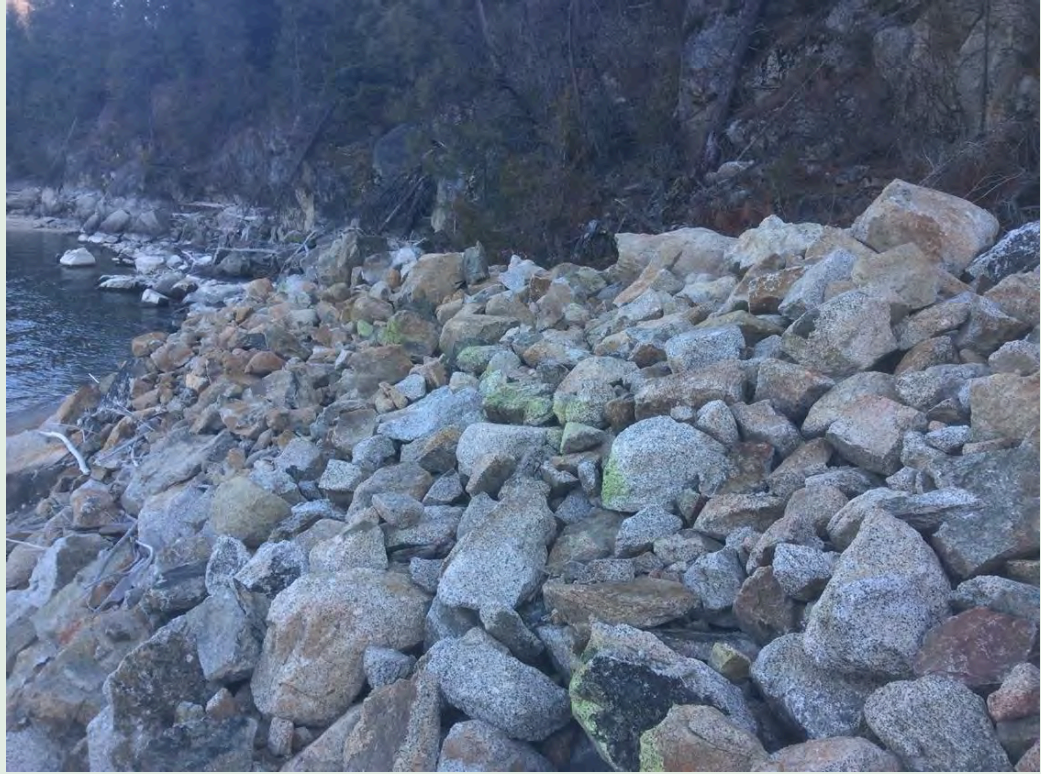
-
Green spray paint
to mark the limit
to construction
work without
disturbing
material above
the natural lake
boundary

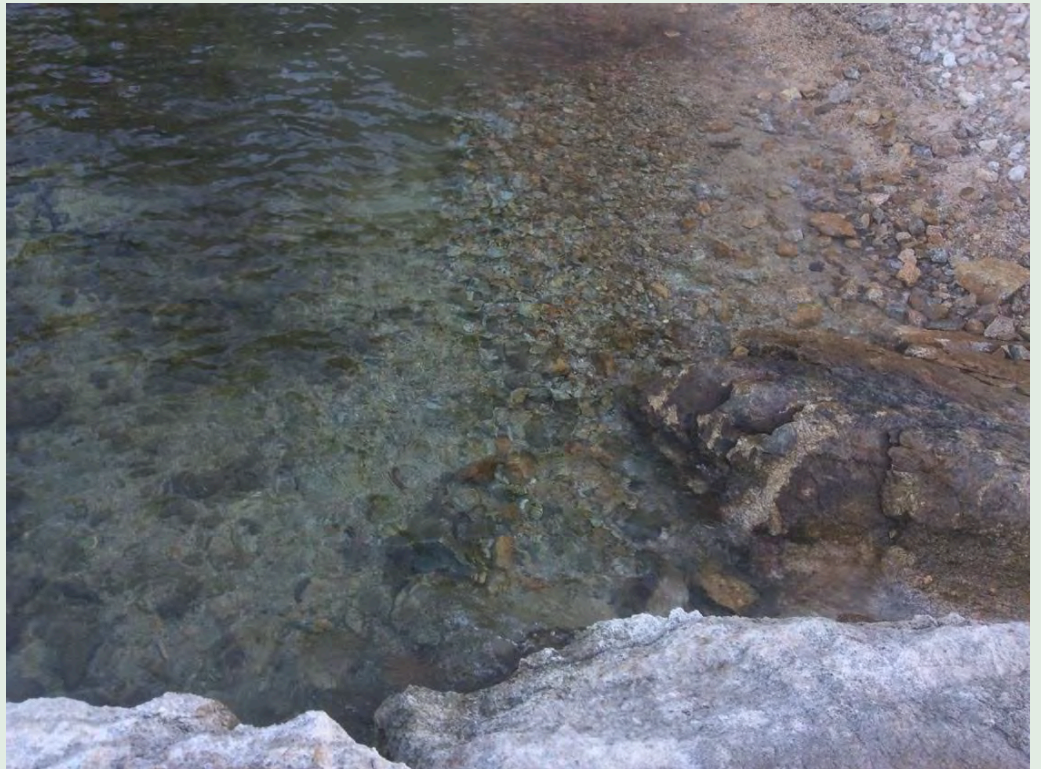
-
Reference of the
NW corner of the
channel before
the placement of
large boulders

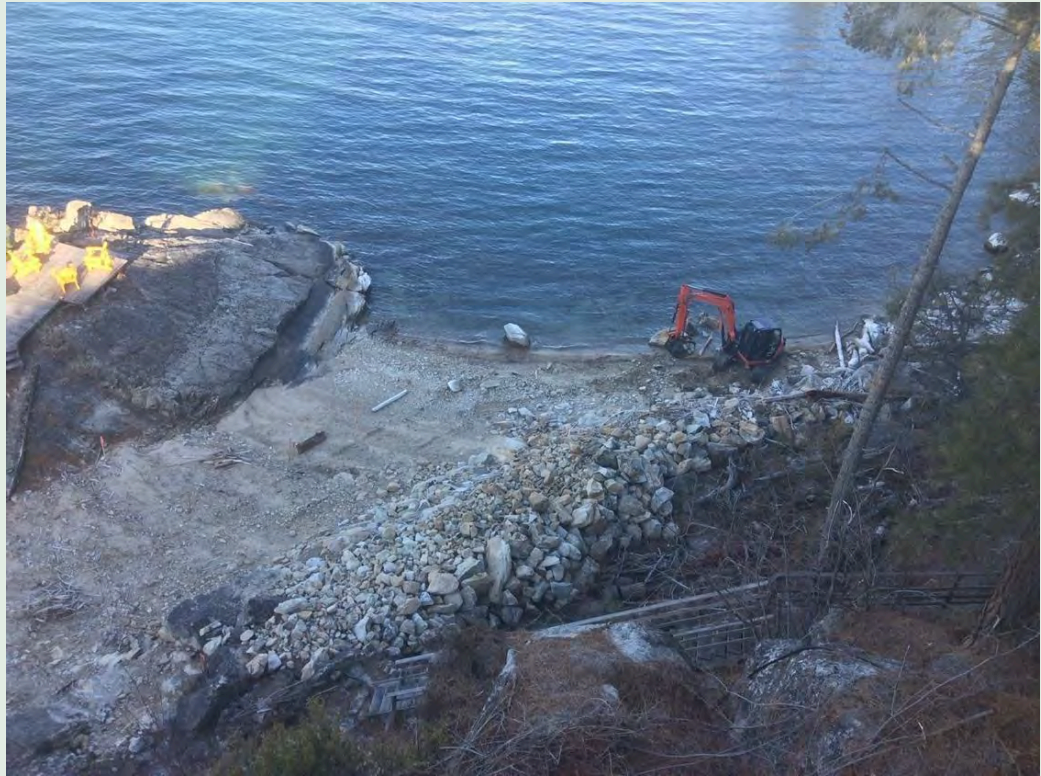
-
Above view of
the channel
during the start
of the
construction

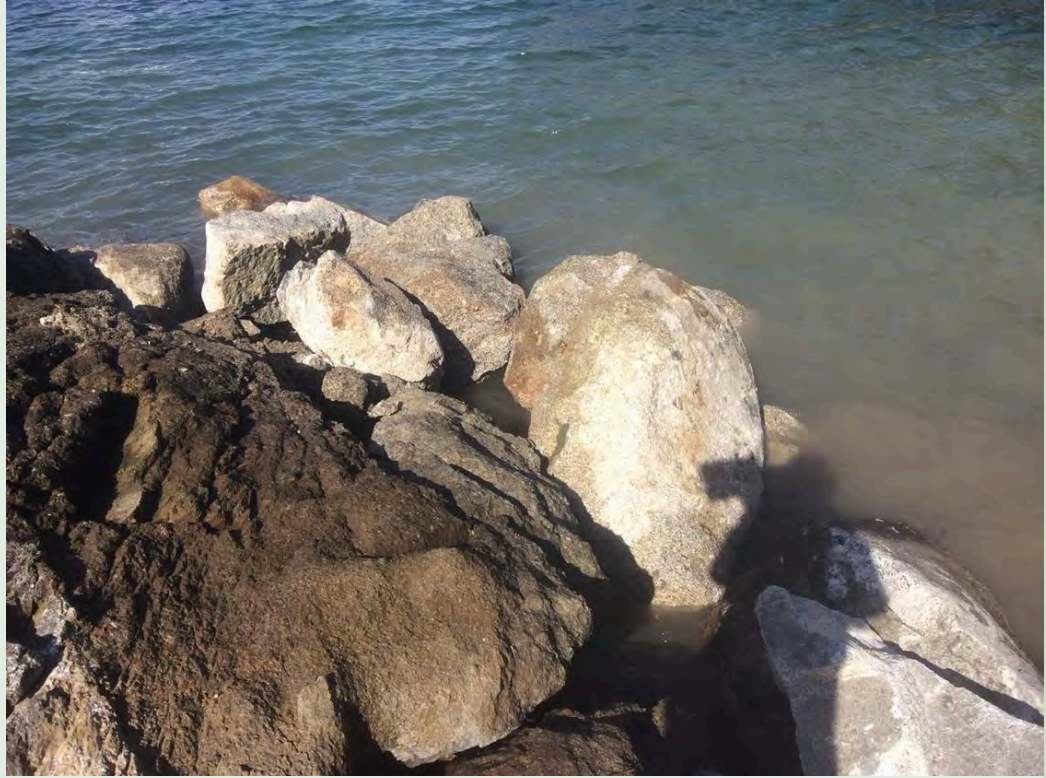
-
NW corner of the
channel with all
large boulders in
place

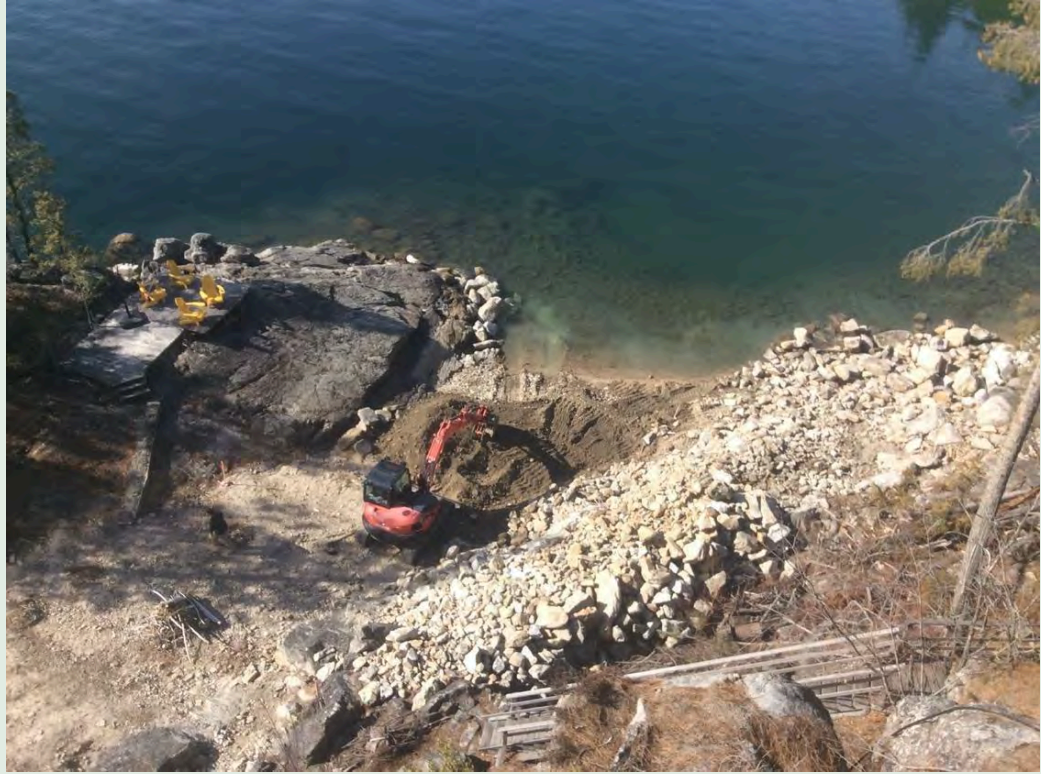
March 16, 2023
14:15

-
Digging of the
east side trench

March 16, 2023 14:00	<ul style="list-style-type: none"> Began “trench” on the east side of the channel and placing material on the west side Placed larger sized boulders in the most NE corner (in the water) to mimic reference shoreline 	<ul style="list-style-type: none"> Approximately 75% of the work complete Held a conversation about digging the sand lower down on the east side of the channel to create more room for the removal of material off the rock berm Plan is to dig approximately 50cm lower, fill with rock layer, replace sand, and add additional rock layer - the approach will create a strong foundation for the future marine railway system, as well as reduce rock material that may need to be pushed east in the final stages
March 16, 2023 16:45	<ul style="list-style-type: none"> Filling in of “trench” with small-large boulders – used the mini-excavator bucket to stabilize placed rocks, reducing the likelihood of shifting during work 	<ul style="list-style-type: none"> 100% of scheduled work complete Discussed the potential need to use some of the removed sand from the east side of the channel to slope towards the west side gradually should there be a difference in height after rock placement Reviewed again with the site supervisor what the result should look like and provided an example of acceptable rock sizes and gaps for fish habitat within the completed channel Discussed the potential to use some of the excavated sand on top of the lowered rock berm to help fill in gaps before topsoil placement and planting Confirmed the location of the temporary sand stockpile is acceptable as long as it stays above water level (must be moved if lake levels rise)

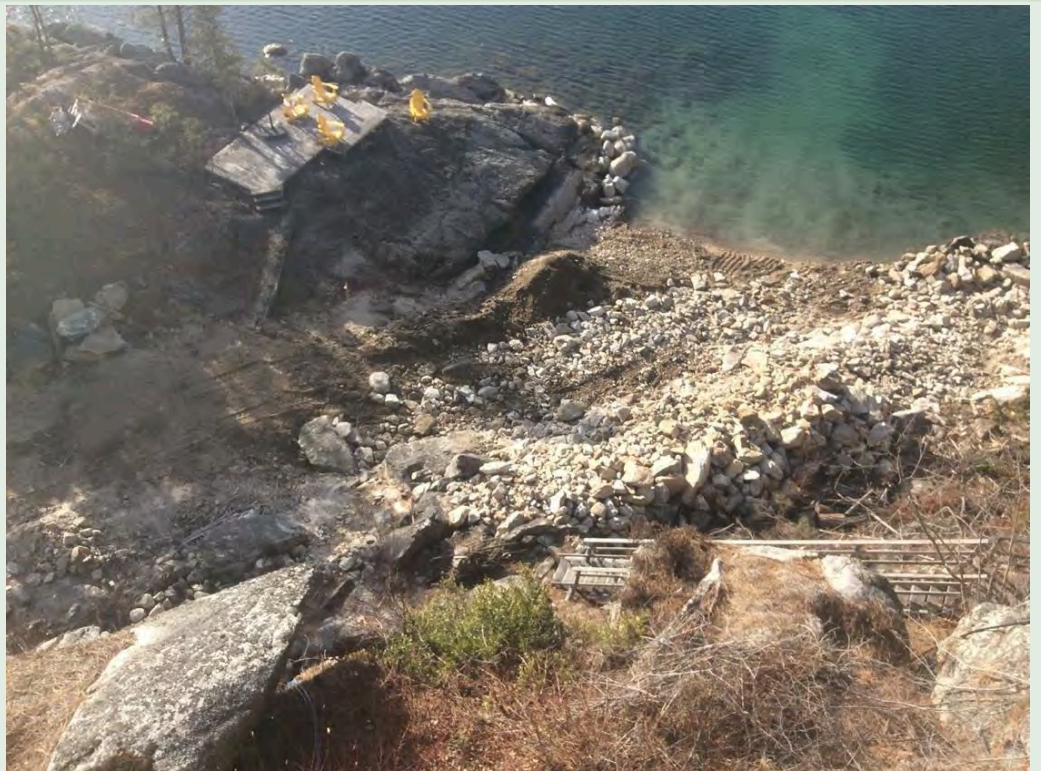
March 16, 2023
16:52

-
The east trench
filled in with
material from the
rock berm (first
layer)

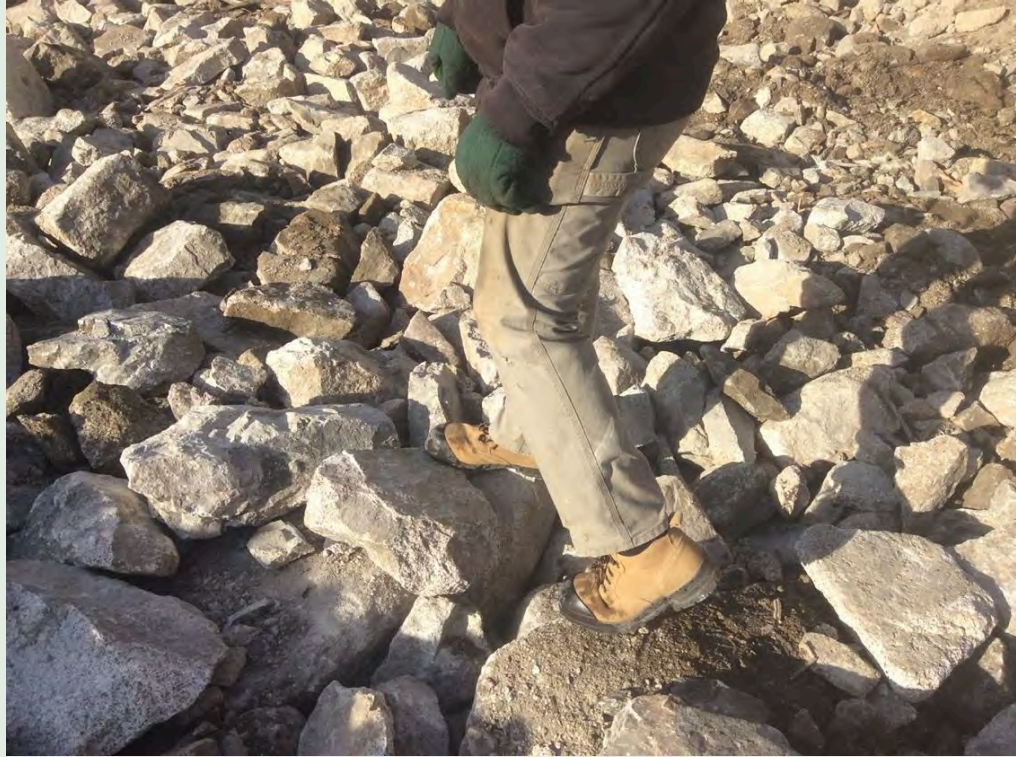
March 16, 2023
16:57

-
Reference photo
for suitable rock
sizes for the
channel

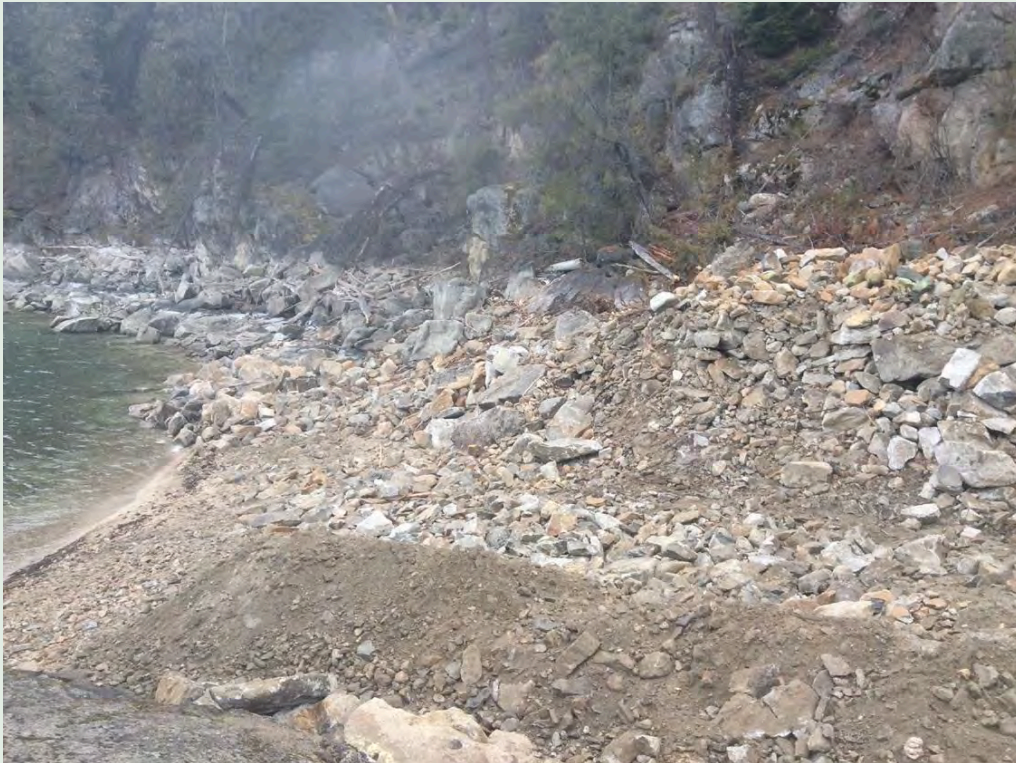
March 25, 2023
09:11

-
The site before
beginning
construction for
the day

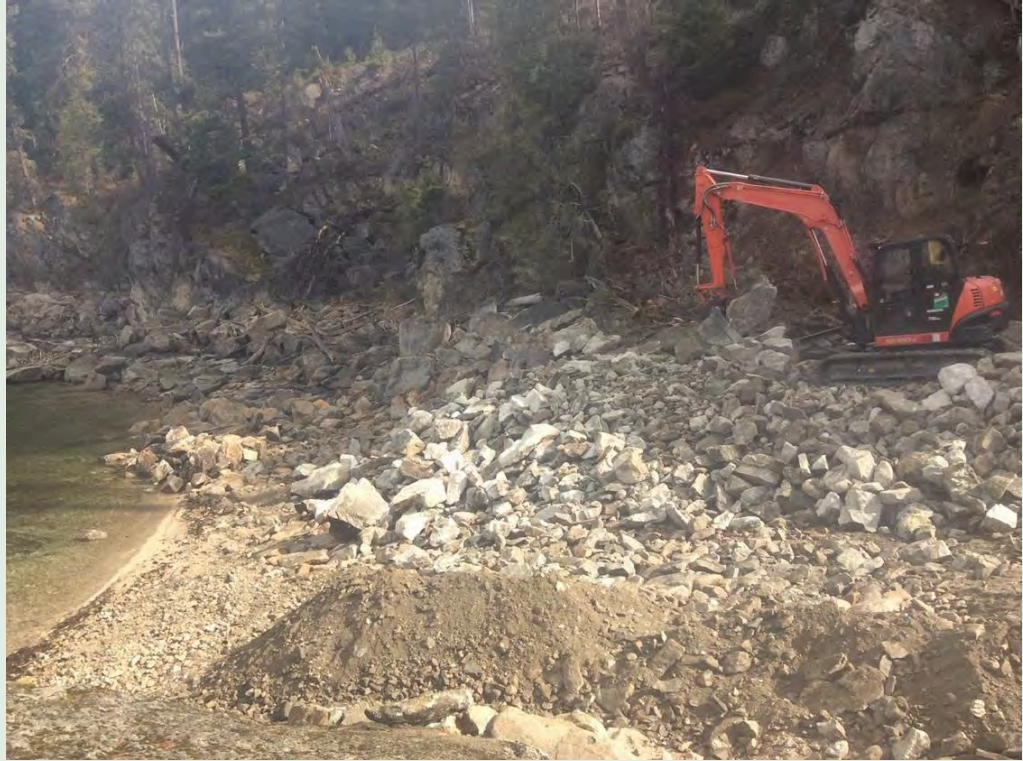
March 25, 2023
10:42

-
The NE corner of the berm area completed with the relocation of several large boulders

March 25, 2023 09:00	<ul style="list-style-type: none"> Arrived on site Discussed plan with machine operator and site supervisor Confirmed that maintenance checks were performed on the machine before commencing work 	<ul style="list-style-type: none"> Discussed the limits of removing rock berm without disturbing areas above the natural lake boundary Approved plan to bury one layer of rocks with sand and covering with another layer of rocks to create a sturdy foundation for the marine rail system without compromising fish habitat

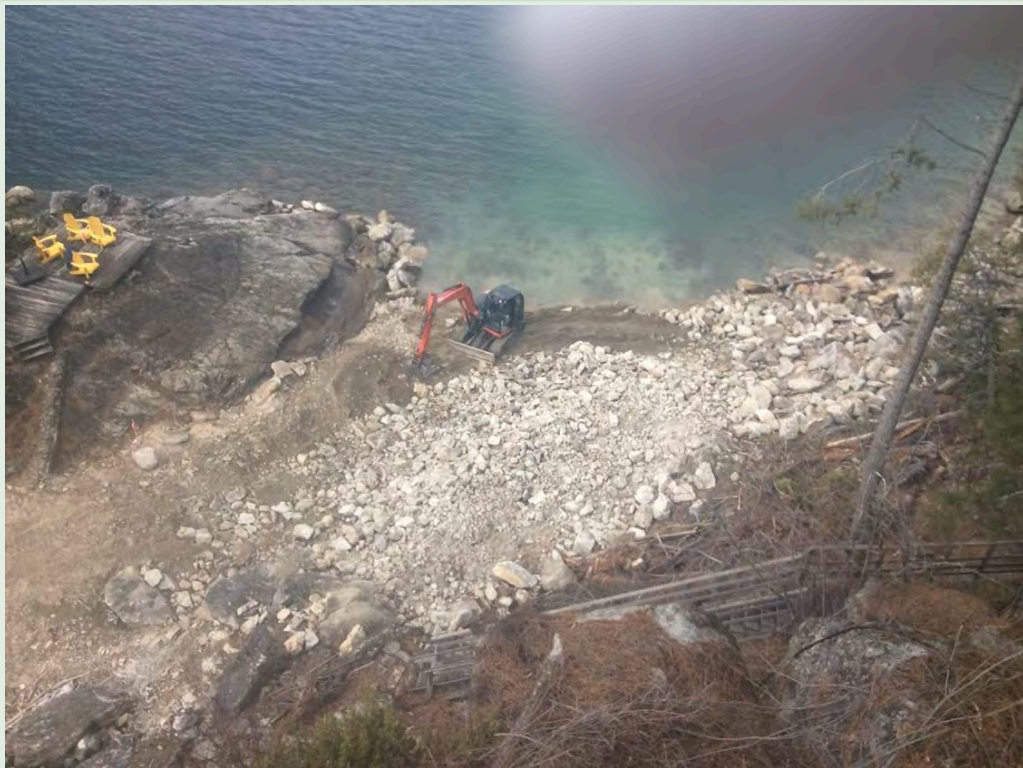
March 25, 2023
12:05

-
Spreading small-medium rocks from the base of the rock berm onto the east side of the channel

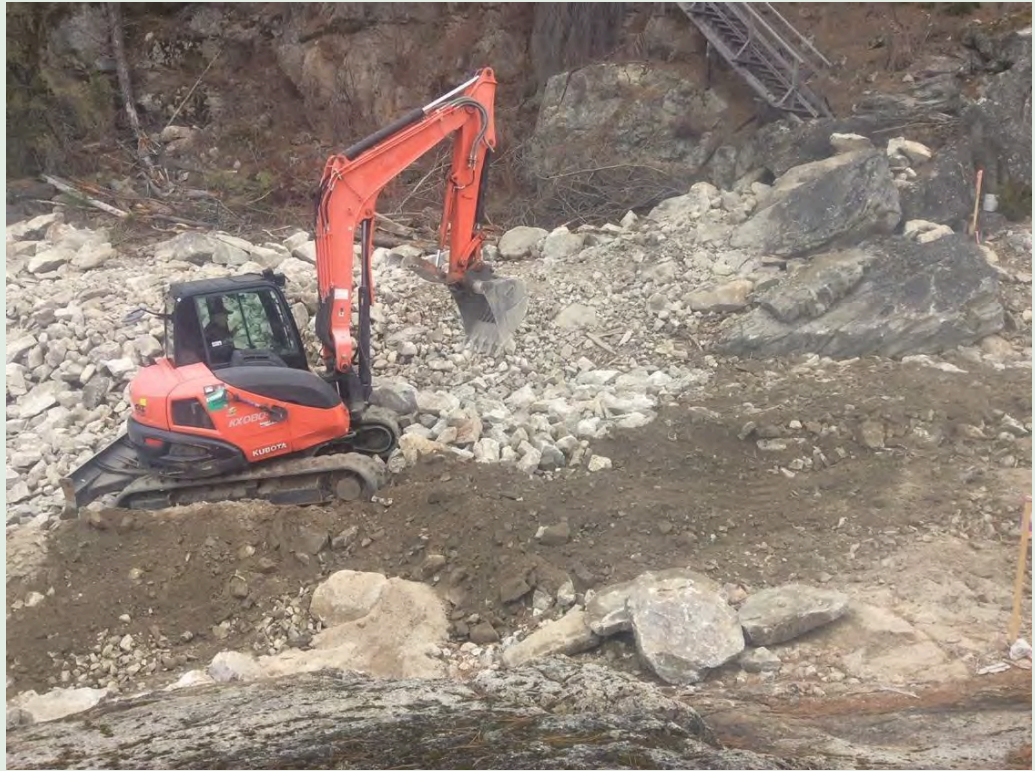
March 25, 2023
13:44

-
Relocating sand
from the
stockpile on the
west side of the
channel to the
east

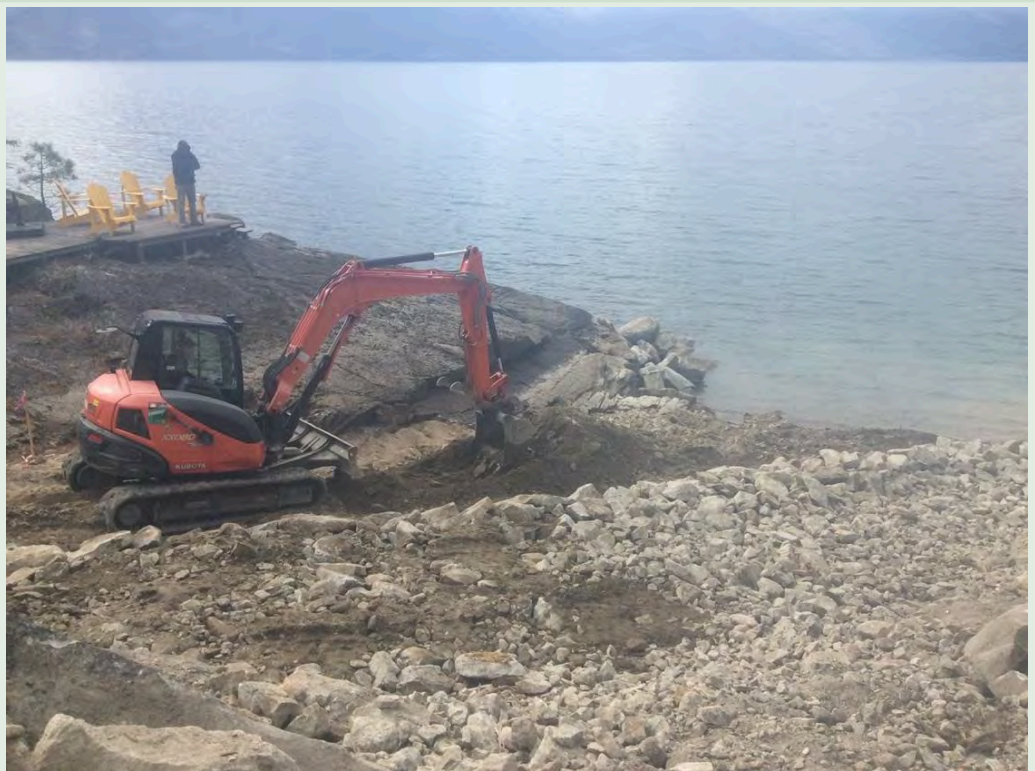
March 25, 2023
15:44

-
Relocating sand
from the
stockpile on the
west side of the
channel to the
east

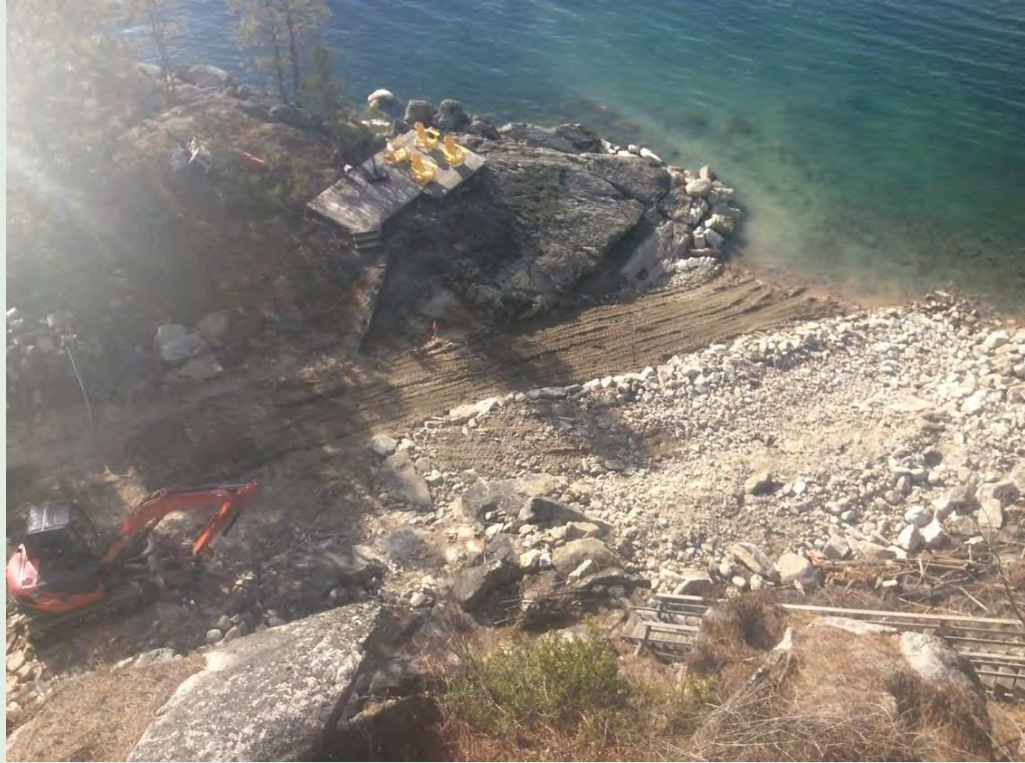
March 25, 2023
16:28

-
The sand stockpile completely removed from the west side of the channel

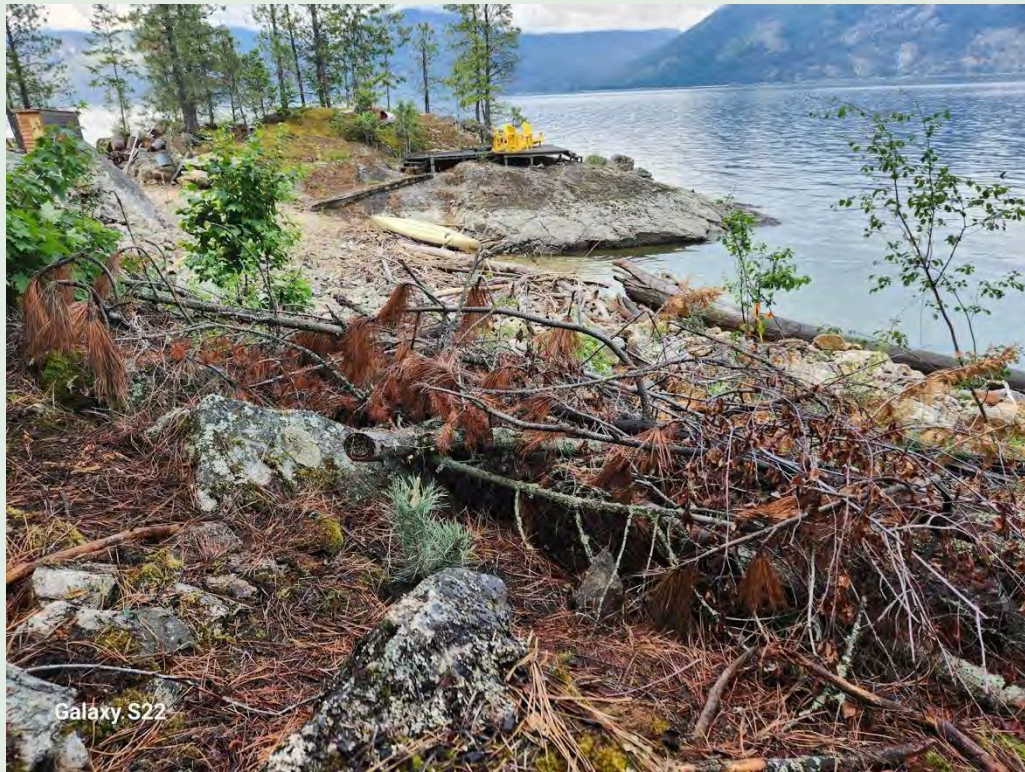
June 14, 2023
11:00

-
Planted tree along the eastern edge of the channel

June 14, 2023 10:30	<ul style="list-style-type: none"> Arrived at site Met with site supervisor to discuss the plan 	<ul style="list-style-type: none"> Discussed the location and method for planting
June 14, 2023 10:45	<ul style="list-style-type: none"> Soil and plants were brought to site Planting began along the south east side of the channel, above the high-water mark 	<ul style="list-style-type: none"> EM noted that the machine operator was not on site, however the rock berm appeared to be leveled appropriately and had adequate fish habitat Planting also extended further east from the rock berm due to lack of suitable planting conditions (large coarse fragments occupying most of the soil and deadfall)
June 14, 2023 12:30	<ul style="list-style-type: none"> Planting was completed 	<ul style="list-style-type: none"> 100% of the work completed

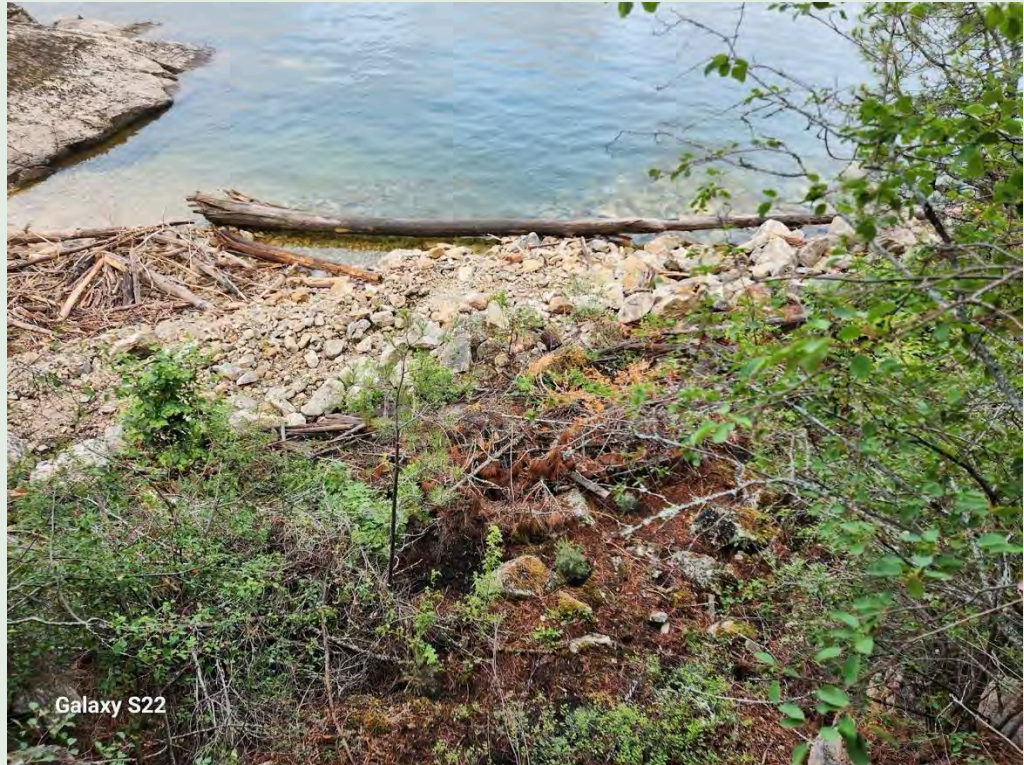
June 14, 2023
11:15

-
Rock berm
(appears to be
appropriately
leveled) with
planting on the
east side and
extending up the
hill

- Reduce the height of the rock berm for sections below the natural lake boundary
- Place 10-15 large boulders along the northwest corner of the channel to recreate fish habitat
- Place small-medium size cobbles and boulders along the east side of the channel to recreate fish habitat and construct a stable foundation for a future marine railway system
- Maintain a 2-3 metre (m) wide boulder-free section along the west channel for access (following photos from the Riparian Area Assessment Report submitted on January 13, 2022)

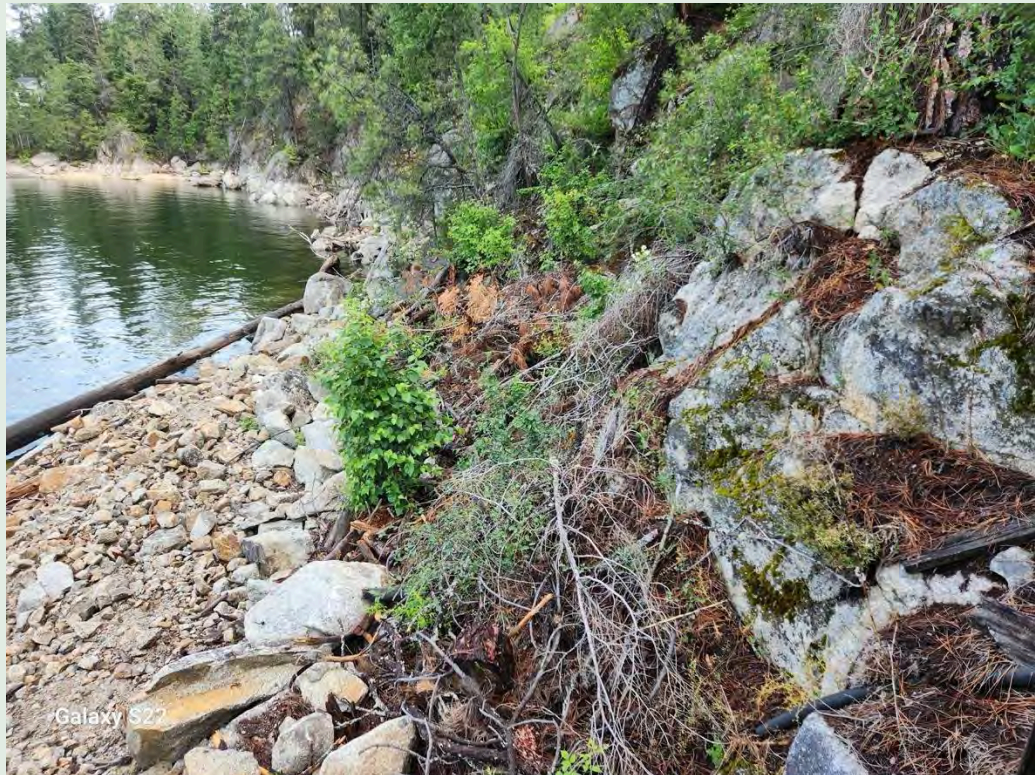
June 14, 2023
11:20

-
Northeastern end
of the channel

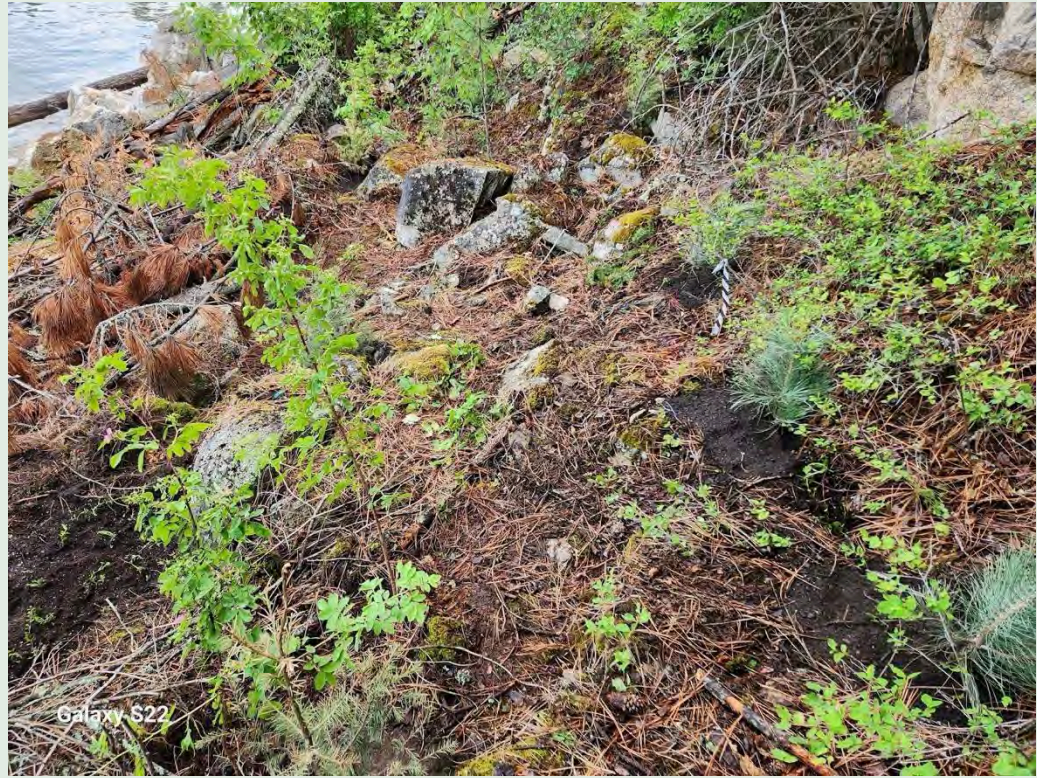
June 14, 2023
12:00

-
Plants on the
northeast side of
the channel,
above the natural
lake boundary

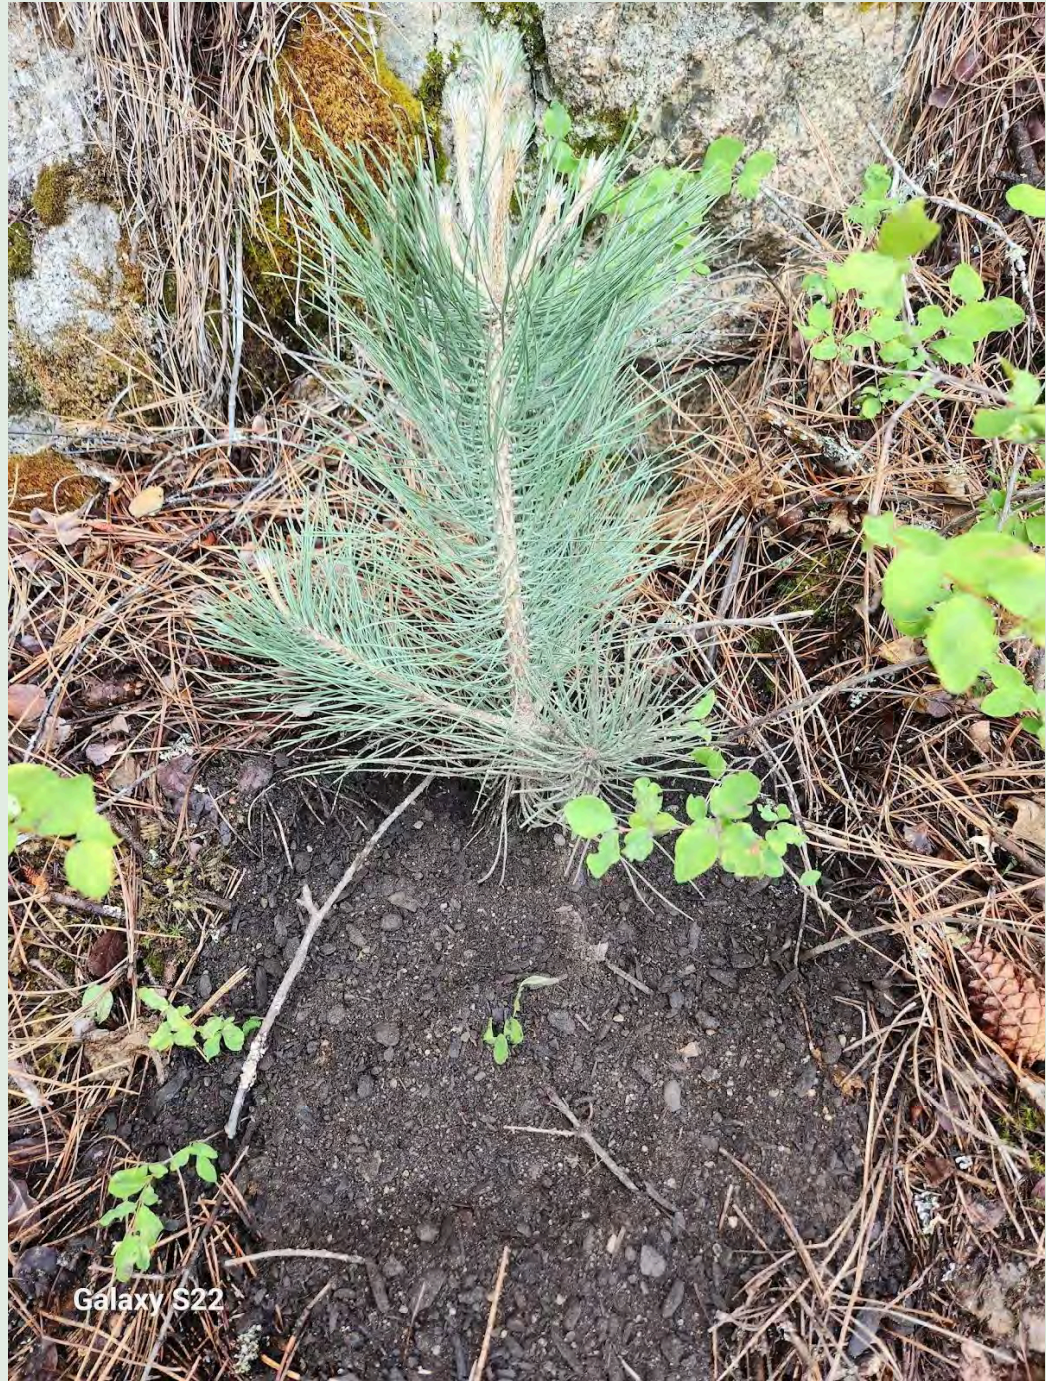
June 14, 2023
12:00

-
Closer view of
planted
ponderosa pine

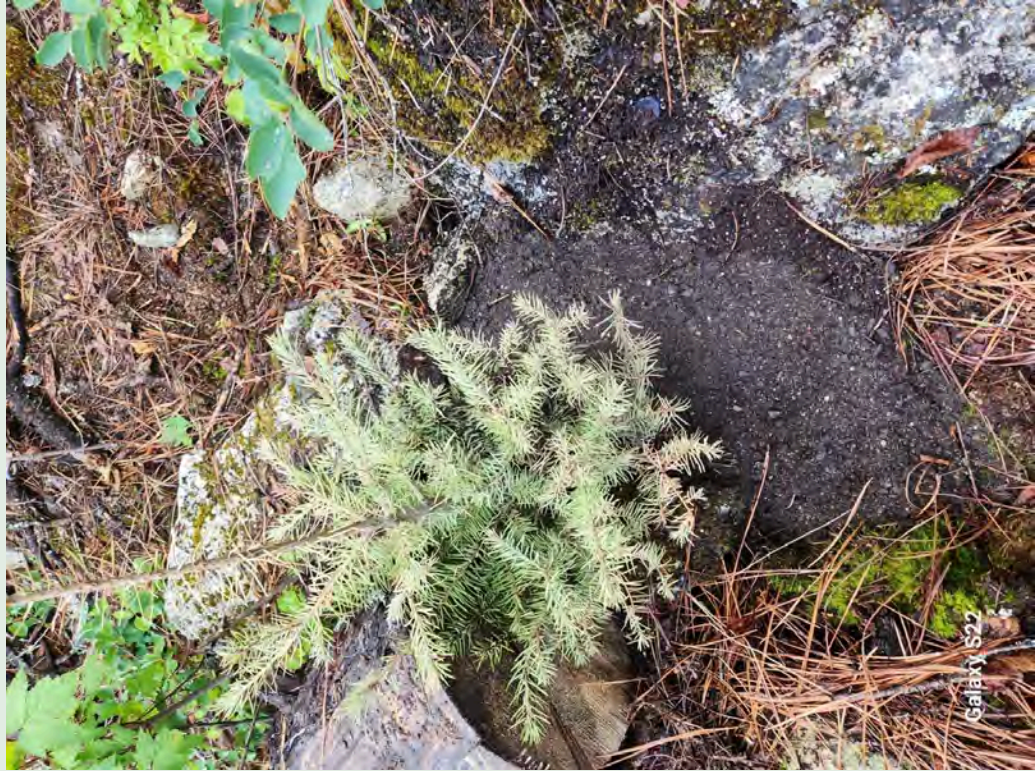
June 14, 2023
12:00

-
Planted
Douglas-fir tree
with a long, thin
leader

While planting the vegetation, the EM noticed that the Douglas-fir appeared to be in less than average health condition. After reaching out to the supplying nursery (Bron & Sons Nursery), KES was notified that the Douglas-fir stock suffered a cold shock the previous fall and many were showing delayed symptoms. Accordingly, the Douglas-fir will be monitored for the remainder of the year and replanted as necessary in the spring of 2024.

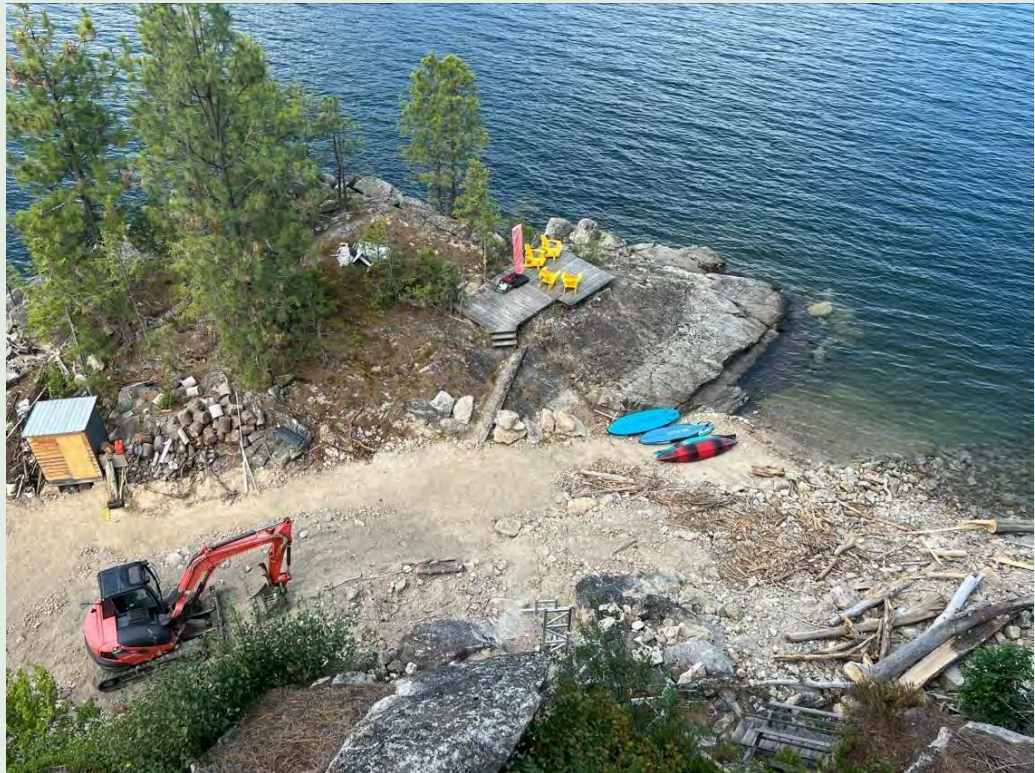
July 10, 2023

-
Overhead view of
the completed
remediation
works (provided
by Bevan May)
