Development Permit Report

Date of Report: April 25, 2018
Author: Kristin Aasen, Planner
Subject: DEVELOPMENT PERMIT (JULIEN - 4724 TWIN BAY ROAD)
File: 09\4260\20\2018\DP1801D-01231.010-JULIEN-DP000082
To: GENERAL MANAGER OF DEVELOPMENT SERVICES
X-reference: BP024322

**4724 TWIN BAYS ROAD
KASLO, BC
Riparian Assessment**

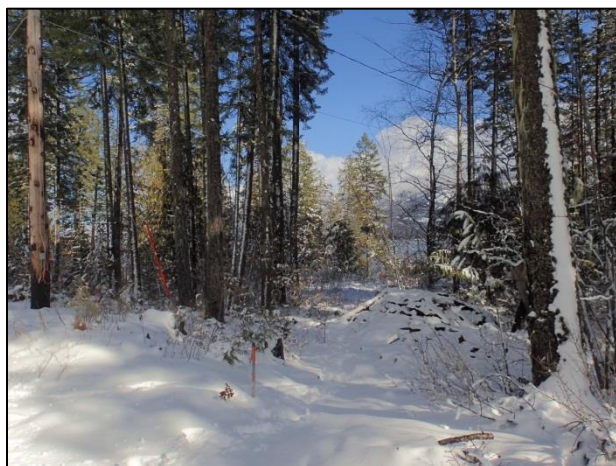
Photo 1. Entrance to property from Twin Bays Road and small stand of mature Douglas fir to the left.

The property has been largely cleared of timber approximately 10-13 years ago, and the proposed building site has been landscaped with a low retaining wall and site levelling. The dominant vegetation is a regenerating stand of mixed conifer and deciduous saplings, native shrubs and some invasive weeds. The riparian area east of the proposed site has also been cleared for an additional 5-10 m from the proposed building footprint up to the point where the slope begins to drop sharply to Kootenay Lake. A buffer patch of approximately 15 mature (~120 year-old) Douglas-fir (*Pseudotsuga menziesii*) trees has been retained on the western side of the property adjacent to Twin Bays Road (Photo 1). This small stand of trees provides privacy for the proposed building site by visually blocking Twin Bays Road. The site is accessed via a rough trail to Twin Bays Road, just north of the patch of Douglas-fir (Photo 1). A 5.5 x 7.6 m septic field has been dug in the northwest corner of the property, and a 2700 L septic tank has been installed just northwest of the proposed building footprint (Photo 2; Appendix 3).

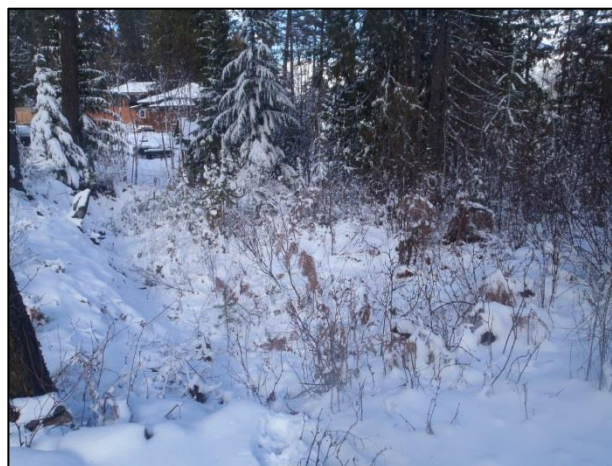
Photo 2. Septic field.

Sewage disposal for the proposed home will be serviced by an existing septic disposal field located on the northwest corner of the property (Appendix 3). The proposed new home will be tied into a community water supply by a line running along the driveway west to Twin Bays Road. Likewise, electrical service will be tied into existing infrastructure via a line running west along the driveway to a power pole on the southwest corner of the property.

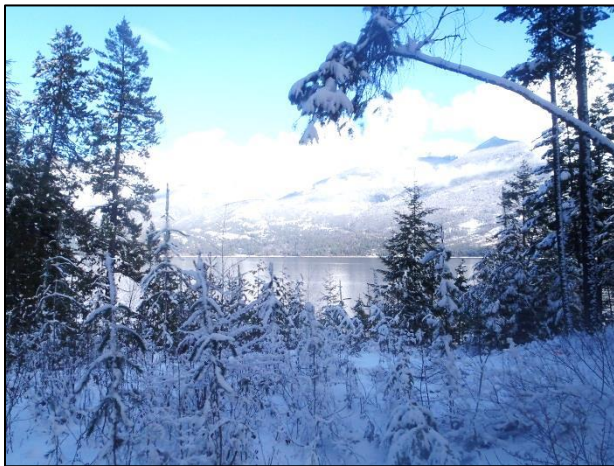
Photo 3. Proposed building site.

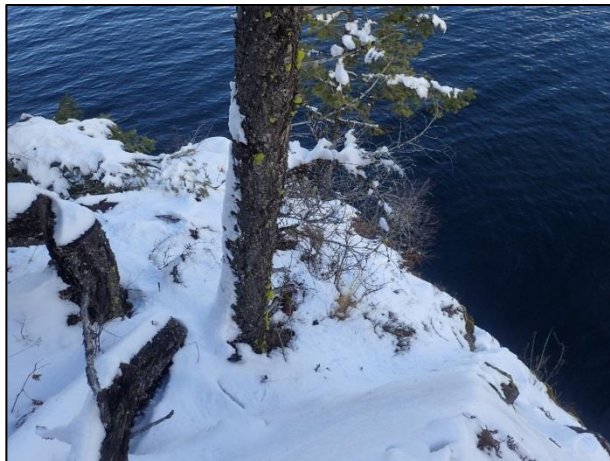
Photo 6. Shoreline habitat and riparian vegetation.

The foreshore consists of exposed bedrock cliffs, with some overlying boulders (Photo 5 and Photo 6). The rocky shoreline provides potential rearing and cover habitat for juvenile and adult fish. No aquatic vegetation was observed within the shoreline along this property.

The riparian area on the property has an eastern aspect and consists of ~20 m high cliffs, and steep rocky grades above with slopes between 60-70% (Photo 5 and Photo 6). Tree cover is low, though a few mature Douglas-fir remain. Soils are thin, and the development of shrub and herbaceous cover is minimal. Lichens and mosses cover the rocky outcrops throughout the riparian zone. The western margin of the riparian area has been cleared of timber and vegetation is currently dominated by regenerating mixed conifers and black cottonwood (*Populus trichocarpa*; photo 2). Observations of invasive weed species include hawkweed (*Hieracium* sp.) and knapweed (*Centaurea* sp.), though winter conditions precluded a complete assessment of all herbaceous species.
