Funding Water Infrastructure for the Long Term

Regional District of Central Kootenay

Riondel

October 1, 2018

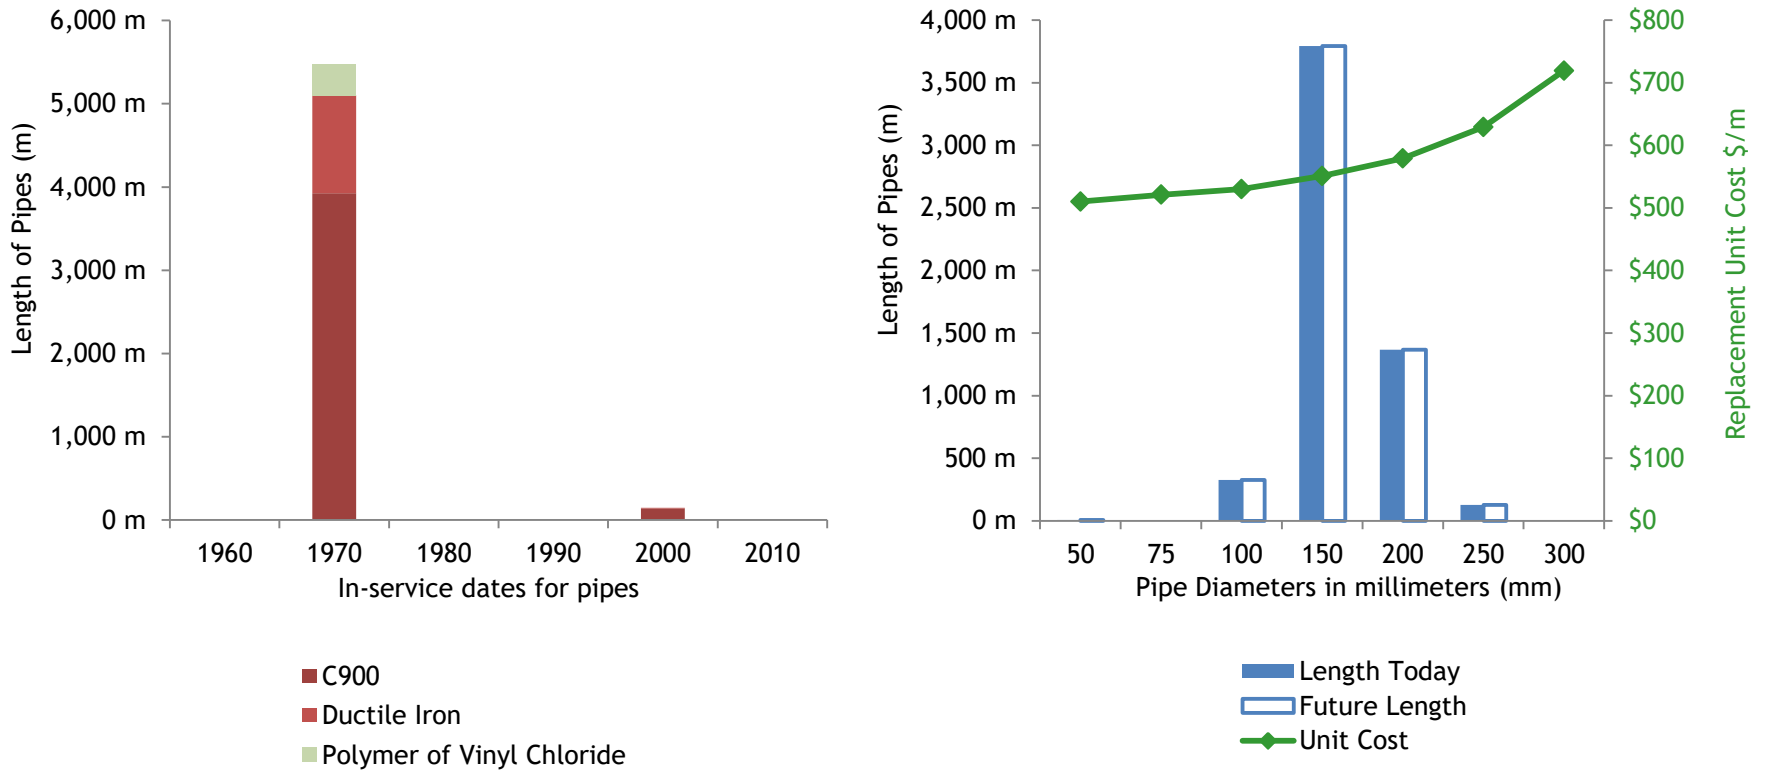
Figure 2: Riondel Pipe Distribution Network (Length, Material, Diameter)

Approximately 5.6 Kms of pipes was installed in Riondel since the 1970s.

Note: due to minimal availability of records, some in-service dates may be estimated by decade from old maps.

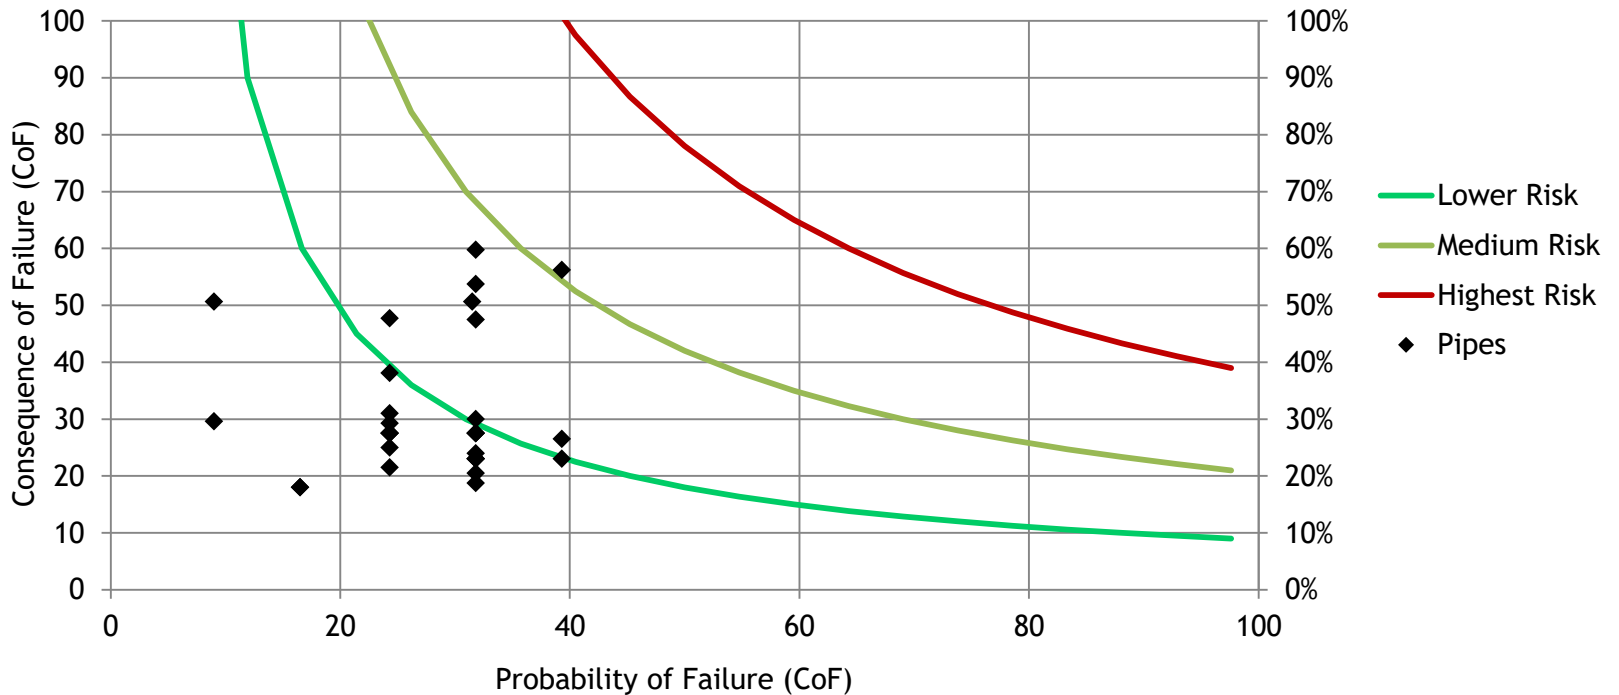
Figure 3: Consequence and Probability of Failure for Distribution Network

Each length of pipe was plotted on this risk matrix based on its probability and consequence of failure. These were determined by applying a risk and criticality scoring method based on specific data for each pipe including: critical land use affected, water pressure, available fire flows, stream proximity, break history, install quality, install depth and number of connections. Explanation for the application of this method is beyond the scope of this report.

The results shown below in Figure 3 provide a way for RDCK management to alter the expected replacement dates and prioritize work based on highest risk/ highest needs.

Depending on its position on the risk matrix in figure 3, each pipe’s estimated service life will be modified. Low risk pipes (those with a low probability and/or low consequence of failure) will have their service life extended. High risk pipes will have their service life decreased and therefore become a higher priority. Figure 4 below summarizes the application of this service life modifier to the total length of pipes in the system.

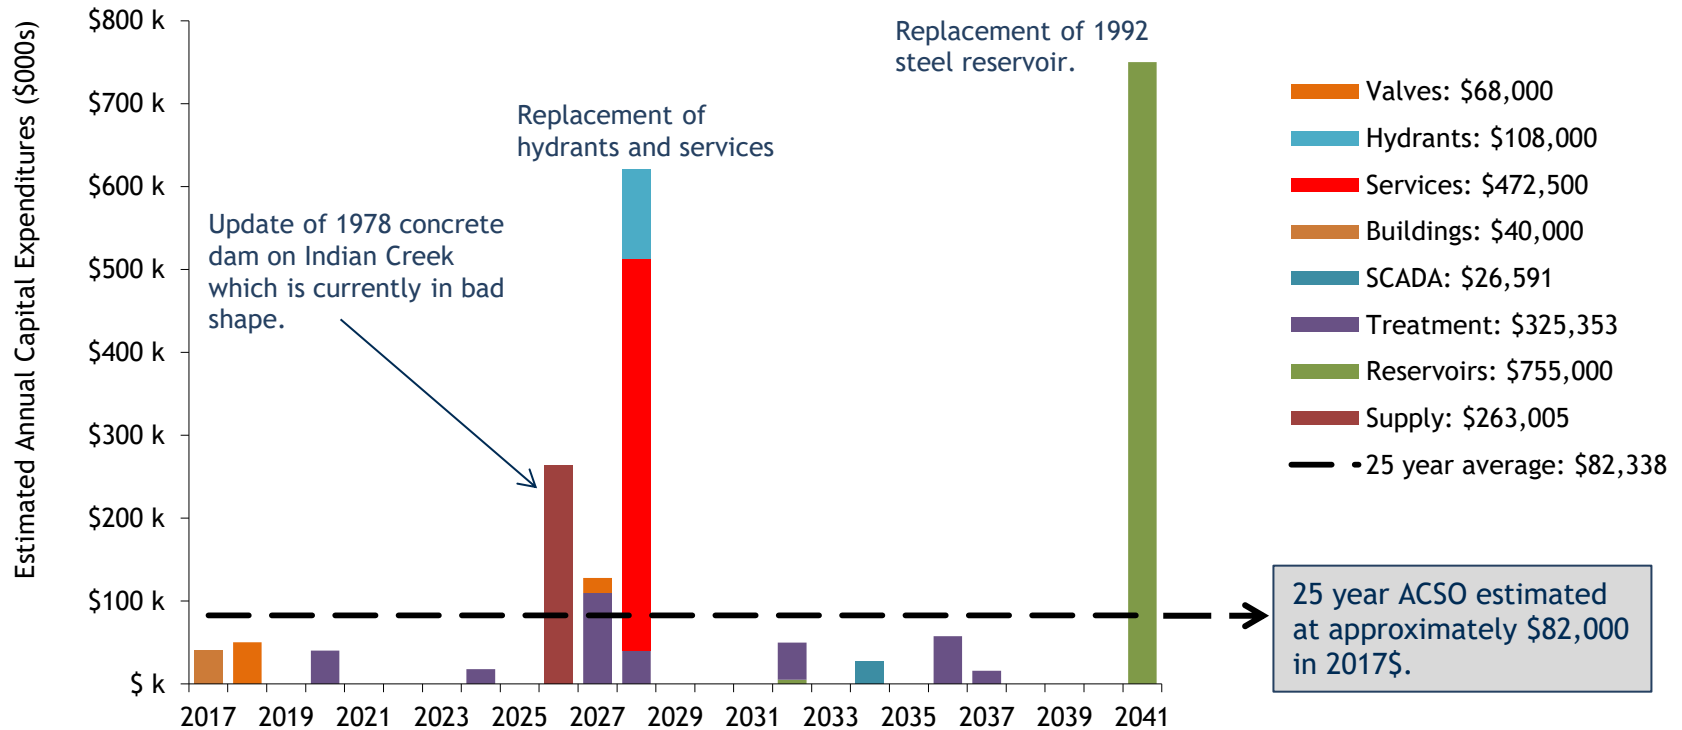
Figure 5: Riondel 25 Year Asset Replacement Schedule

This chart summarizes the Asset Replacement Schedule (ARS) 25 year period projection of asset replacement. The average cost over the 25 year period, also termed the Annual Cost of Sustainable Ownership (ACSO) is shown by the dash line.

Figures are in 2017\$ and not adjusted for inflation.

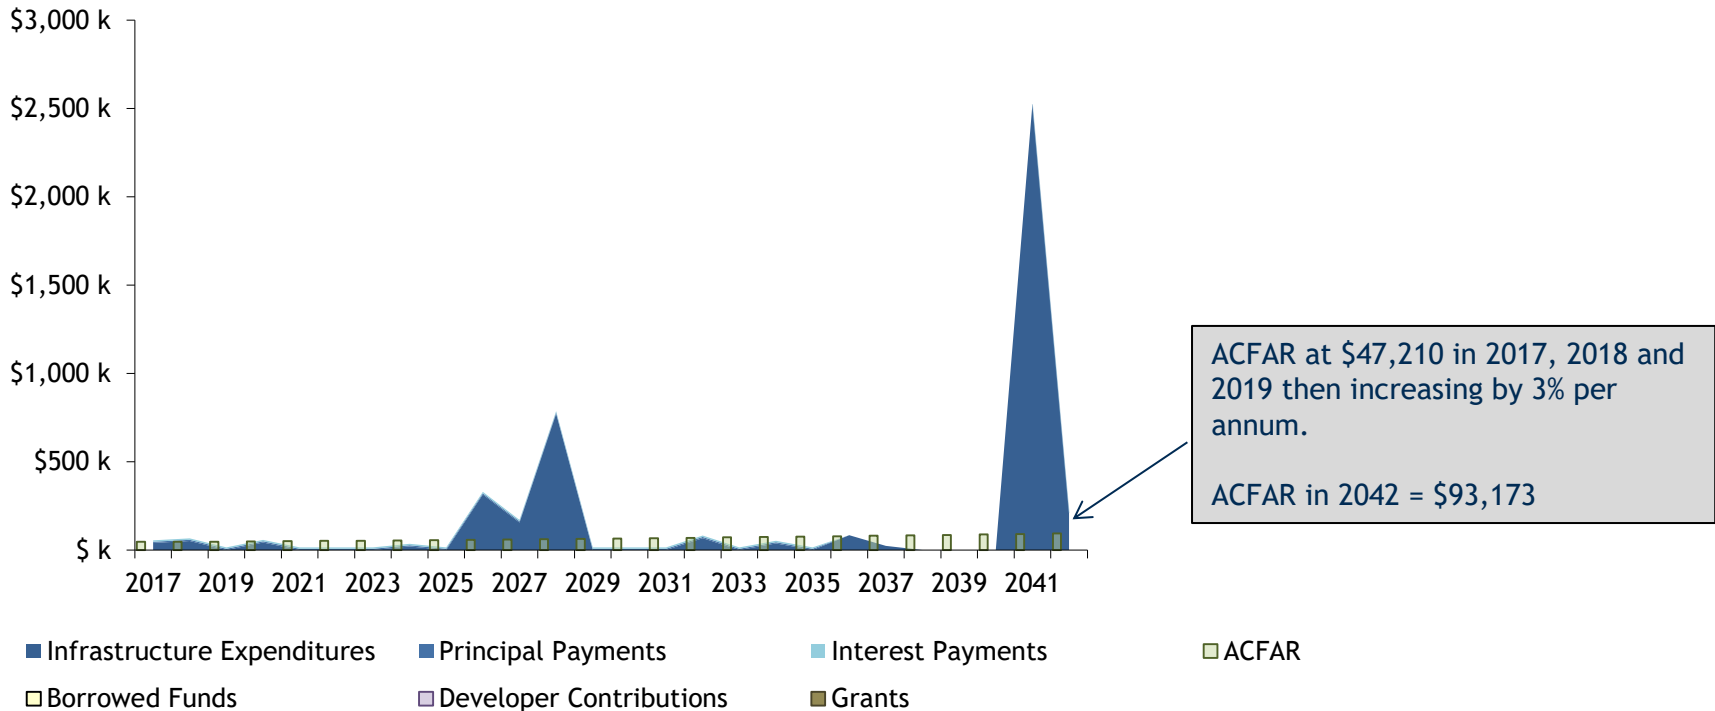
Figure 7: Riondel 25 Year Expenditures and Funding

RDCK policy is to cover ACFAR through parcel taxes. For modeling purposes this scenario assumes that grant funding available today will also be available in the future, however this is not guaranteed.

This chart compares the expenditures and allocated funds from figure 7. The blue line shows the cumulative expenditures, inflation adjusted, projected over the next 25 years in the asset schedule. The green line shows the cumulative funds allocated towards these projects.

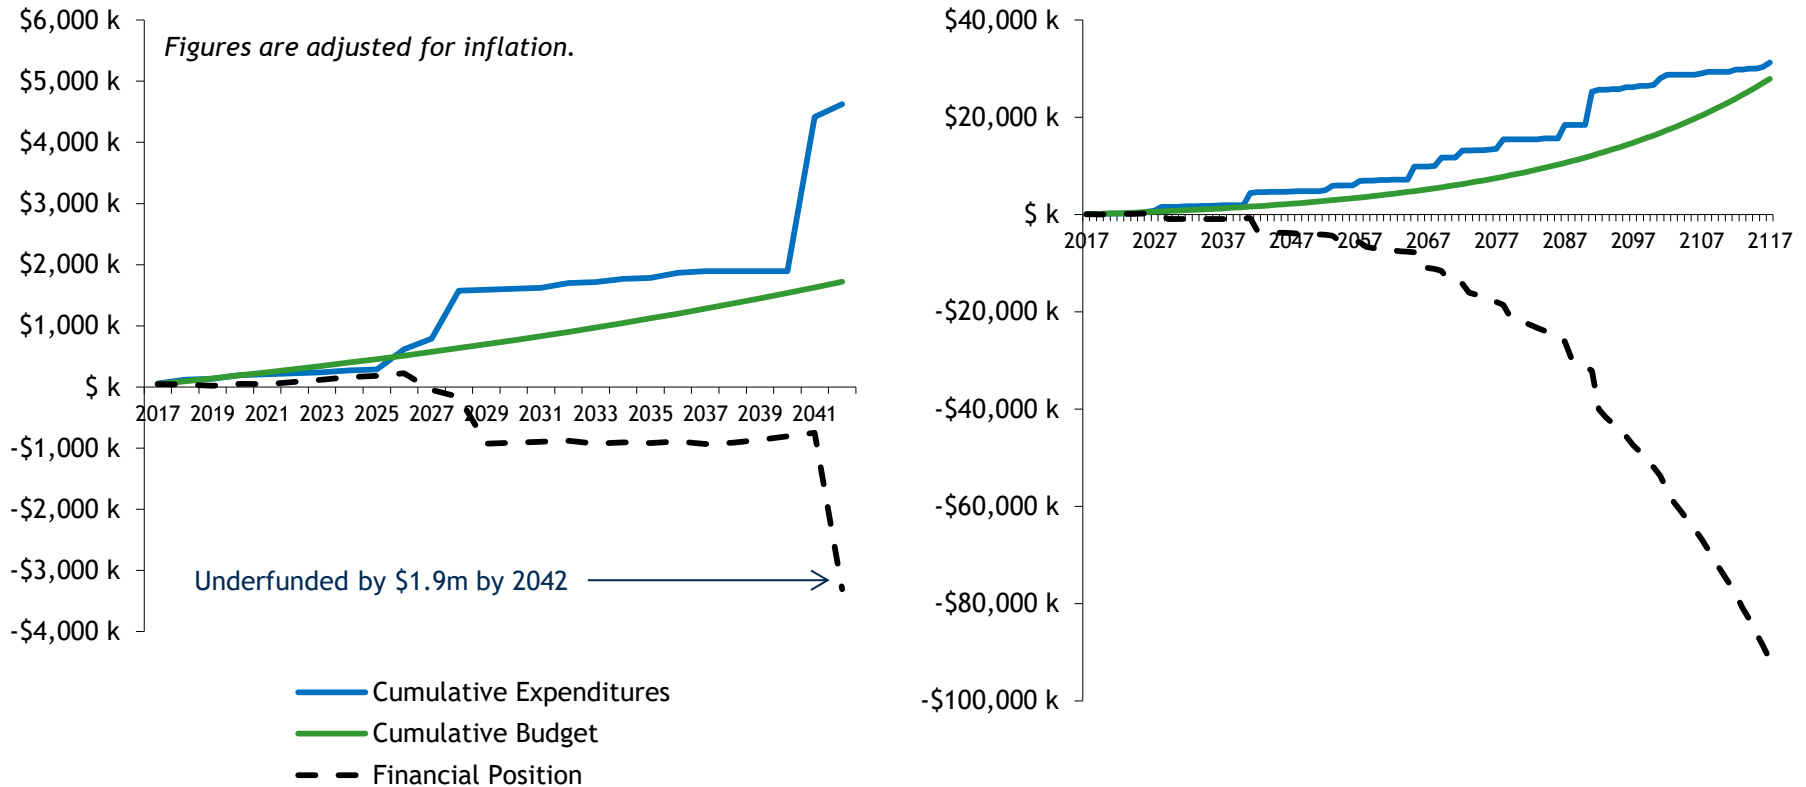
Figure 8: Riondel 25 Year and 100 Year Financial Position

The dash line is the difference between what is projected to be spent and available funds. When this line is above 0, it represents a surplus of funds typically held in an asset reserve fund; when below zero, the dash line represents a shortfall and implies the need for additional funding, or the works need to be delayed or canceled.

3. Make necessary adjustments to rates and fees to bolster the annual contribution for asset replacement (ACFAR) with an aim to have ACFAR meet ACSO and to build up a reserve fund in advance of large future expenditures. The financial position on page 20 can be a guide in determining reserve fund target level; and,
