REGIONAL DISTRICT OF CENTRAL KOOTENAY

RIONDEL WATER AND DRAINAGE SERVICES COMMUNITY ADVISORY COMMITTEE DISCUSSION NOTES

Reference: Condition Assessment for Existing Drainage Infrastructure at Riondel, BC- Rev B

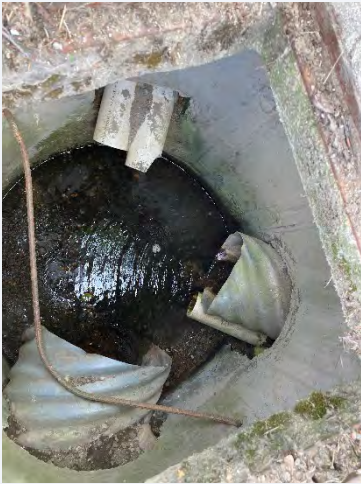
Three Unknown (Private) Connections

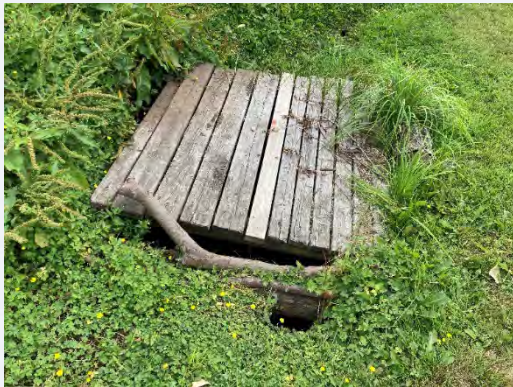
Wood Decking Catch Basin Cover
Safety Concern for Traffic and Pedestrians

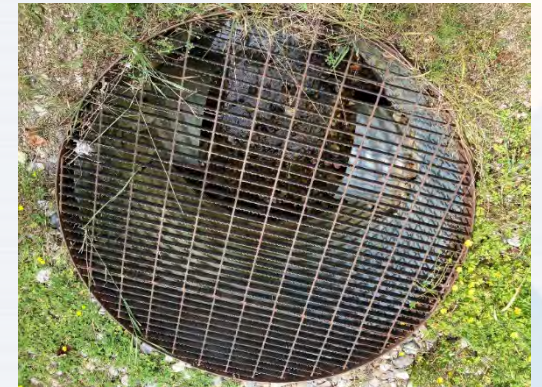
Non Traffic Rated Grate

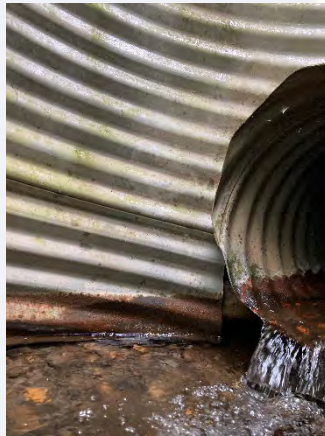
No Concrete Base

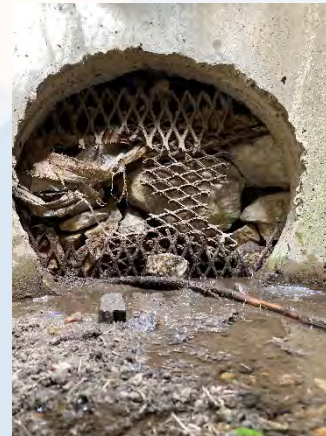
Infiltration Opening

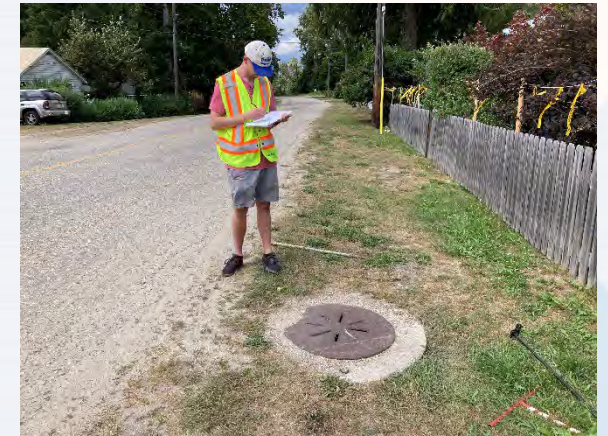
Non Standard Cover

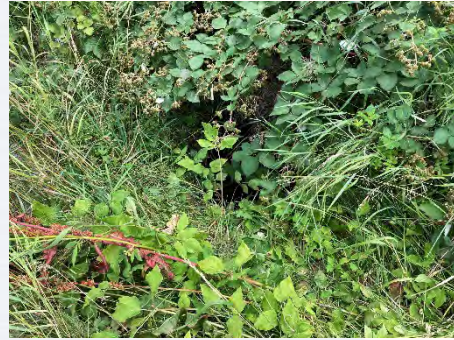
Private Service Inlet

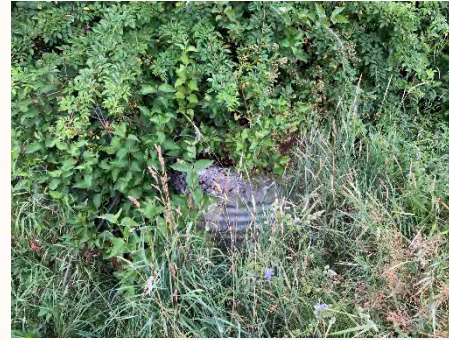
Surface Water Cannot Flow In

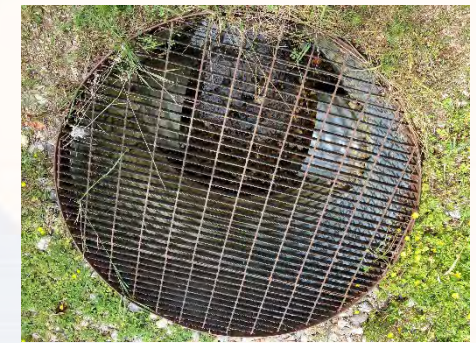
Non Traffic Rated Grate

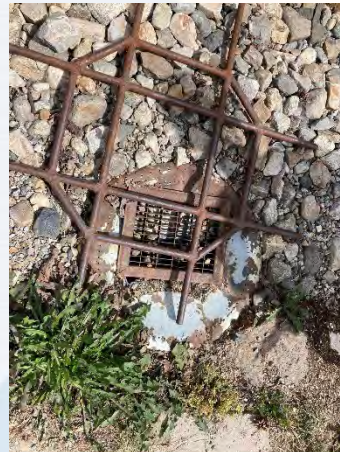
Laundry Tub CB

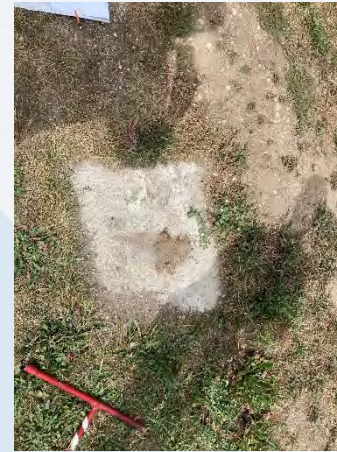
Cannot Remove Cover

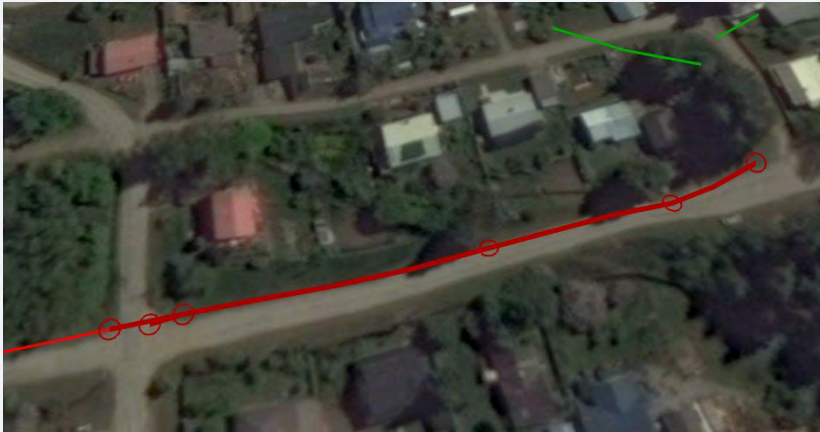
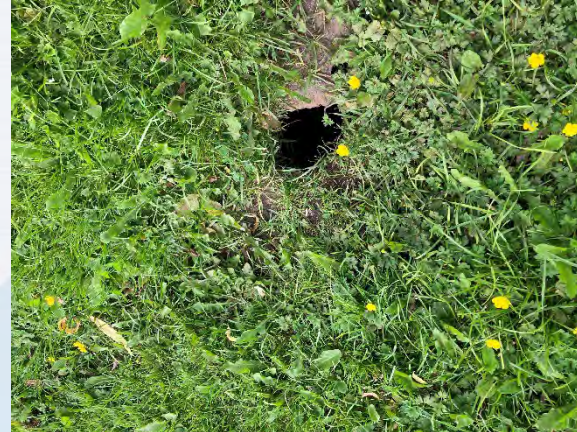
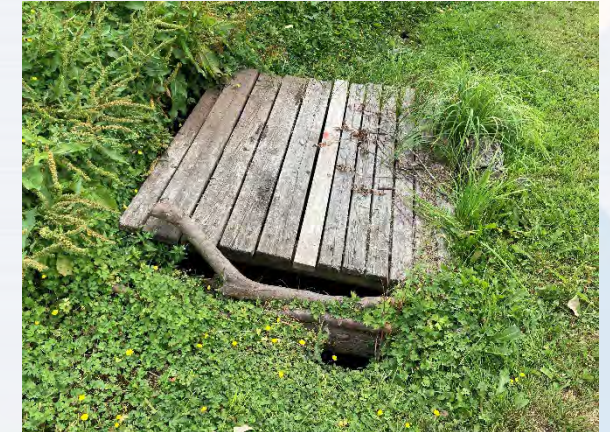
Ainsworth South Replacement

- Two new catch basins on Ainsworth might cost \$20,000 but the line also needs replacement
- Due to catch basin size, even temporary traffic rated lids might cost \$10,000
- Catch basins have been barricaded for now and staff is recommending catch basin and line replacement in 2024

- Riondel Drainage is funded from drainage service parcel taxes based on lot frontage
- Average tax per parcel in 2023 was \$72
- Ainsworth south drainage line replacement is anticipated to cost \$152,000 in 2024
- Riondel drainage service projected to have \$35,000 in reserves at year end 2023 with an additional contribution of \$20,000 in 2024.
- \$100,000 in short-term financing would be required for Ainsworth south replacement
- Public have not been supportive of replacement of the drain line with a lower cost swale

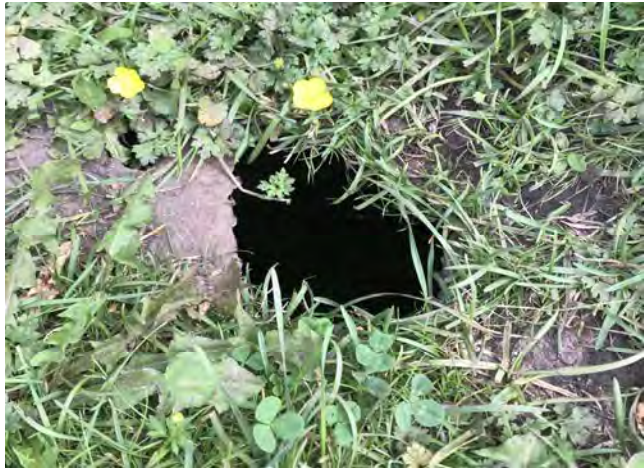
Basin #: CB 14	Material: Wood	Material Condition: Very Poor Dangerous *Non Standard
	Depth:	
	Sediment: Medium	
Inlet(s): 100mm (4") wrapped steel ~200mm (8") Wrapped Steel	Comments: Pipe entering the manhole has a hole in it. There are gaps surrounding the catch basin as well that could be a hazard. Replacement is deemed a high priority.	
Outlet(s): 250mm (10") CSP

Overall Condition **V. Poor**

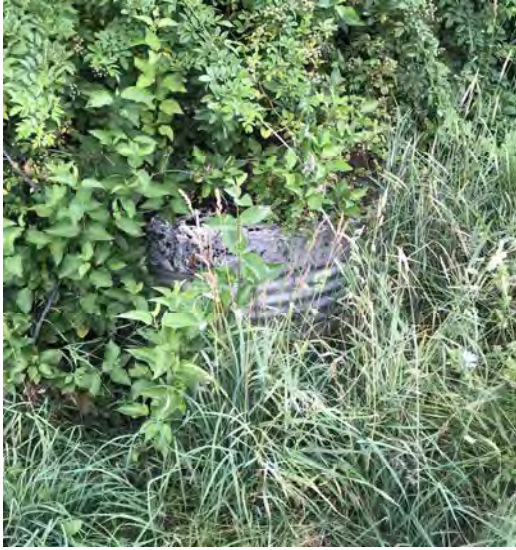
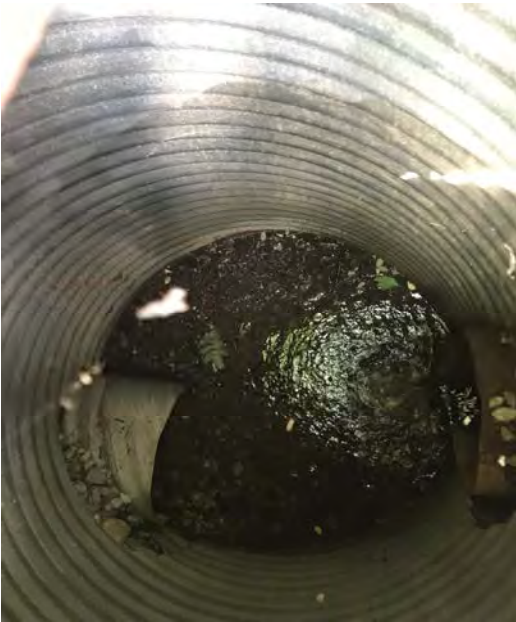
Basin #:	CB 16	Material:	CSP	Material Condition:	Fair *Non Standard
		Depth:	200cm		
		Sediment:	Medium		
Inlet(s):	500mm (20") CSP	Comments: Overgrown. Top of catch basin is well above ground level. There is a hole cut in the side from inspection ~10 years ago			
Outlet(s):	500mm (20") CSP

Overall Condition **Poor**

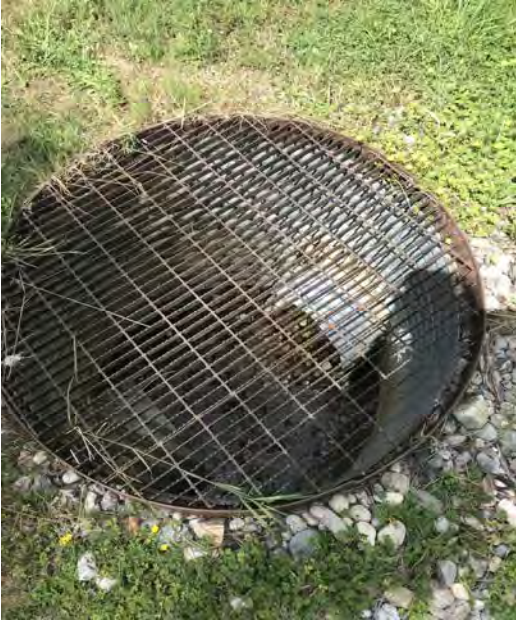
<u>Basin #:</u> CB 18	<u>Material:</u> CSP	<u>Material Condition:</u> Fair *Non Standard
	<u>Depth:</u> 114cm	
	<u>Sediment:</u> Medium	
<u>Inlet(s):</u> 500mm (20") CSP	<u>Comments:</u> 125cm width	
<u>Outlet(s):</u> 500mm (20") CSP

Overall Condition **Poor**

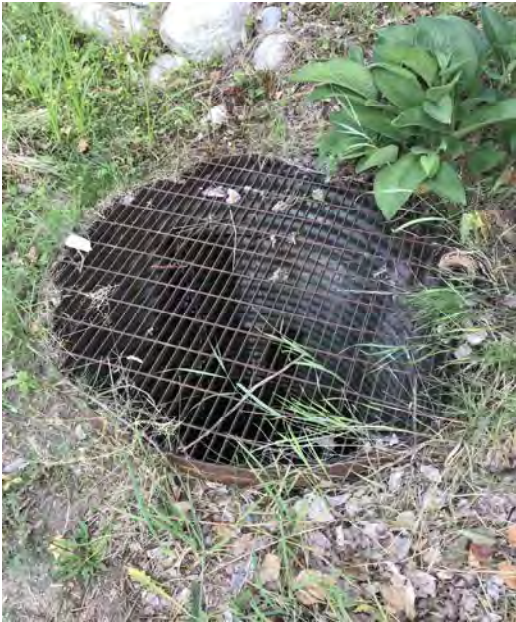
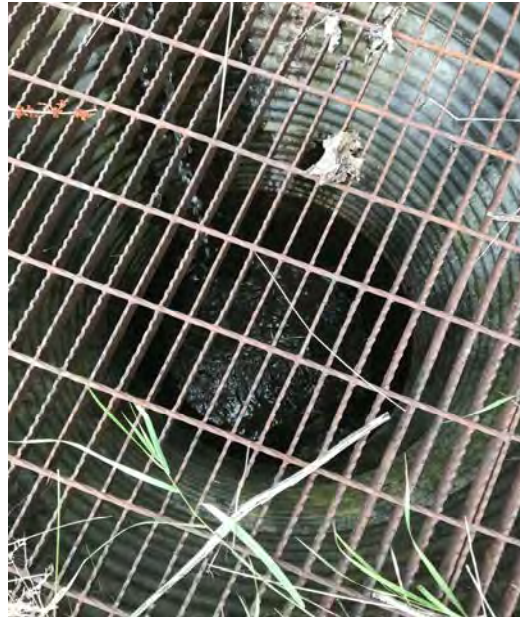
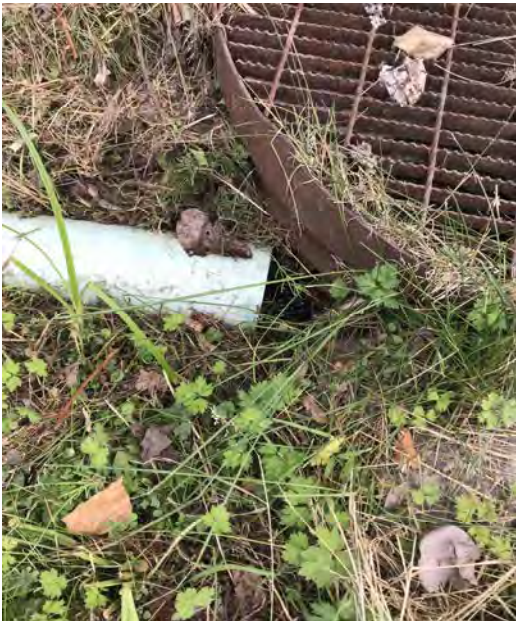
Basin #: CB 20	Material:	Material Condition: Fair *Non Standard
	Depth: 265cm	
	Sediment:	
Inlet(s): 500mm (20") CSP 200mm (8") PE private inlet enters the drainline downstream of catch basin	Comments: Includes a private inlet that is not completely attached (see photo). 125cm width.	
Outlet(s): 500mm (20") CSP

Overall Condition **Poor**

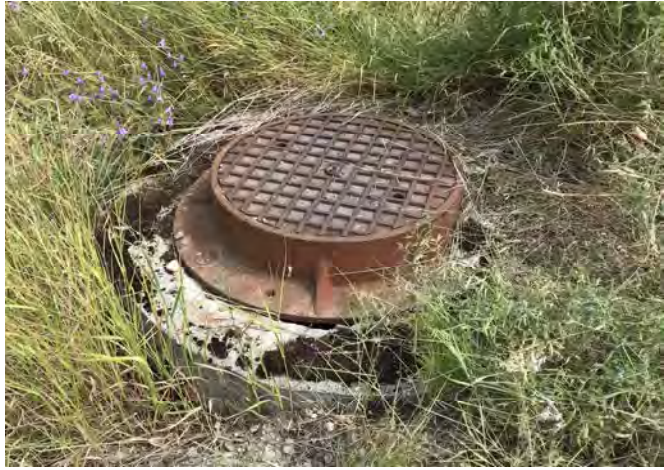
<u>Basin #:</u> CB 22	<u>Material:</u> CSP	<u>Material Condition:</u> Fair *Non Standard
	<u>Depth:</u> 425cm	
	<u>Sediment:</u>	
<u>Inlet(s):</u> 500mm (20") CSP	<u>Comments:</u> Lid is above ground and does not allow for inflow.	
<u>Outlet(s):</u> 500mm (20") CSP

Overall Condition **Poor**

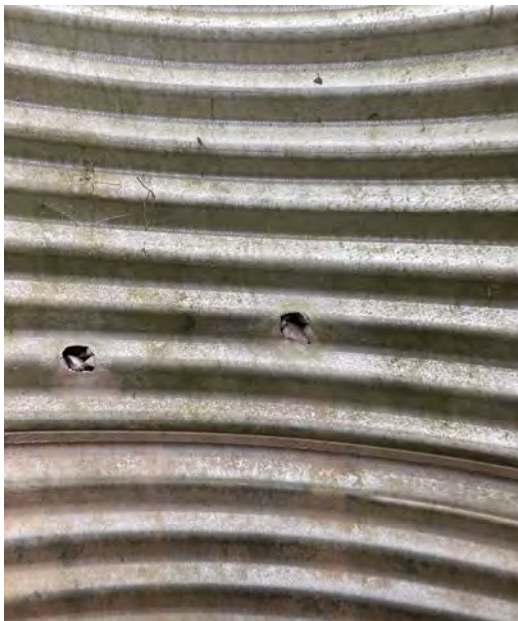
Basin #: CB 23	Material: CSP	Material Condition: Fair *Non Standard
	Depth: 324cm	
	Sediment:	
Inlet(s): 500mm (20") CSP 12 punched holes	Comments: Overgrown and above ground. The drainage ditch does not directly connect to the catch basin. There are 12 inlets drilled into the catch basin walls in a circle at ~235cm depth. The holes are likely draining water from the ground. No pipes appear to be connected to these 12 holes.	
Outlet(s): 600mm (24") CSP

Overall Condition **Poor**

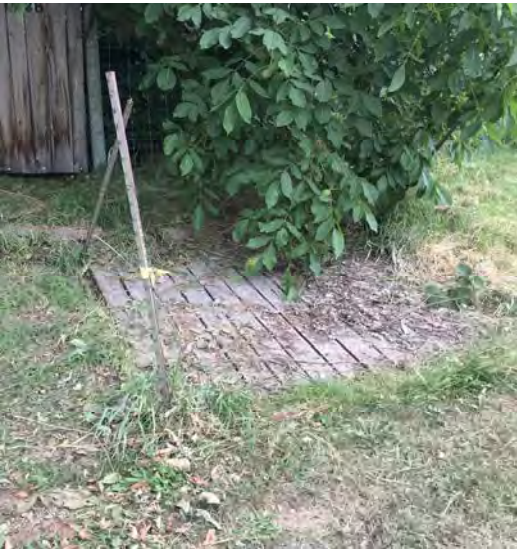
Basin #:	CB 25	Material:	Wood	Material Condition:	Very Poor *Non Standard
		Depth:	Shallow		
		Sediment:	High		
Inlet(s):	~200mm (8") wrapped steel			Comments: Replacement deemed a high priority for safety	
Outlet(s):	~200mm (8") wrapped steel

Overall Condition **V. Poor**

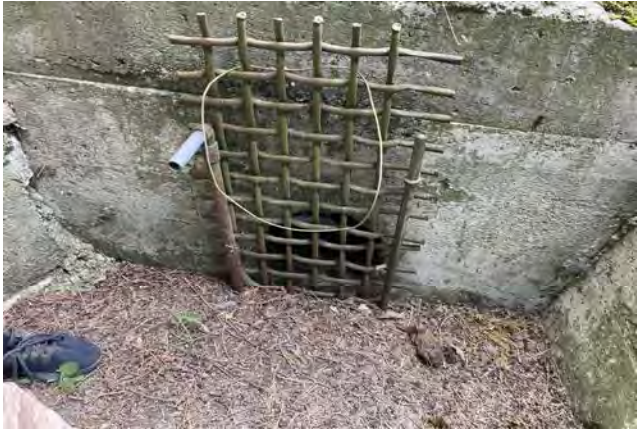
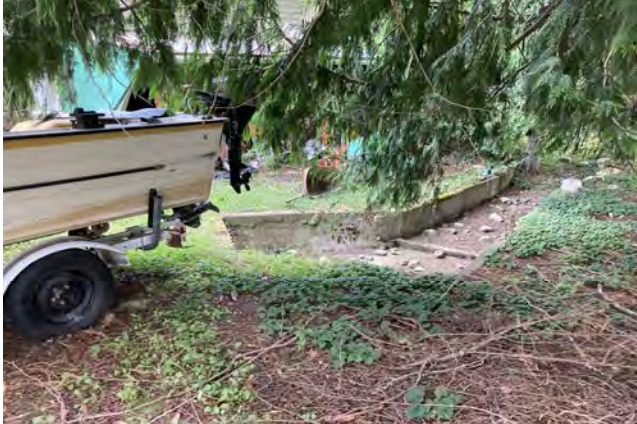
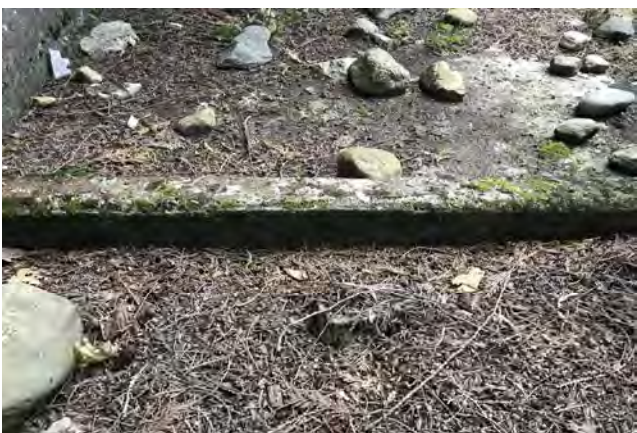
Basin #:	Weir	Material:	Concrete; CSP	Material Condition:	Fair
		Diameter:	300mm		
		Sediment:	Low

Comments: Concrete channel and weir are in fair condition, with some stones and debris in the channel. CSP pipe is in fair condition and connects to catch basin #24 (previously unnumbered) which was not located.

Overall Condition **Fair**

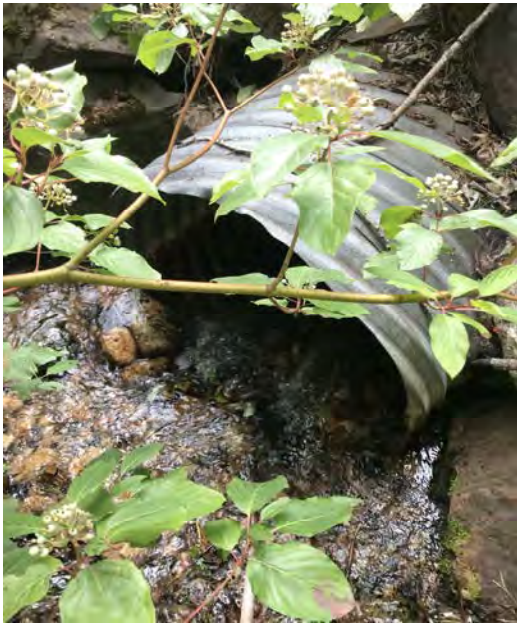
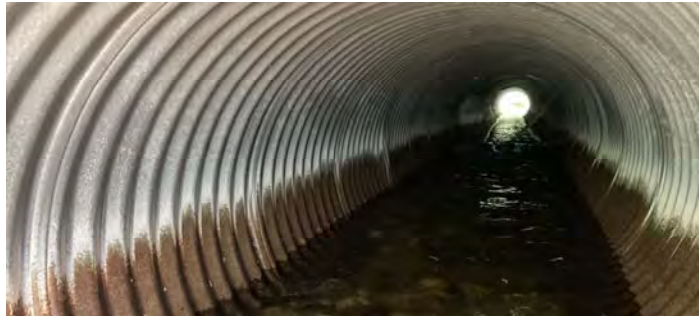
Inlet

Basin #:	CV 1	Material:	CSP	Material Condition:	Fair
		Diameter:	900mm		
		Sediment:	Low

Comments: Culvert crosses Eastman Ave, connecting two drainage ditches. Outlet from catch basin #9 (500mm CSP) t's into the culvert at ~8m from the culvert inlet. This places the connection point at approximately the road shoulder.

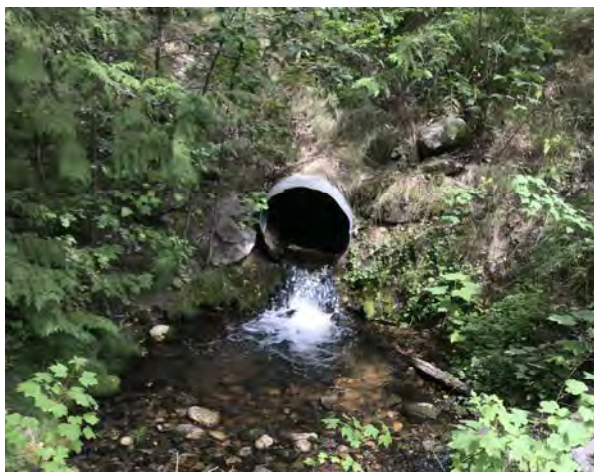
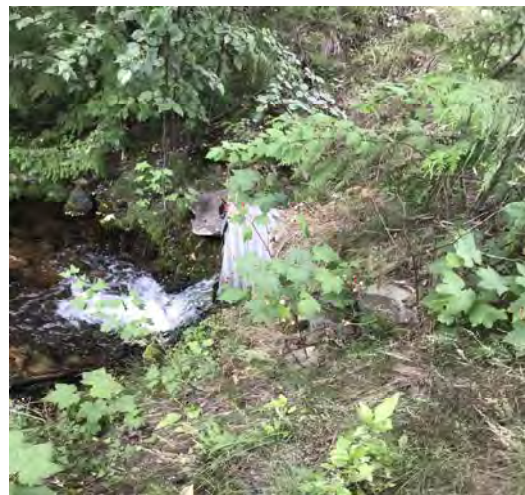
Outlet

Overall Condition **Fair**

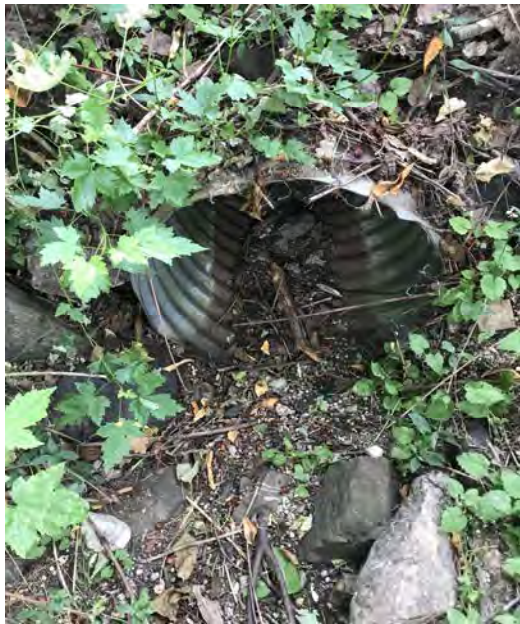
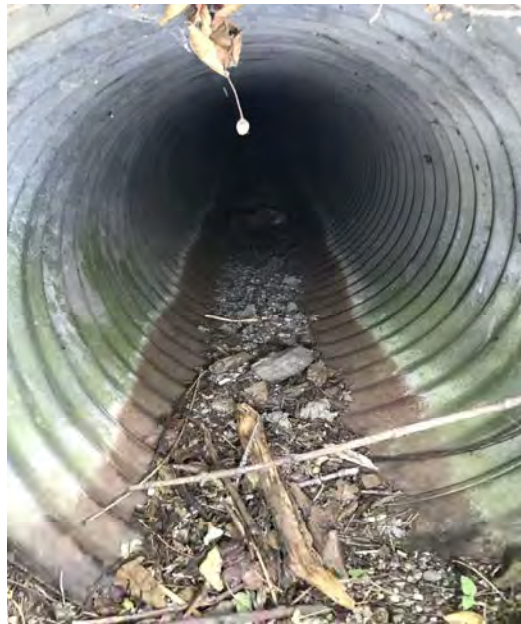
Inlet

Basin #:	CV 3	Material:	CSP	Material Condition:	Fair
		Diameter:	600mm		
		Sediment:	Medium

Comments: Culvert crosses Russel Ave and connects two drainage ditches. Neighbour has said that the culvert has no flow in the spring. The outlet is likely on Teck land. The outlet is difficult to access.

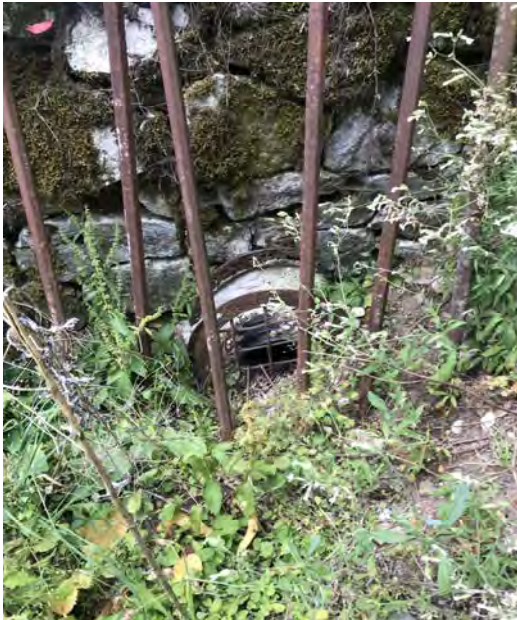
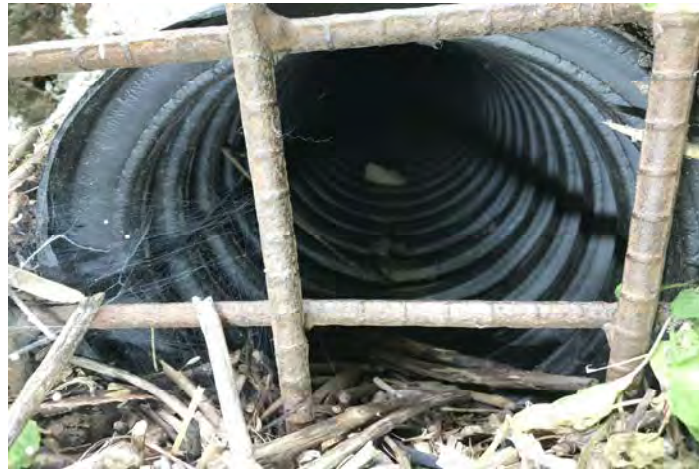
Basin #:	CV 4	Material:	Big O HDPE; CSP	Material Condition:	Fair
		Diameter:	200mm (ID); 500mm		
		Sediment:	Medium

Comments: Culvert crosses the alley between Russel Ave and Ainsworth Ave and connects two drainage ditches. Inlet is 240mm and transitions to 500mm CSP at some point underground. Culvert was dry at time of inspection. Inlet and outlet are located on park land (Teck).

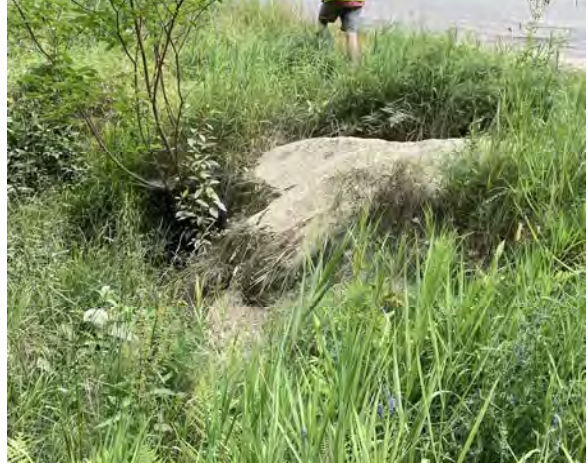
Outlet

Basin #:	CV 5	Material:	CSP	Material Condition:	Fair
		Diameter:	300mm		
		Sediment:	Medium

Comments: Culvert crosses Riodel Rd and connects two drainage ditches. Pipe is in fair condition but could be cleaned up.

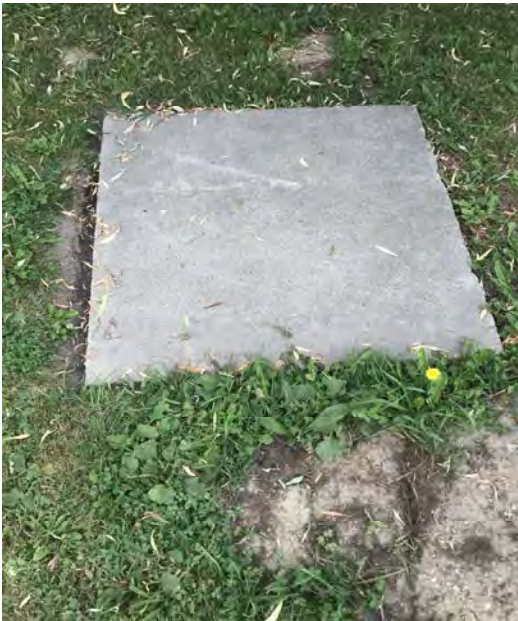
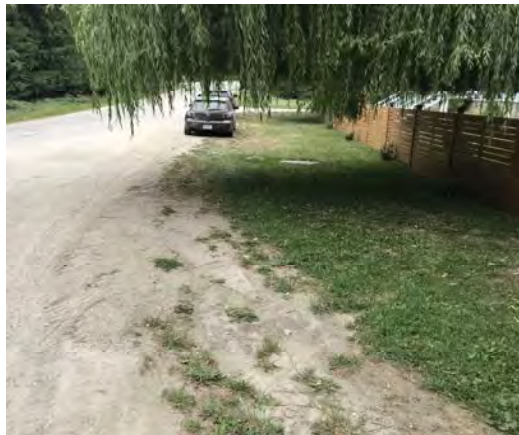
Outlet

Basin #:	CV 6	Material:	CSP	Material Condition:	Fair
		Diameter:	600mm		
		Sediment:	High

Comments: Culvert crosses Folwer St and connects a drainage ditch to an unknown location. There is a concrete pad on the North side of Fowler St that may be covering a catch basin. The culvert may continue into the neighbouring property (416 Folwer St). Recommended to confirm culvert outlet and replace concrete pad with a steel grate if covering a catch basin. Culvert should be graded appropriately for MoTI.

Overall Condition **Poor**

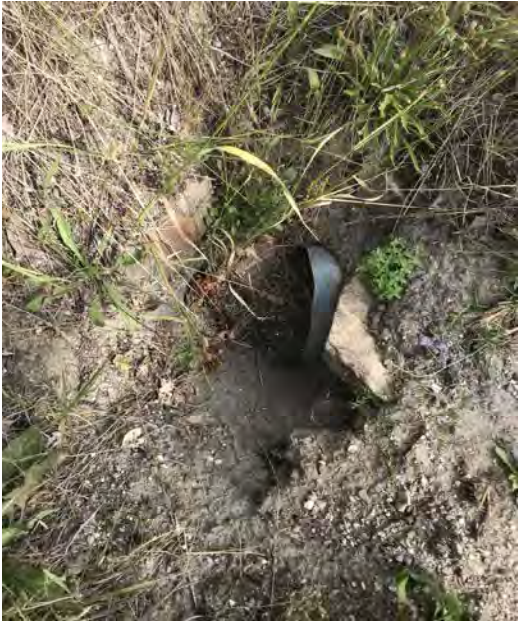
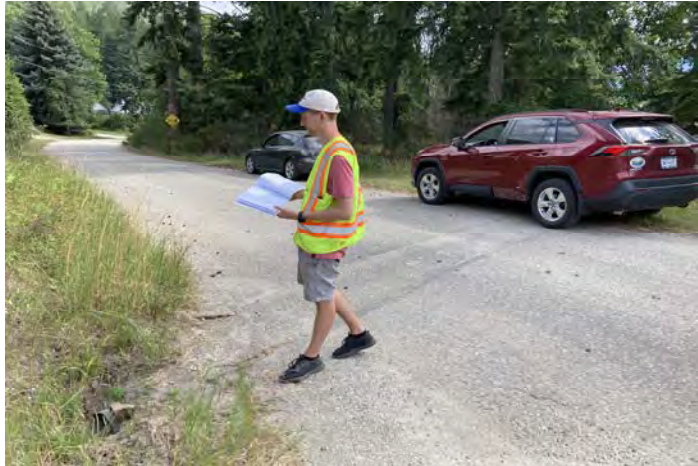
Basin #:	CV 7	Material:	CSP	Material Condition:	Poor
		Diameter:	300mm		
		Sediment:	High

Comments: Culvert crossing Galena Bay Wharf Rd. Inlet is partially buried and surround area does not flow appropriately into the inlet. Outlet is completely buried and unable to be identified.

Overall Condition **Very Poor**

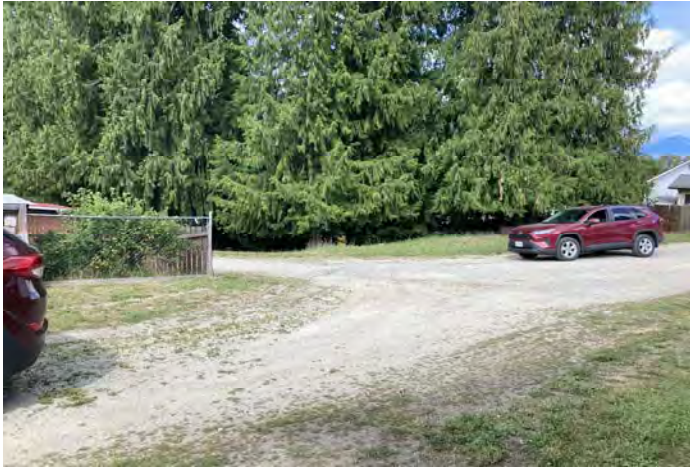
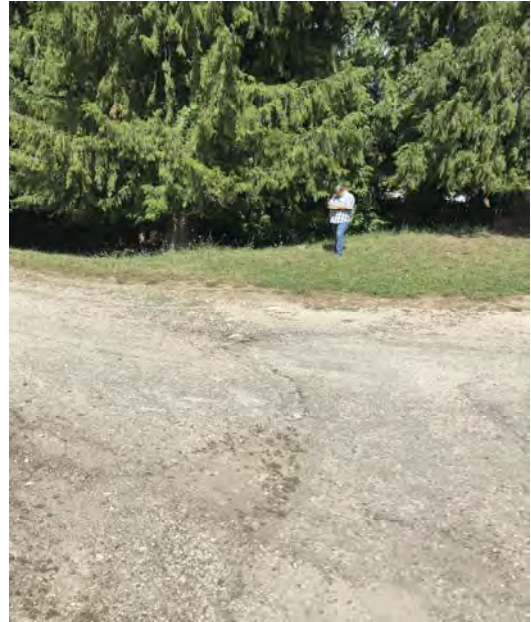
Inlet

Basin #:	CV 8	Material:	Big O HDPE	Material Condition:	Good
		Diameter:	~200mm (ID)		
		Sediment:	Low

Comments: Privately installed culvert crossing the alley between Ainsworth Ave and Russel Ave. The inlet was not able to be located but a neighbour reported that it comes from a private property (house on corner of alley).
